**Bedrock Associated with the Ranch House at the
Tallgrass Prairie National Preserve,
Chase County, Kansas**

**KGS OPEN-FILE
REPORT 2008-10**

Robert S. Sawin
Kansas Geological Survey

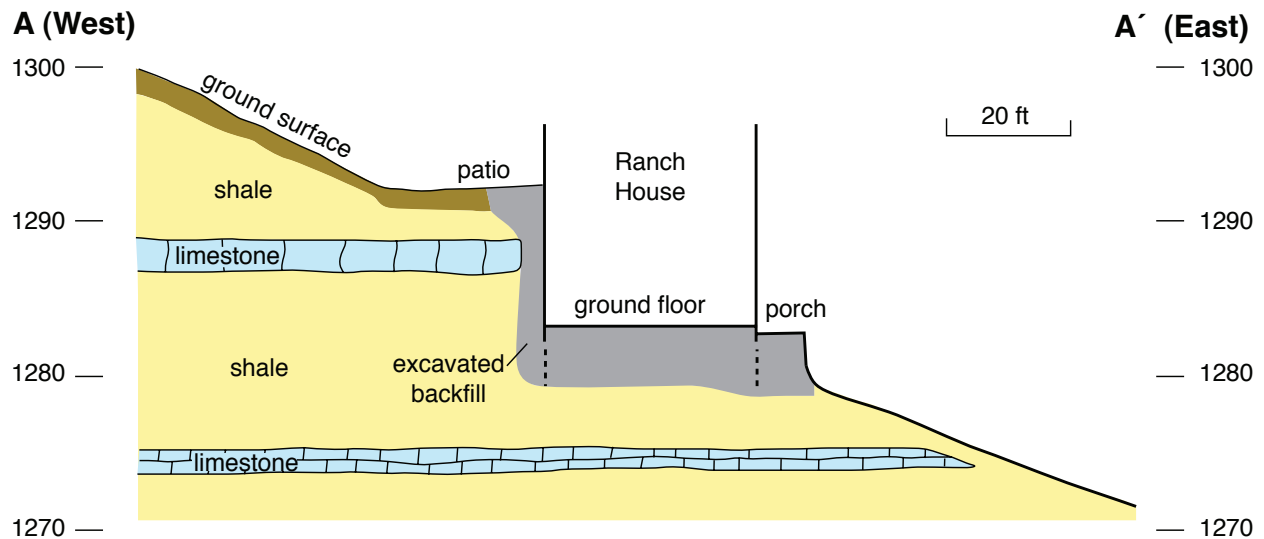
Figure 2. Cross Section A-A'.

Figure 2 (Cross Section A-A') depicts the west-east cross sectional view through the Ranch House and hillside. The upper limestone shown on the cross section (lower Crouse Limestone) was observed in the waterline trench southwest of the Ranch House (Figure 3). The thickness of the limestone is about 2.4 feet in this trench. Regularly spaced

The lower limestone shown in Figure 2 (limestone in the Easley Creek Shale) was observed in the waterline trench that was dug in the driveway west of the main entrance to the top of the hill. The thickness of this limestone is about 1.4 feet at this location.

At the Ranch House, the upper limestone shown in Figure 2 is probably a water-bearing unit during times of abundant precipitation.

Where this limestone intersects the Ranch House foundation excavation, it probably transports water to the excavation's backfill material. This might explain reports of running water in the crawl space under the

ground floor, and temporary seeps or springs that occur around the front porch.

together make up the foundation and floor supports. While the total depth of the foundation was not observed, it probably does not extend to the lower limestone shown

in Figure 2. This suggests the Ranch House foundation probably rests on shale bedrock. Further investigation would be necessary to confirm this conclusion.

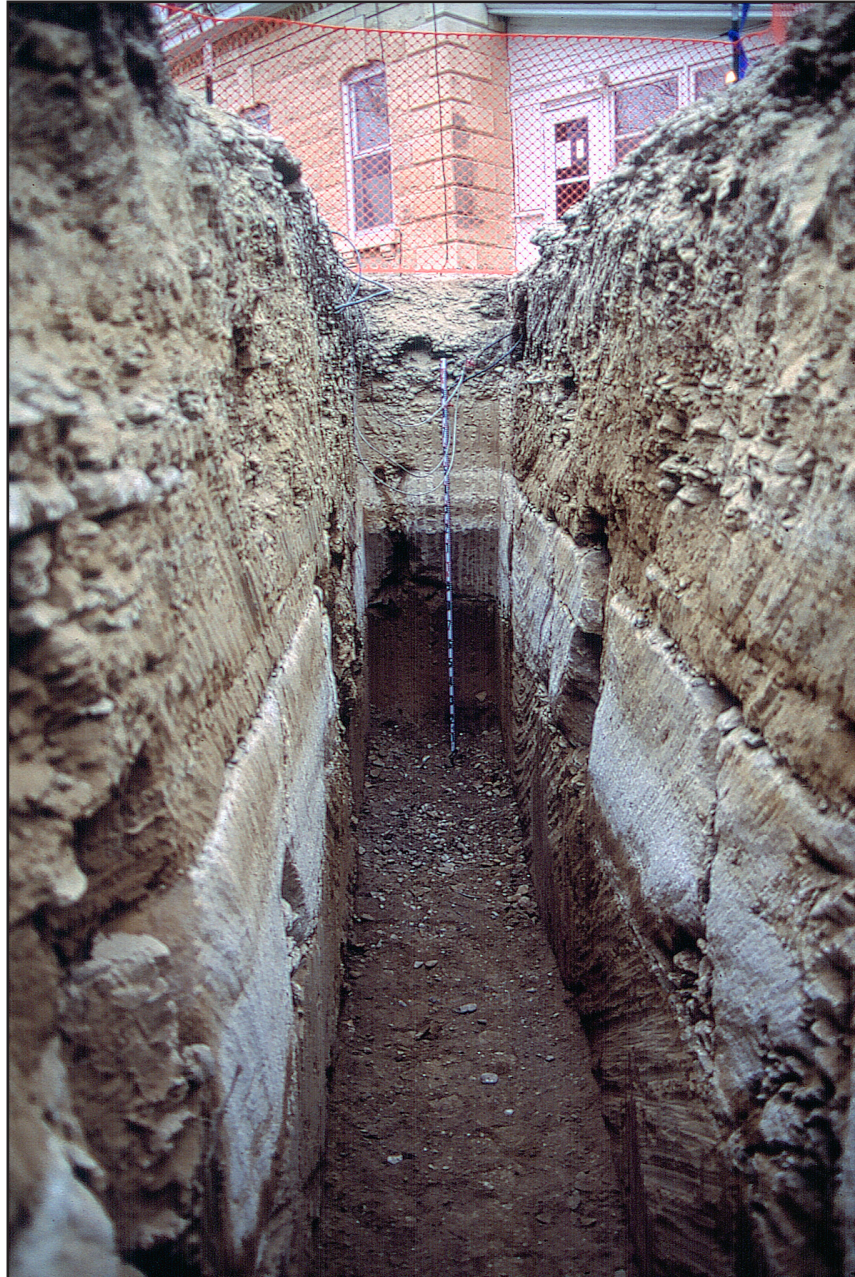
Figure 3. *Limestone layer (2.4 feet thick) in waterline trench southwest of Ranch House. This is the upper limestone in Cross Section A-A'.*

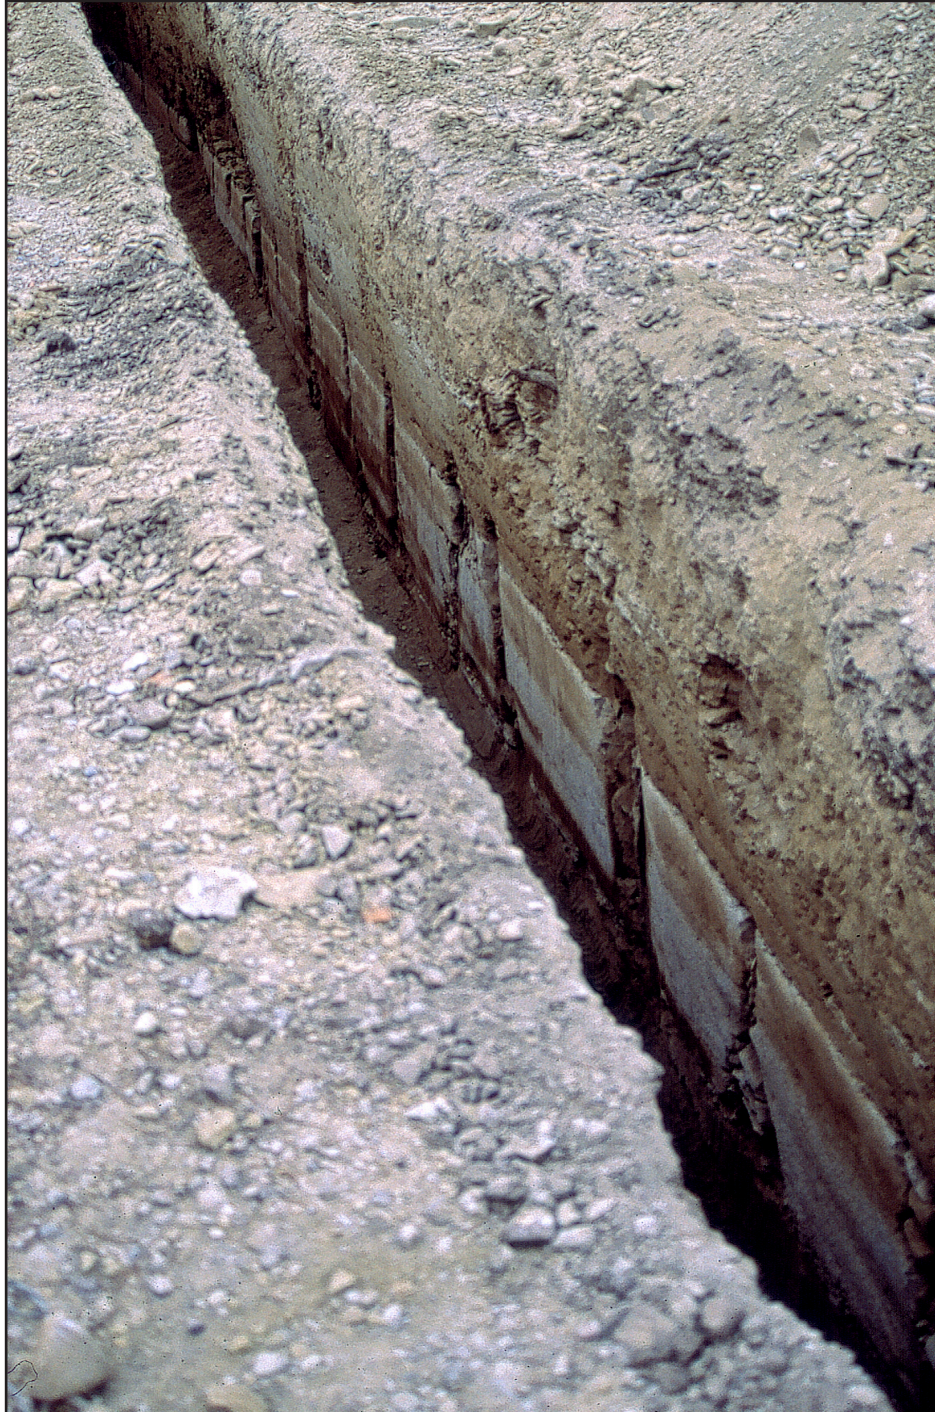
vertical joints (fractures) have been widened by the flow of ground water and are easily seen in Figure 4. Figure 5 is a close-up of one of these enlarged joints. Water was observed dripping from this joint about four hours after the trench was excavated.

Figure 4. *View of the east side of trench. Note the regularly spaced vertical joints in the limestone.*

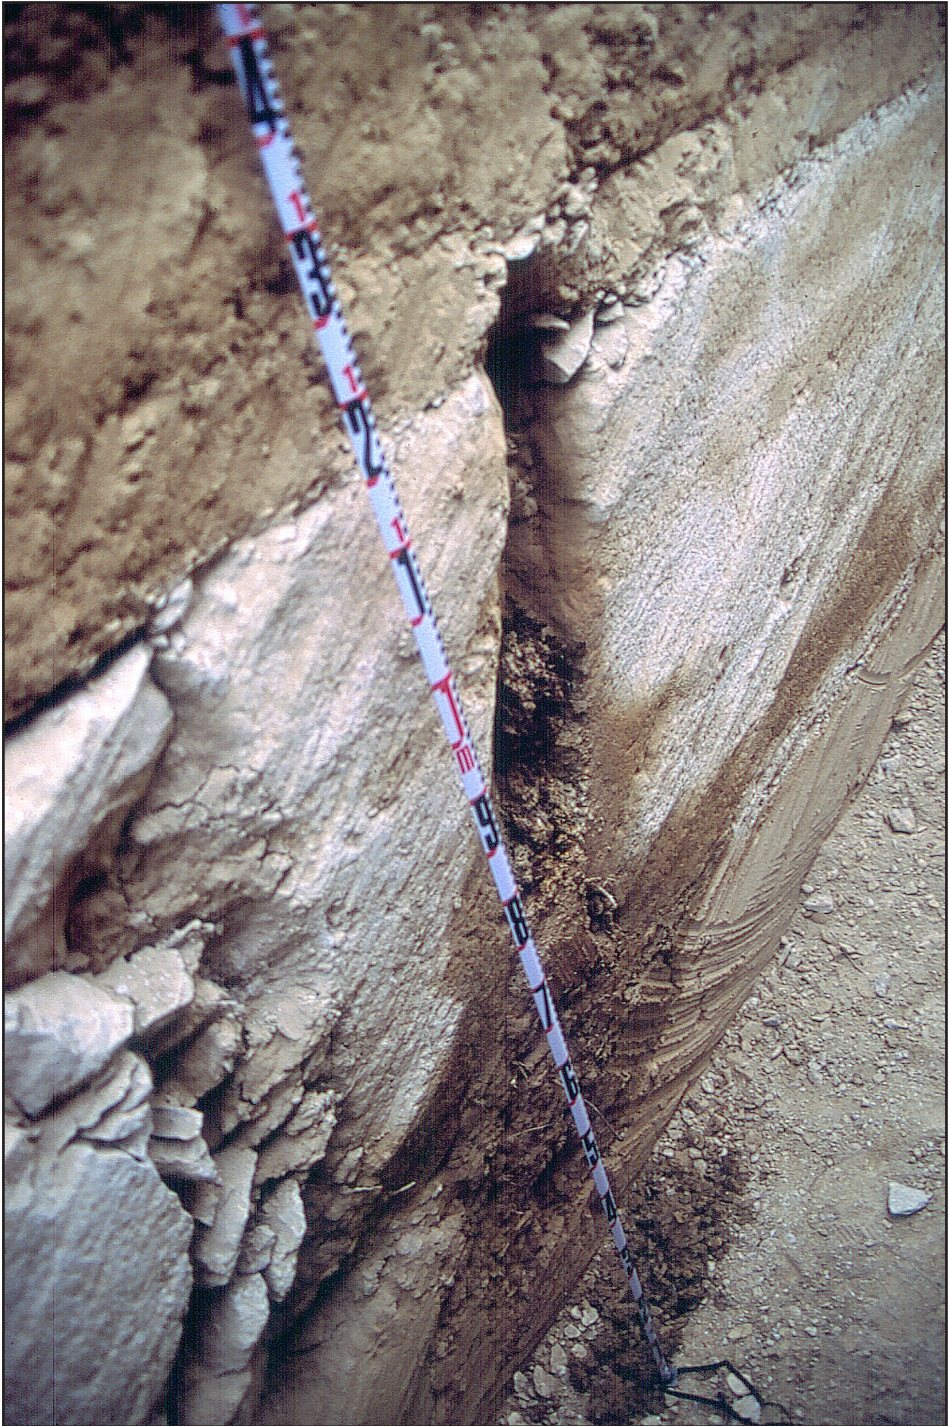
Figure 5. *Close-up of a vertical joint. This joint was dripping water about four hours after the trench was excavated.*
