**KANSAS GEOLOGICAL SURVEY
Open File Report 2009-02**

RECONNAISSANCE OF A SUBSIDENCE FEATURE IN BUTLER COUNTY, KANSAS

Prepared by
Michael T. Dealy, L.G.
February 1, 2009

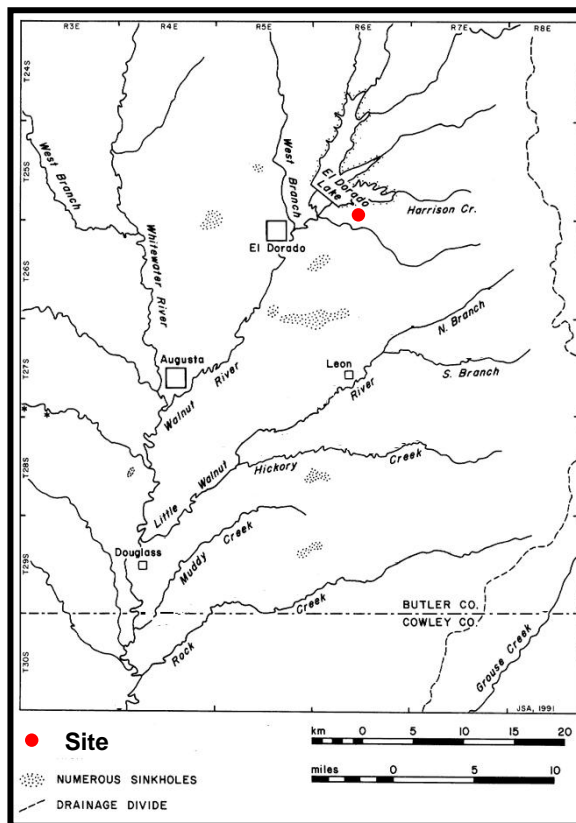
Known sinkholes in Butler County and the site location of the feature are shown in Figure 8¹³. Zones of dense sinkhole development are associated with several structural and topographic conditions:

The site has two karst conditions described by Aber: an anticline and level to gently sloping surface topography. To the north of the site, sinkholes are found around El Dorado Reservoir and to the south numerous sinkholes have been located, Figure 8.

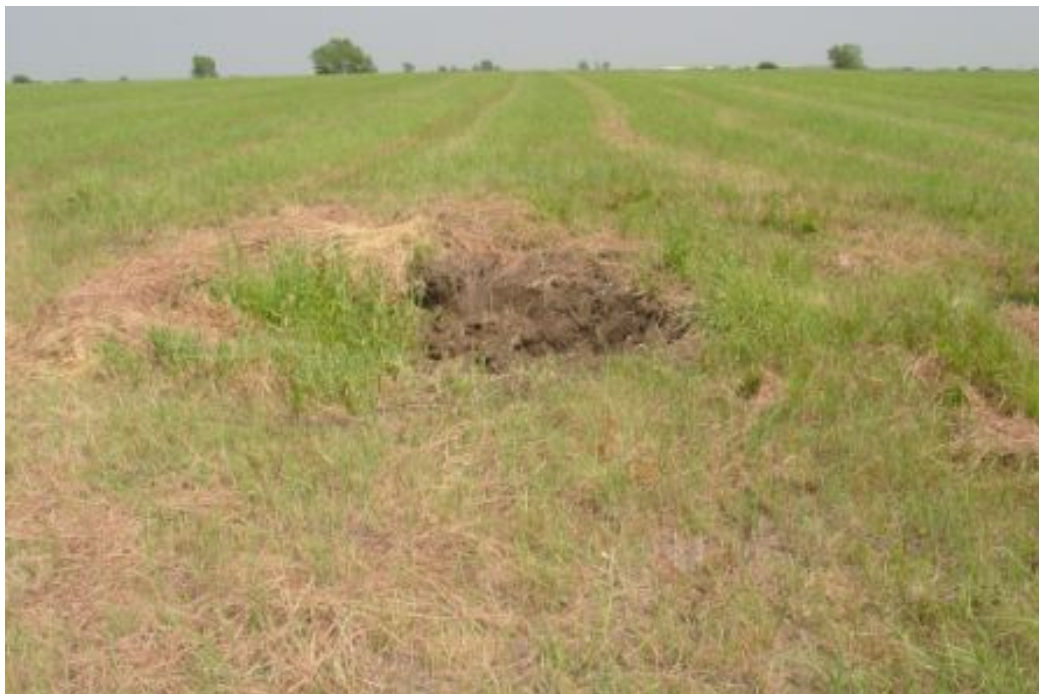
After a cutting of native grass in the summer 2008, the land owner observed the backfill had settled about three feet. Additionally, the land owner noted that the backfill material appeared to be churned up³. The land owner contacted Sandy Koontz, Butler County Conservation District (BCCD), about the feature and a field inspection was conducted by BCCD staff July 23, 2008, Appendix - Images 1 and 2.

Image 1.—Backfilled sinkhole SW 34-25-06E, north view direction, by S Koontz, BCCD, July 2008

Because of site surface conditions and the regional hydrology and geology that are favorable to karst, the sinkhole may continue to develop and may not be an isolated karst feature. For safety purposes it is recommended that the feature's protective fencing is maintained and caution used as other karst features may develop in the vicinity.

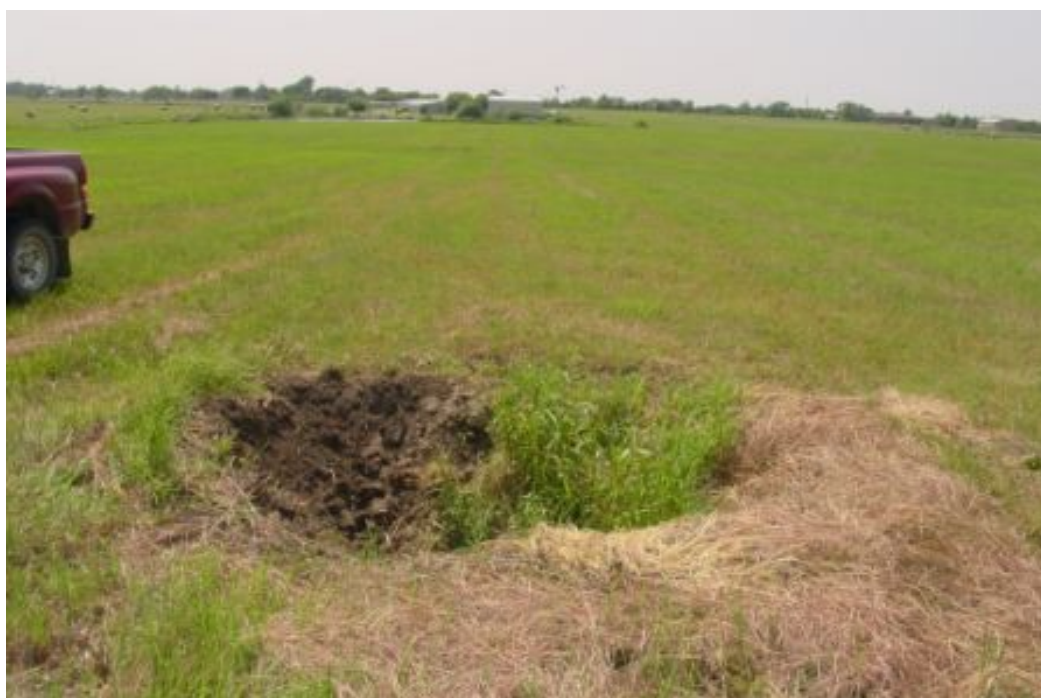
Image 2.— Backfilled sinkhole SW 34-25-06E, south view direction, by S Koontz, BCCD, July 2008

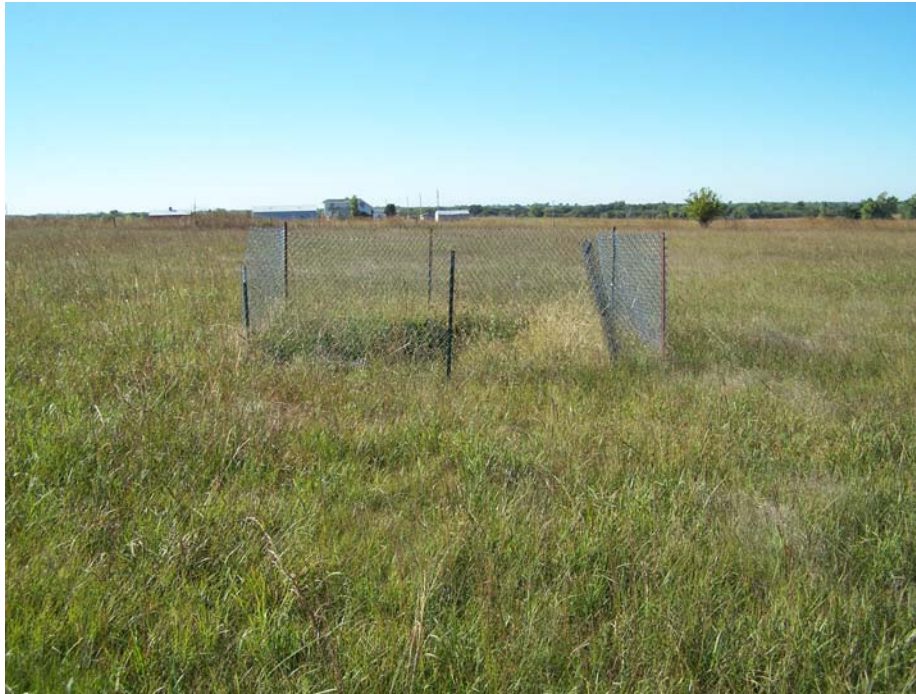
Based on the report findings, the subsidence feature appears to be a natural sinkhole caused by vertical drainage of water into fractured, soluble limestone with resulting sinkhole solution.

Image 3.—Backfilled sinkhole SW 34-25-06E, south view direction, by MT Dealy, KGS, October 2008
