**KANSAS GEOLOGICAL SURVEY
OPEN-FILE REPORT 1937-2**

Memorandum to the District Engineer
Inspection of Failure of Wyandotte County Dam

Marshall Creek Dam, Kansas

Subject: Inspection of failure of Wyandotte County Dam.

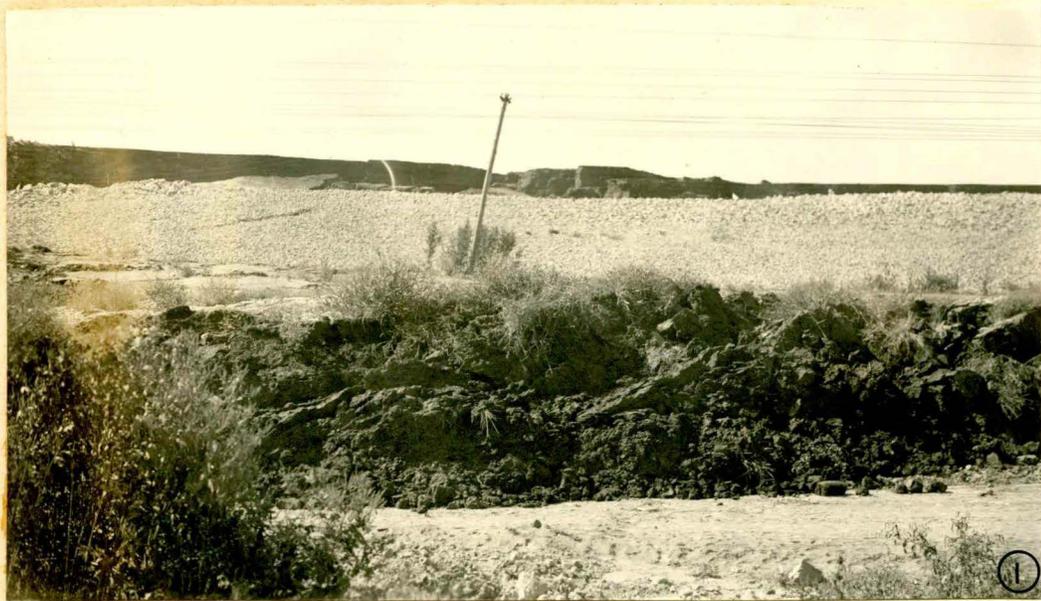
Taken from the Missouri Pacific Railroad embankment showing the downstream face of the dam and the material pushed out on the old creek bank by the slide.

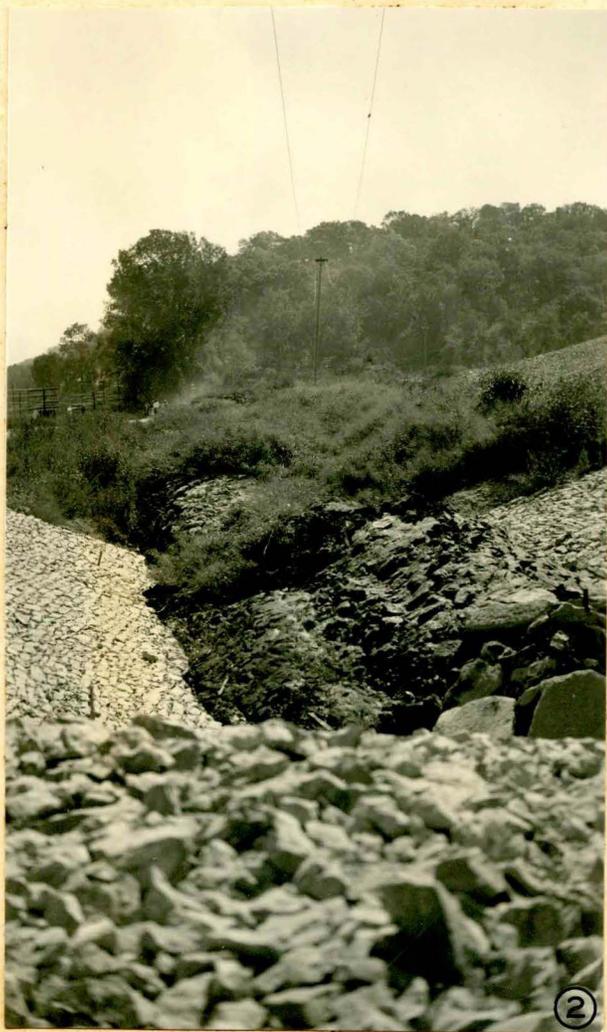
Taken from near the head wall of the spillway outlet, looking down along the spillway outlet channel, showing the earth pushed up by the slide.

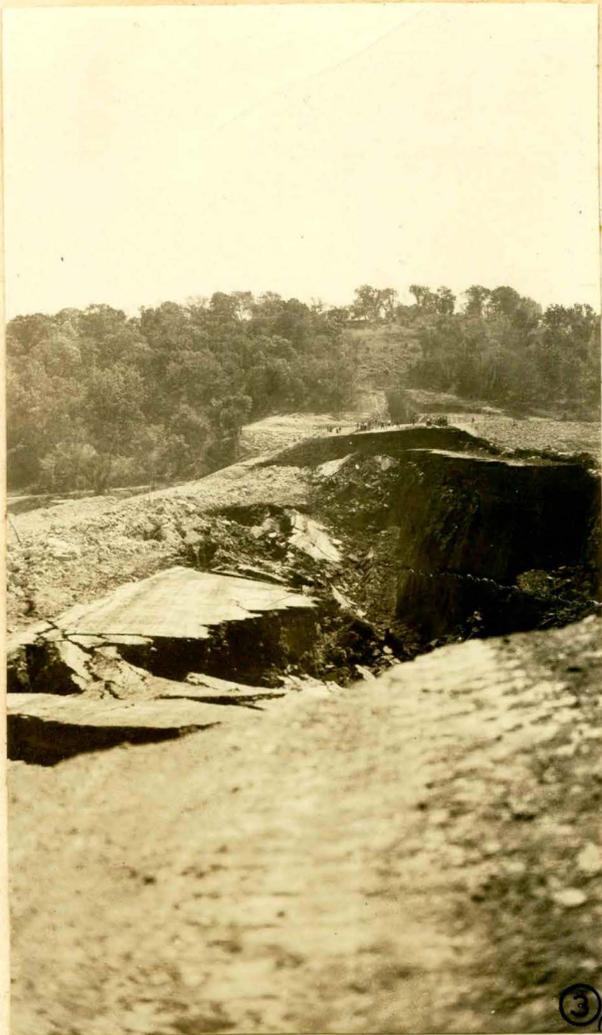
Looking east along the center line of the dam from Station 11, showing the depth of the fissure left by the movement of the downstream section of the dam.

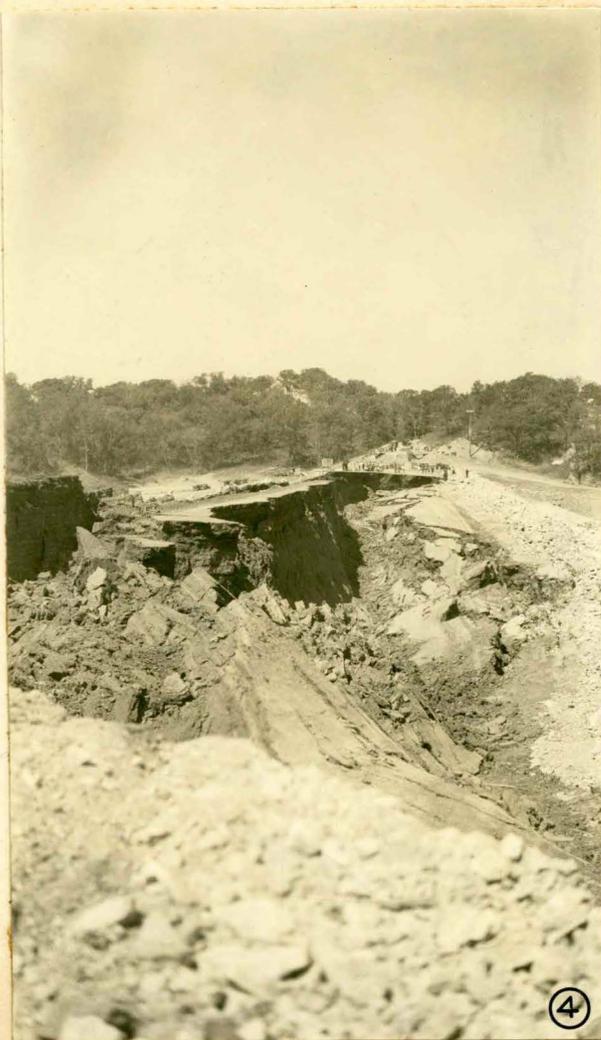
Taken from below the crest of the dam, looking west showing the fissure left by the slide.

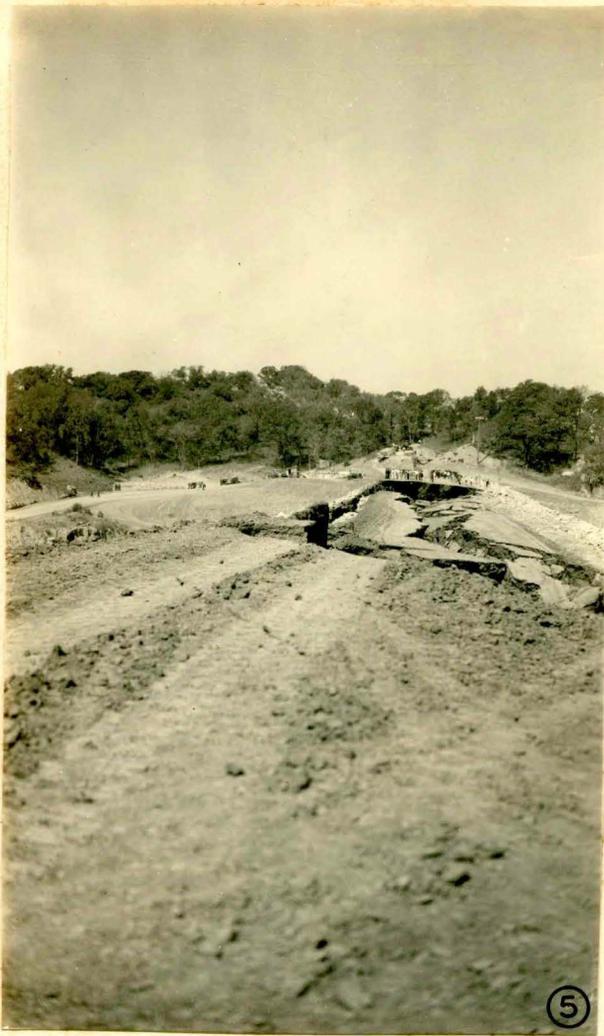
Taken from approximately station 4 on center line looking west, showing the cleavage between the upstream face and a portion of the crest of the dam.

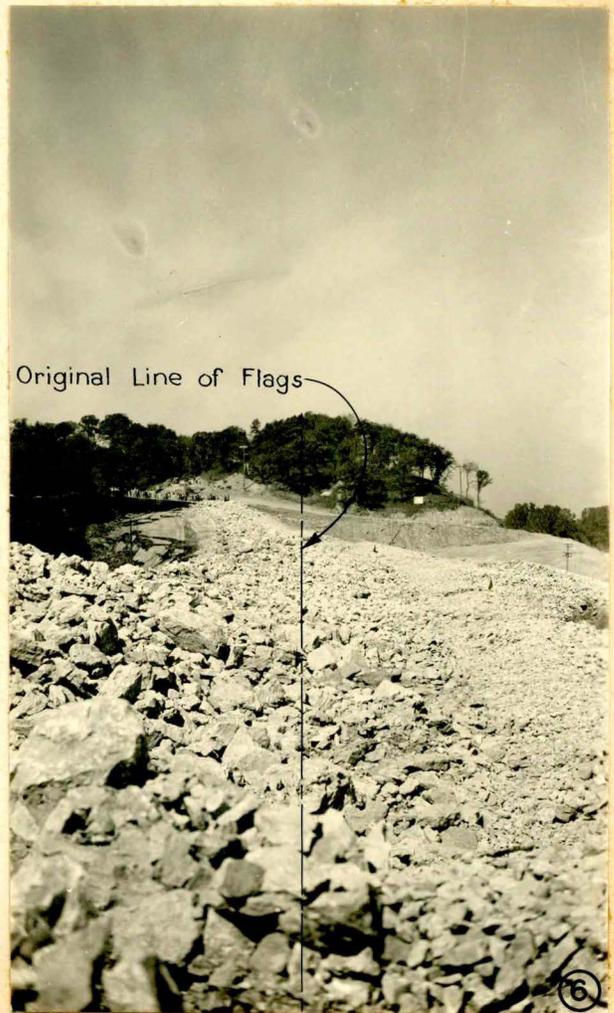
Looking west along the line of the first berm below the top of the dam, showing the lateral displacement of the berm flags which were, previous to the failure, on the line indicated in ink on the photograph.

Original Line of Flags

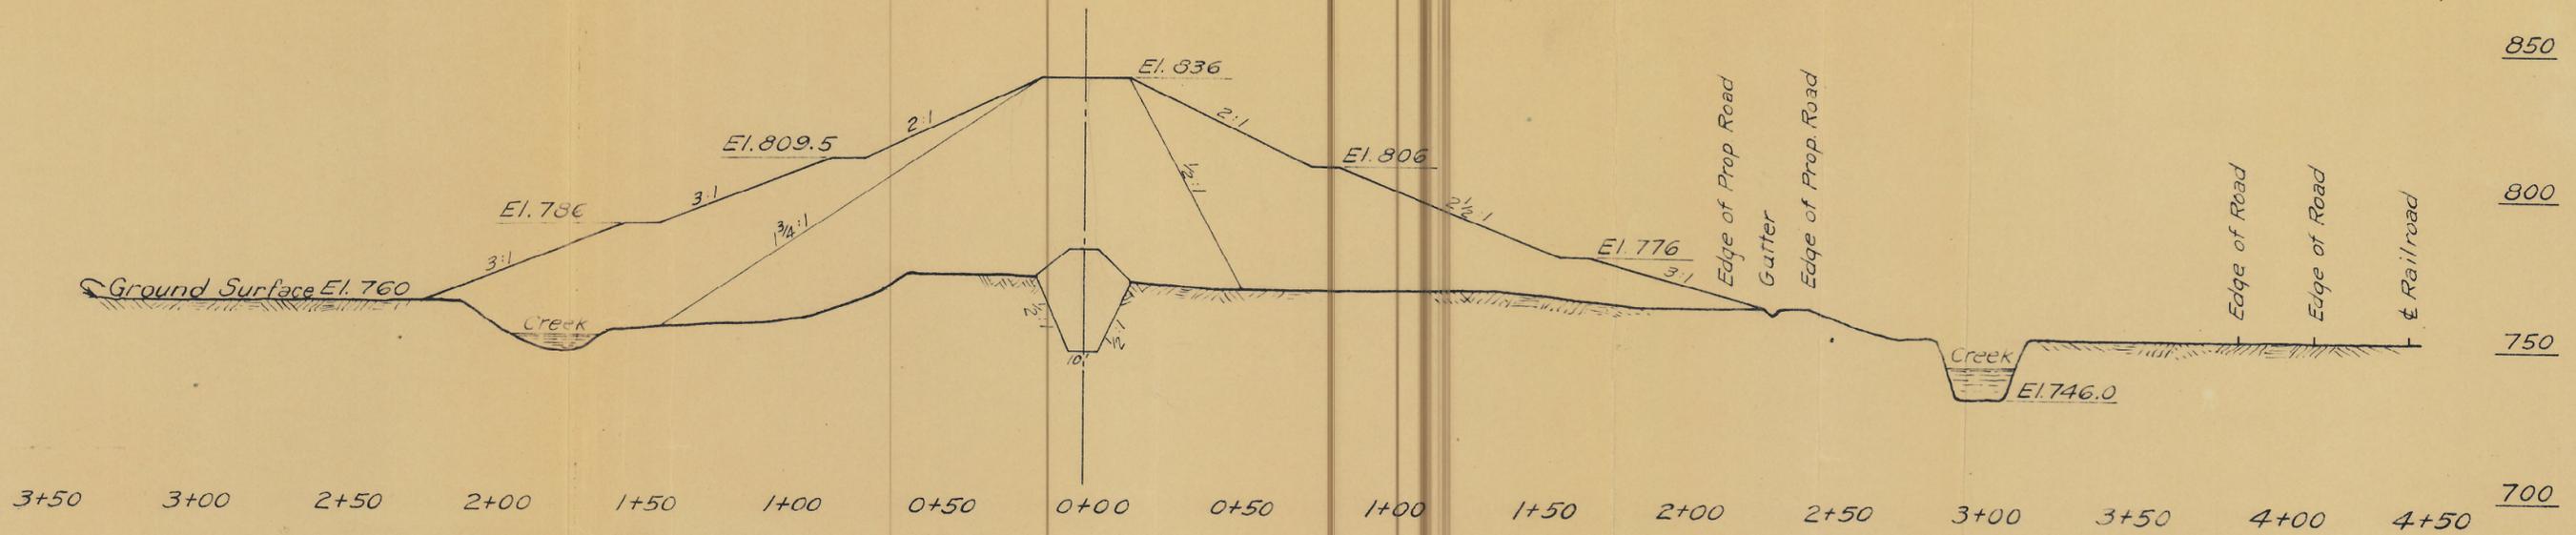
WYANDOTTE COUNTY DAM
 Section at Station 8+50
 Scale 1"=50'

4. The earth work on the center line of the dam was at approximately elevation 830 at the time of the failure. There was little water in the reservoir above the dam, the water surface elevation being at approximately elevation 765. The geological cross-sections on the center line of the dam shows a layer of soft blue clay from Station 4+00 to Station 10+00. This clay is located roughly between elevations 730 and 750, being approximately 100 feet below the projected top elevation of the dam (elevation 838).
