# Kansas Geological Survey

## Report on the 2000 Ashland and the 1999 Plains sinkholes

**Open File Report 2000-39**

July, 2000

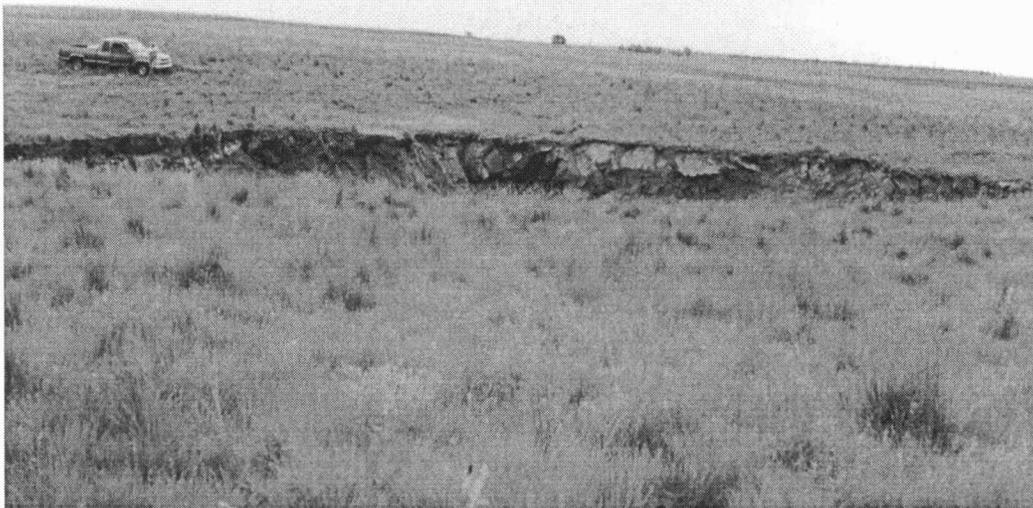
Three sinkholes were observed at this location. The first sinkhole is a catastrophic failure. It is teardrop shaped in map view with nearly vertical sides. The dimensions are approximately 33.5 m (110 ft) by 30.5 m (100 ft), and the depth is estimated to be 15 m (50 ft). Water had collected in the bottom of the sinkhole at the time of my visit. The ranch operator reported that there had been water in the sinkhole immediately after the failure, but it dried out until recent rains. The walls exposed red to orange sandstone, siltstone, and shale of the Permian Whitehorse Formation. The geologic map (Fairer and Green, 1994) shows the area as Quaternary Dune Sand; however, no dune sand was observed. Bedrock in the walls of the sinkhole is highly fractured. The dip of bedrock is horizontal except at the west end where it dips gently west. These dipping strata may indicate the presence of an earlier, healed sinkhole west of the current failure. Numerous perimeter fractures around the outside of the sinkhole extend for a distance of about 30 m (100 ft) beyond the rim. Perimeter fractures are curved cracks in the ground surface

that are approximately parallel with the rim of the sinkhole. The ground surface increases in elevation for about 30 m (100 ft) beyond the rim in all directions until it reaches the pre-failure elevation. It was reported that the area was flat prior to the failure.

The second sinkhole is located east of the first. The center of the second sinkhole is approximately 46 m (151 ft) east of the center of the first. It was a gradual failure with gently sloping sides. The amount of subsidence was less than 3 m (10 ft). No water had collected in this sinkhole. Several small ridges, less than 15 cm (0.5 ft), had formed in the center of this sinkhole. These ridges probably formed due to compression in the center of the subsiding area. Tangential tension cracks were observed away from the central region.

The Kansas Geological Survey was requested by the ranch operator to examine the collapse sinkhole and comment of the stability of the walls. The operator wanted to know if he could collapse one side and build a ramp that would provide an exit for any cattle entering the sinkhole. Based on the highly fractured nature of the bedrock in the walls and the perimeter fractures, I told the operator that the sides were unstable. The walls of the sinkhole will recede (the sinkhole will increase in diameter) over the next several years even if nothing is done. I recommended placing a fence around the sinkhole. If the owner or the operator wish to do more, I recommend they hire a geotechnical engineering consultant and a geologist to advise and design any remedial measures.

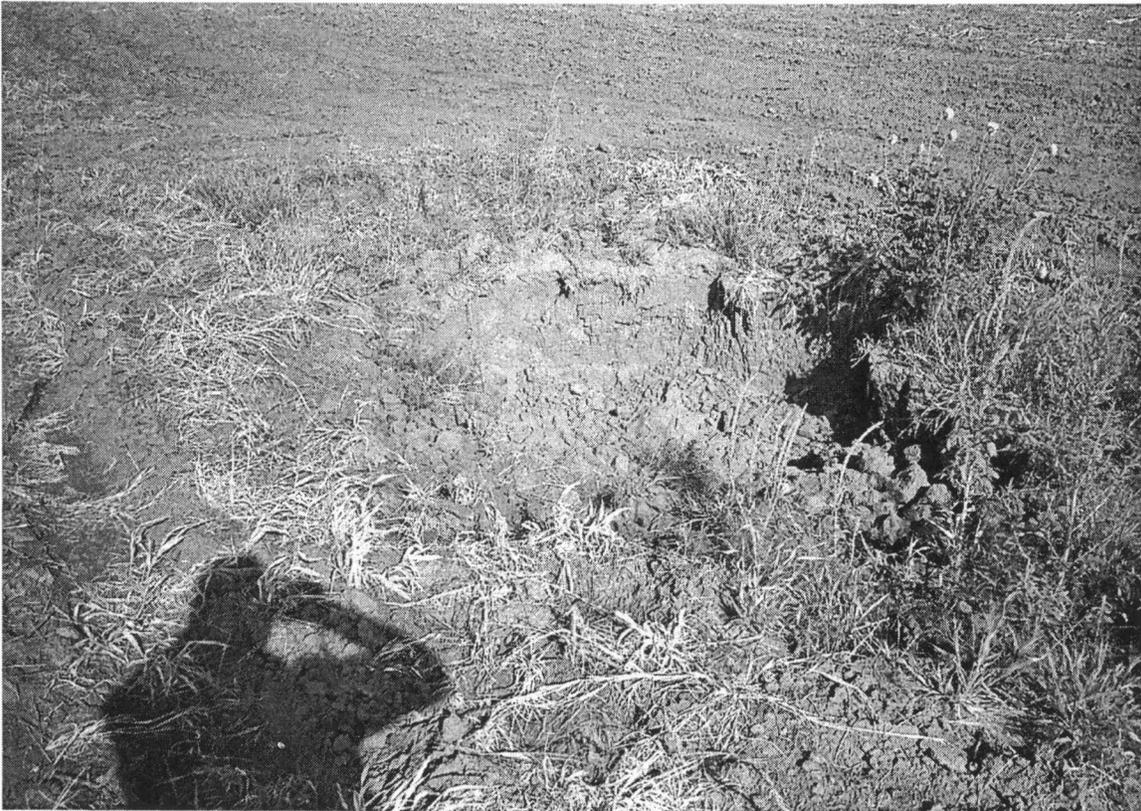
Photograph by Earl Shinogle

The farmer reported that a sinkhole opened in his wheat field in 1999. The sinkhole was oval shaped in map view, and the dimensions were 5.8 m (19 ft) by 3.2 m (10.5 ft) by approximately 1.1 m (3.5 ft) deep. The farmer filled the sinkhole with soil. This year the region has continued to subside and a perimeter fracture has formed at the location of the rim of the sinkhole.

I observed the perimeter fracture at the former rim of the sinkhole. The fracture is nearly vertical and has opened about 15 cm (6 in.) in two locations. I lowered a steel tape measure about 13.4 m (44 ft) down the fracture and didn't appear to hit bottom. However, I was unsure whether the

tape was collecting in a larger void. No additional fractures were observed. The sinkhole has subsided an additional 15 cm (6 in.) since the sinkhole was filled.

My minimum recommendation is to monitor the sinkhole. Since the cause of the subsidence is unknown, the extent of the void is uncertain. Thus the risk is unknown. The farmer should watch for signs that the sinkhole is enlarging, including material sloughing into the perimeter fracture, new perimeter fractures opening beyond the current sinkhole, and increases in the rate of subsidence. If evidence of enlargement occurs, the area should be fenced off. In its current state, potential exists for personal injury or damage to personal property. If this is a concern to

the owner or the farmer, the area should be fenced off. If the owner or the farmer wish to do more, I recommend hiring a geotechnical engineering consultant and a geologist to advise and design any remedial measures.
