Kansas Geological Survey

The Potential for Ground Subsidence Associated with the Closure of the AmeriCold Logistics (KC Underground, L.L.C.) Warehouse Facility

Open File Report 2000-9

March, 2000

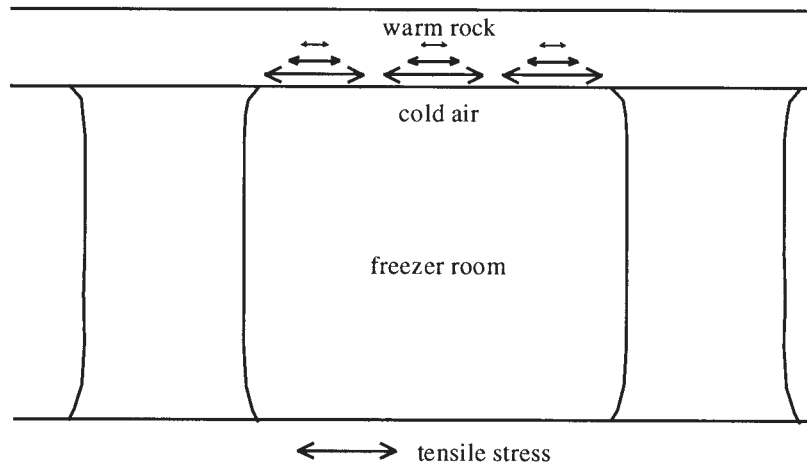
When the freezer units were turned on ground water in the pores and fractures of the rock began to freeze and expand. This can lead to further fracturing of the rock mass. At the same time the mineral grains that make up the rock are contracting. Whether the rock mass (mineral grains and pores) expands or contracts is a function of the amount of water present in the pores. In areas where the rock has lots of pores filled with water, the rock mass will expand during freezing. This will create horizontal compression in the ceiling and the potential for horizontal fracturing, spalling, and possible roof falls. In areas where the rock is dry the rock mass will contract during freezing creating horizontal tension in the ceiling (Figure 3) and conditions would be favorable for vertical fracturing of the rock mass.

Figure 3—Schematic sketch of the tension that develops in the rocks mass as the freezer room cools.

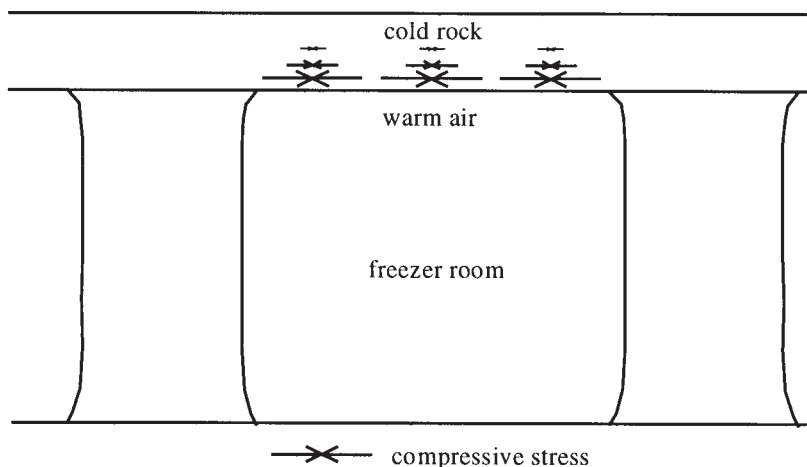
Figure 4—Schematic sketch of the compression that develops in the rock mass after shut down of the refrigeration units.

When the refrigeration units are shut off, the ice in the rocks will begin to melt. Currently, the ice provides some strength to the fractured rock mass. As the ice melts, this strength will be lost and areas of the roof and pillars deteriorated during the operation of the warehouse will begin to fail. Additionally, in areas where the roof mass was initially dry and contraction occurred, the warming of the rocks would cause the rock surface adjacent to the room to expand while the rocks further into the rock mass are frozen and contracted. This leads to horizontal compression (Figure 4) and a chance for spalling and large rock failures. Both rapid heating and melting of ice may have contributed to problems during and after the 1991 fire.
