**KANSAS GEOLOGICAL SURVEY
OPEN-FILE REPORT 2001-74**

Case History of the Collapse, Eruption, and Emergency
Backfilling and Grouting of the Abandoned Crystal Salt
Mine Shaft, Ellsworth County, Kansas

Bruce K. Stover
Senior Mining Geologist
Hayward Baker Inc.
11575 Wadsworth Blvd.
Broomfield, Colorado 80020

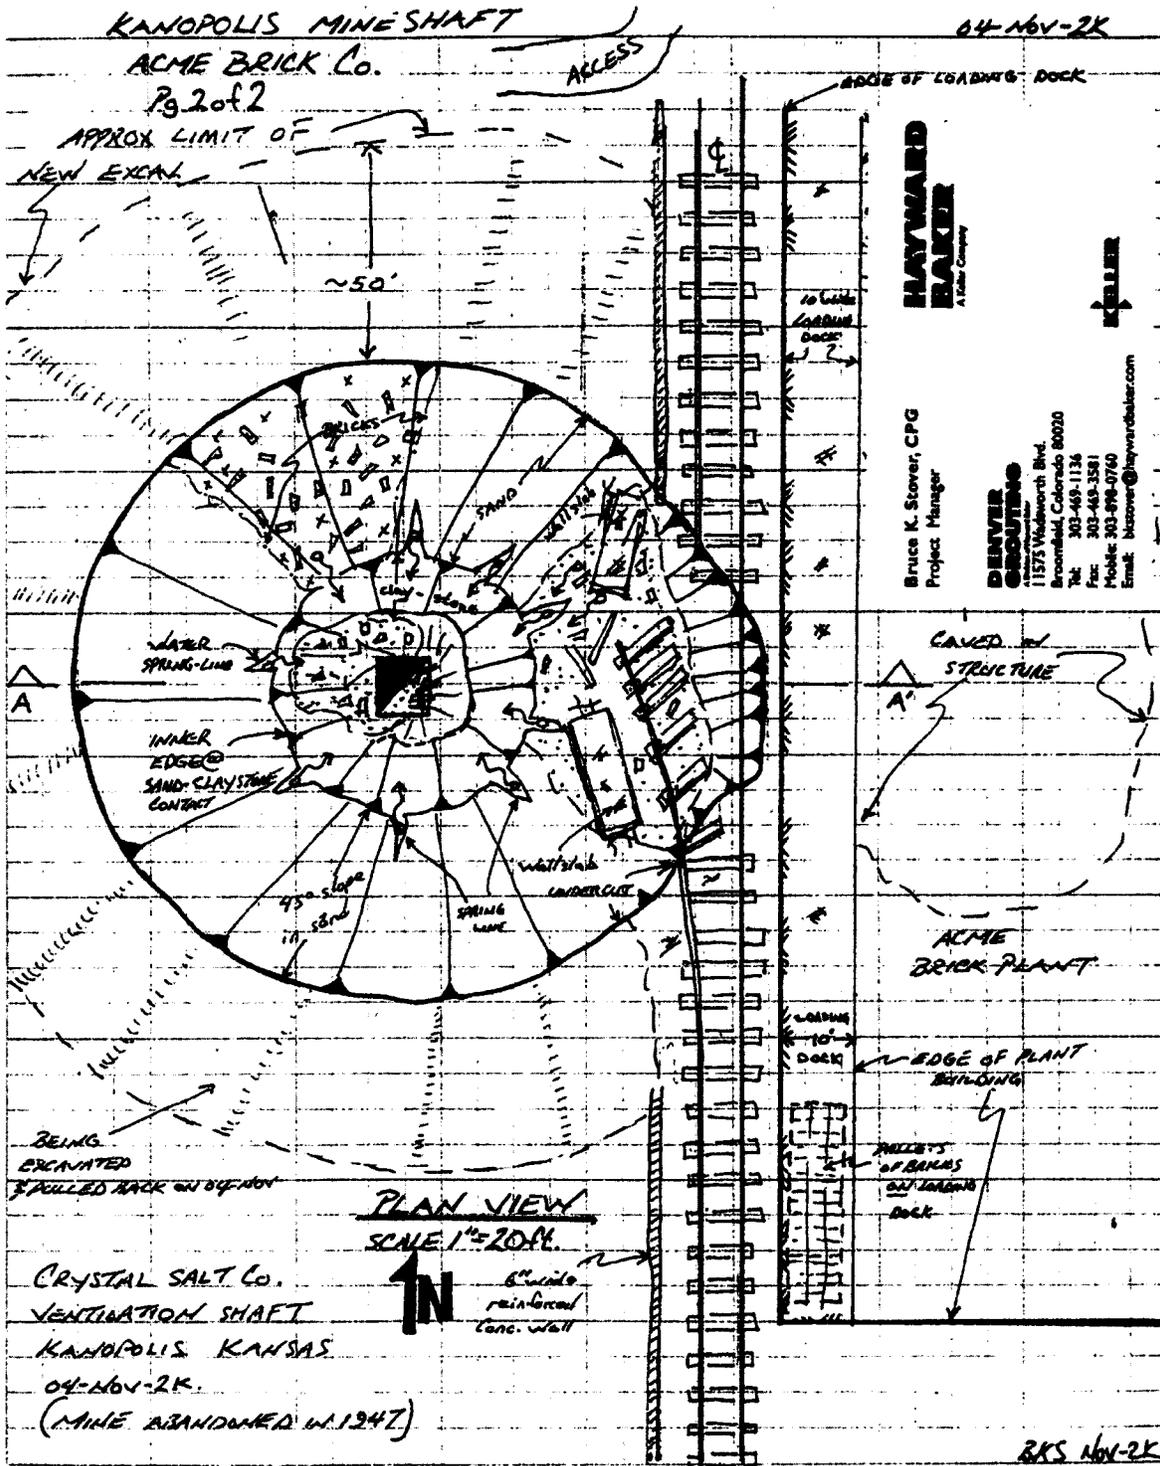
Fifty-one years after abandonment, on October 26, 2000, at 10:02 am local time, the nearby auxiliary shaft adjacent to the brick factory suddenly caved in. Workers reported that a pile of waste brick in the yard adjacent to the railroad siding began to disappear into itself, "like sand down an hourglass". Moments later, accompanied by ground shaking and a tremendously loud roar, a geyser of air, water, sand and several thousand cubic yards of bricks erupted over 300 feet into the air. This debris fell on the adjacent plant building, destroying a large section of the factory. Several more separate eruptions as violent as the initial blast followed during the next few minutes, causing further damage to the factory, and destroying nearly every vehicle in the adjacent parking lot. Miraculously, no one was killed or seriously injured. As before, a large crater quickly formed in the unconsolidated sand aquifer, taking out the railroad siding and a boxcar, and threatening to totally destroy the plant foundations. An estimated 125 to 200 gallons-per-minute of fresh water poured into the open shaft from the base of the unconsolidated surface sand aquifer. The flowing water and soft, weak clay stone bedrock caused the crater to grow from an initial diameter of 45 feet to over 150 feet in diameter. Surface configuration as of November 4, 2000 is shown in Figure 2.

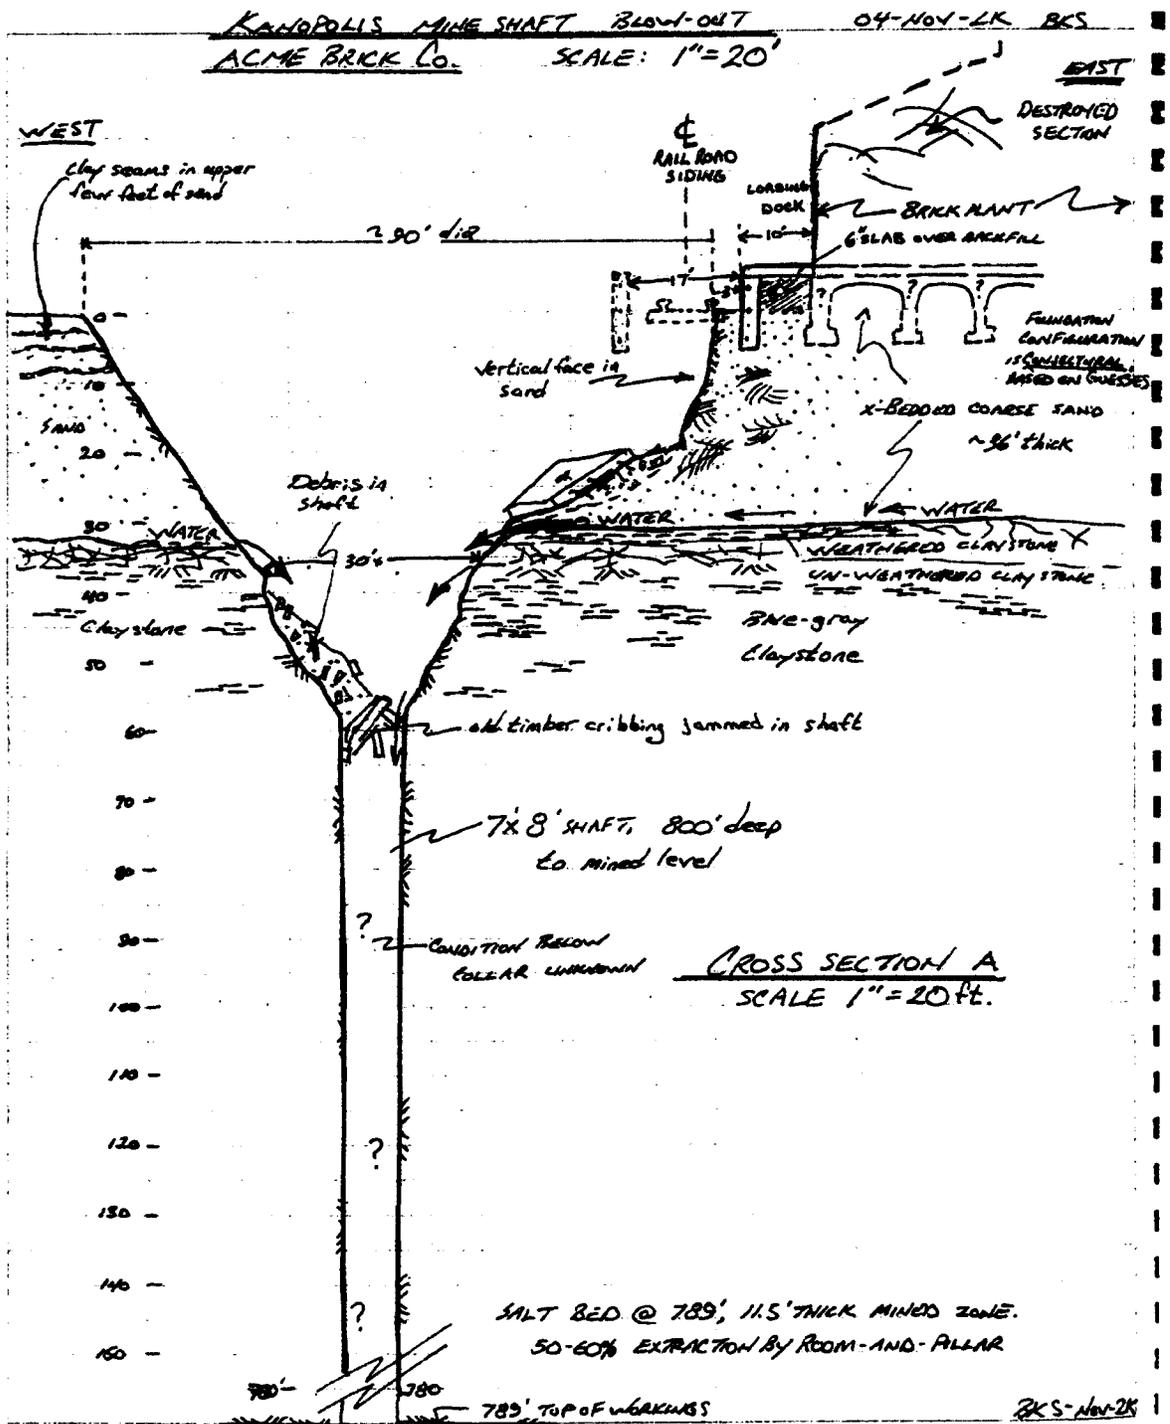
Figure 3.

Stability and viability of the brick plant foundations were in serious doubt after the shaft cave-in. The first issue was whether or not the plant could be protected from the rapidly expanding shaft crater. The edge of the plant floor and foundation were immediately adjacent to the crater on its east side. Unconsolidated loose sand was actively caving into the open shaft, threatening to undermine and destroy part of the building footprint (Figure 3).

A test-grouting program was developed to attempt to stabilize and strengthen the unconsolidated sand supporting the factory foundation adjacent to the crater. Compaction grouting and permeation grouting were conducted through a series of holes drilled through the foundation and into the clay stone bedrock 30 feet below. Compaction grouting stiffened up the sands, and increased resistance to sloughing between the closely spaced holes. Portland-cement grout was injected into the base of the sand at the bedrock interface to strengthen the sand and help control groundwater flow from the area beneath the plant.

The grouting prevented significant sloughing of sand from beneath the plant floor. Throughout the following three months that the shaft remained open, sand continued to slough from the crater walls, except in the area under the plant. On the west side, the crater enlarged from an initial radius of 30 to 40 feet to almost 100 feet. This amount of caving on the east side would have resulted in loss of a significant part of the plant.

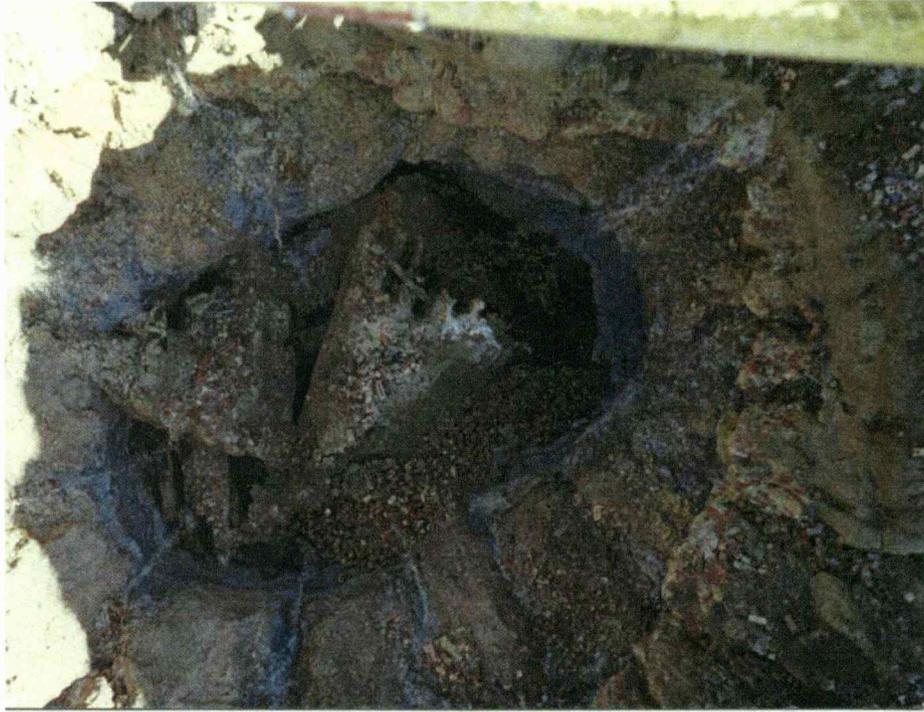
Figure 4.

Concurrent with foundation grouting, a down-shaft video survey was conducted. An 85-ton motor crane with a clamshell bucket was used to clear away timber cribbing and debris blocking the shaft opening 50 feet below the surface (Figure 4). Once the obstructing debris was removed, a borehole camera was lowered through the exposed shaft compartment (Figure 5). The camera showed the shaft open to a depth of 670 feet, without any standing water level. Sand and bricks were seen at the bottom of the shaft, and fresh water could be seen draining directly into the salt mine.
