Final Graph before pulling tool

Company: Berexco

Location: KGS Hartland 6-10 Communication

Test Description: pumping down annulus checking for communication.

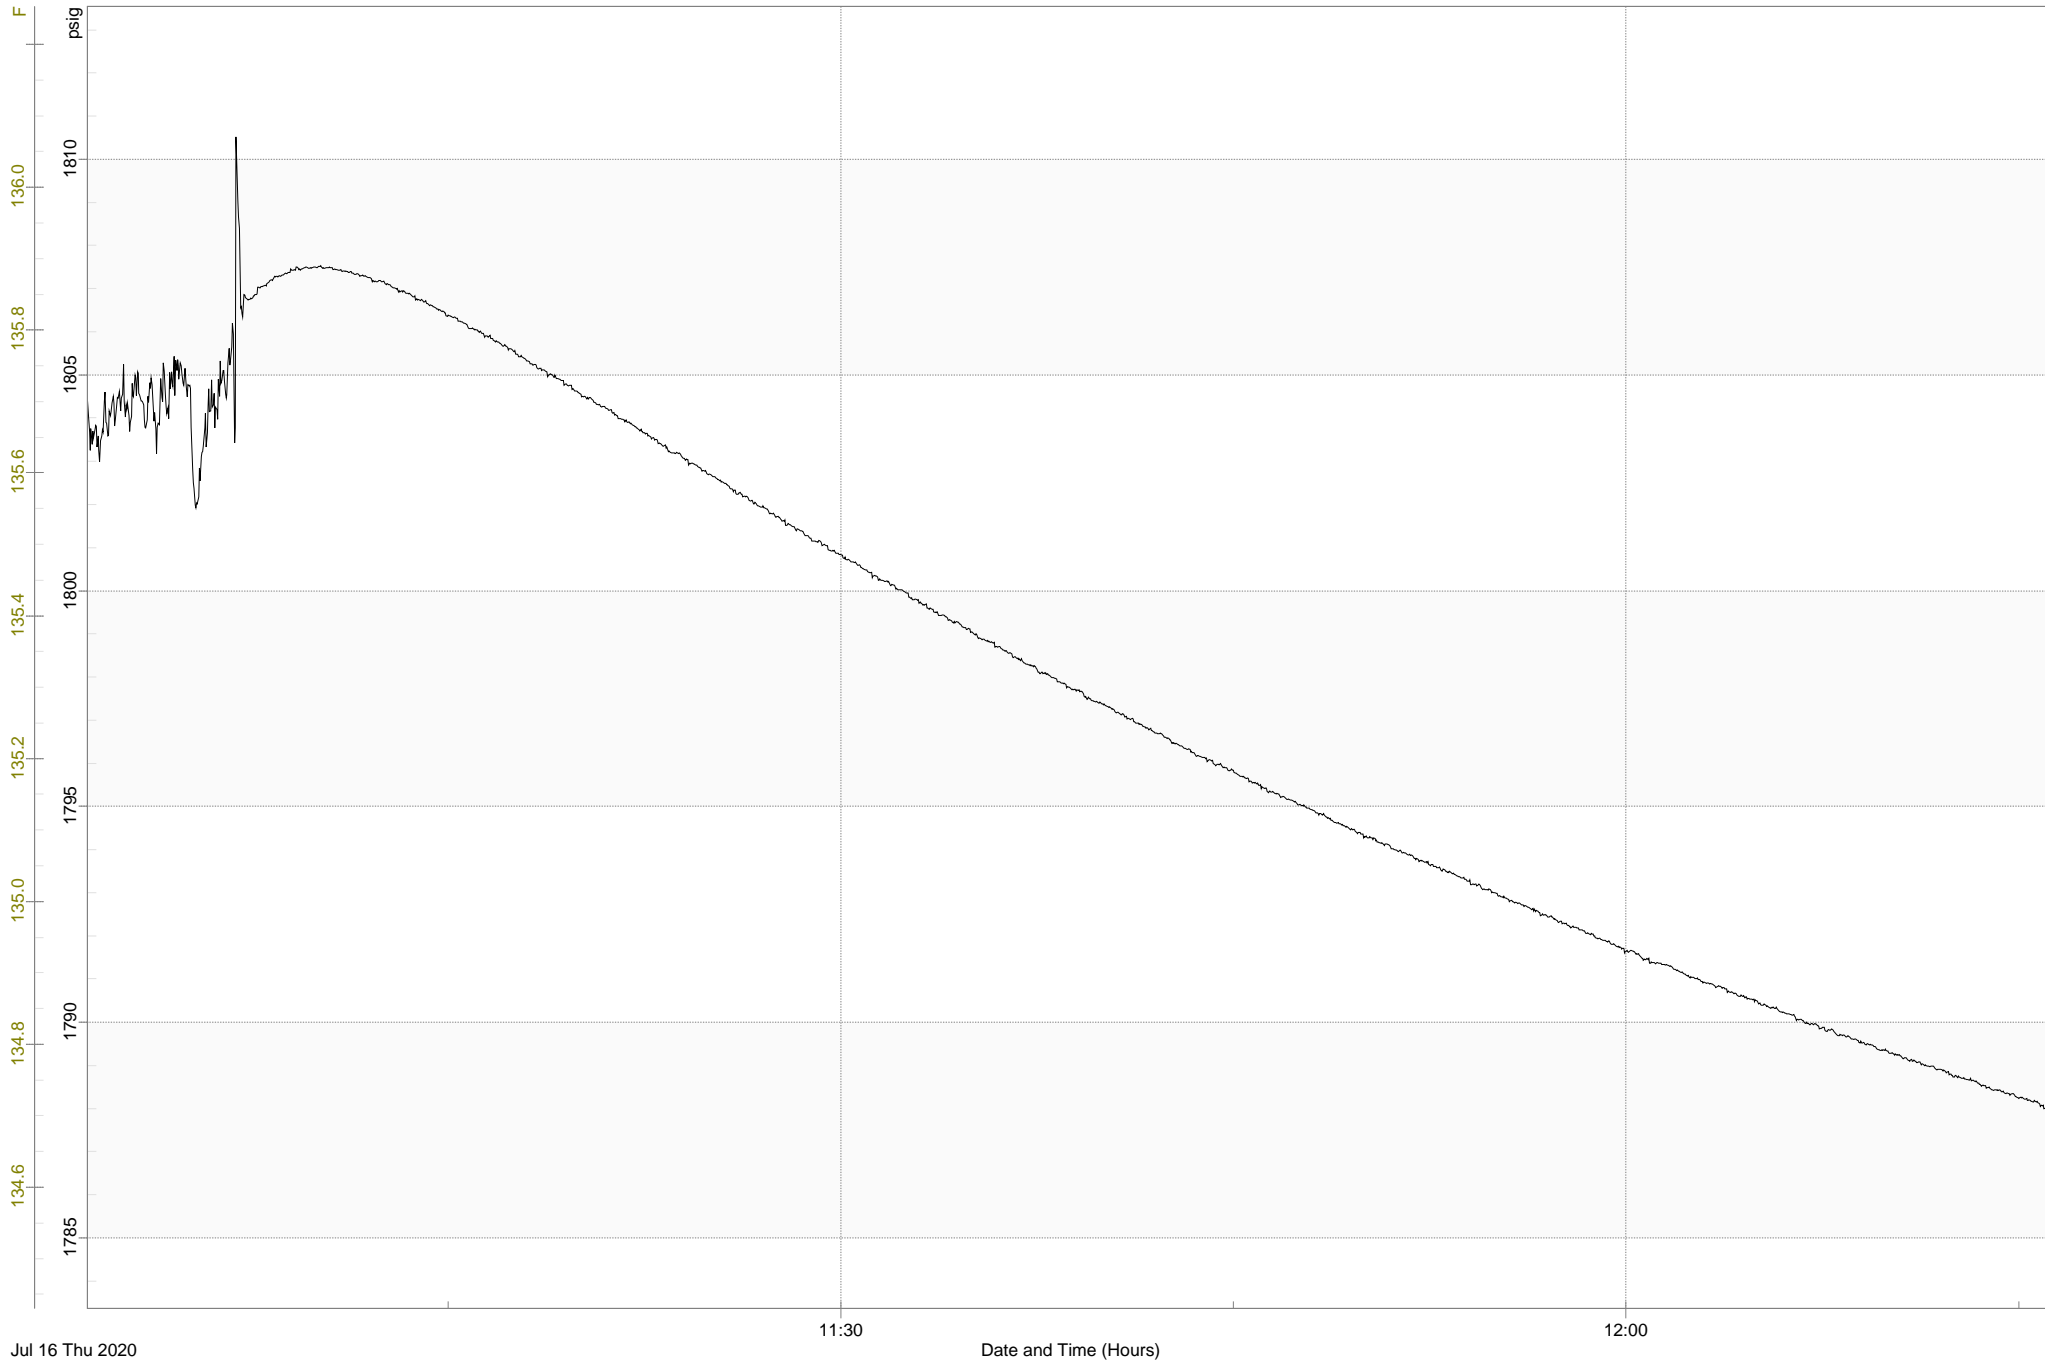
61799 - SRO - W1023 (psig)

Date and Time (Hours)

61799 - SRO - W1023 (F)
