Alternate Site A (AEC 3) Showing Geology and Cultural Features in Parts of Lincoln and Ellsworth Counties, Kansas

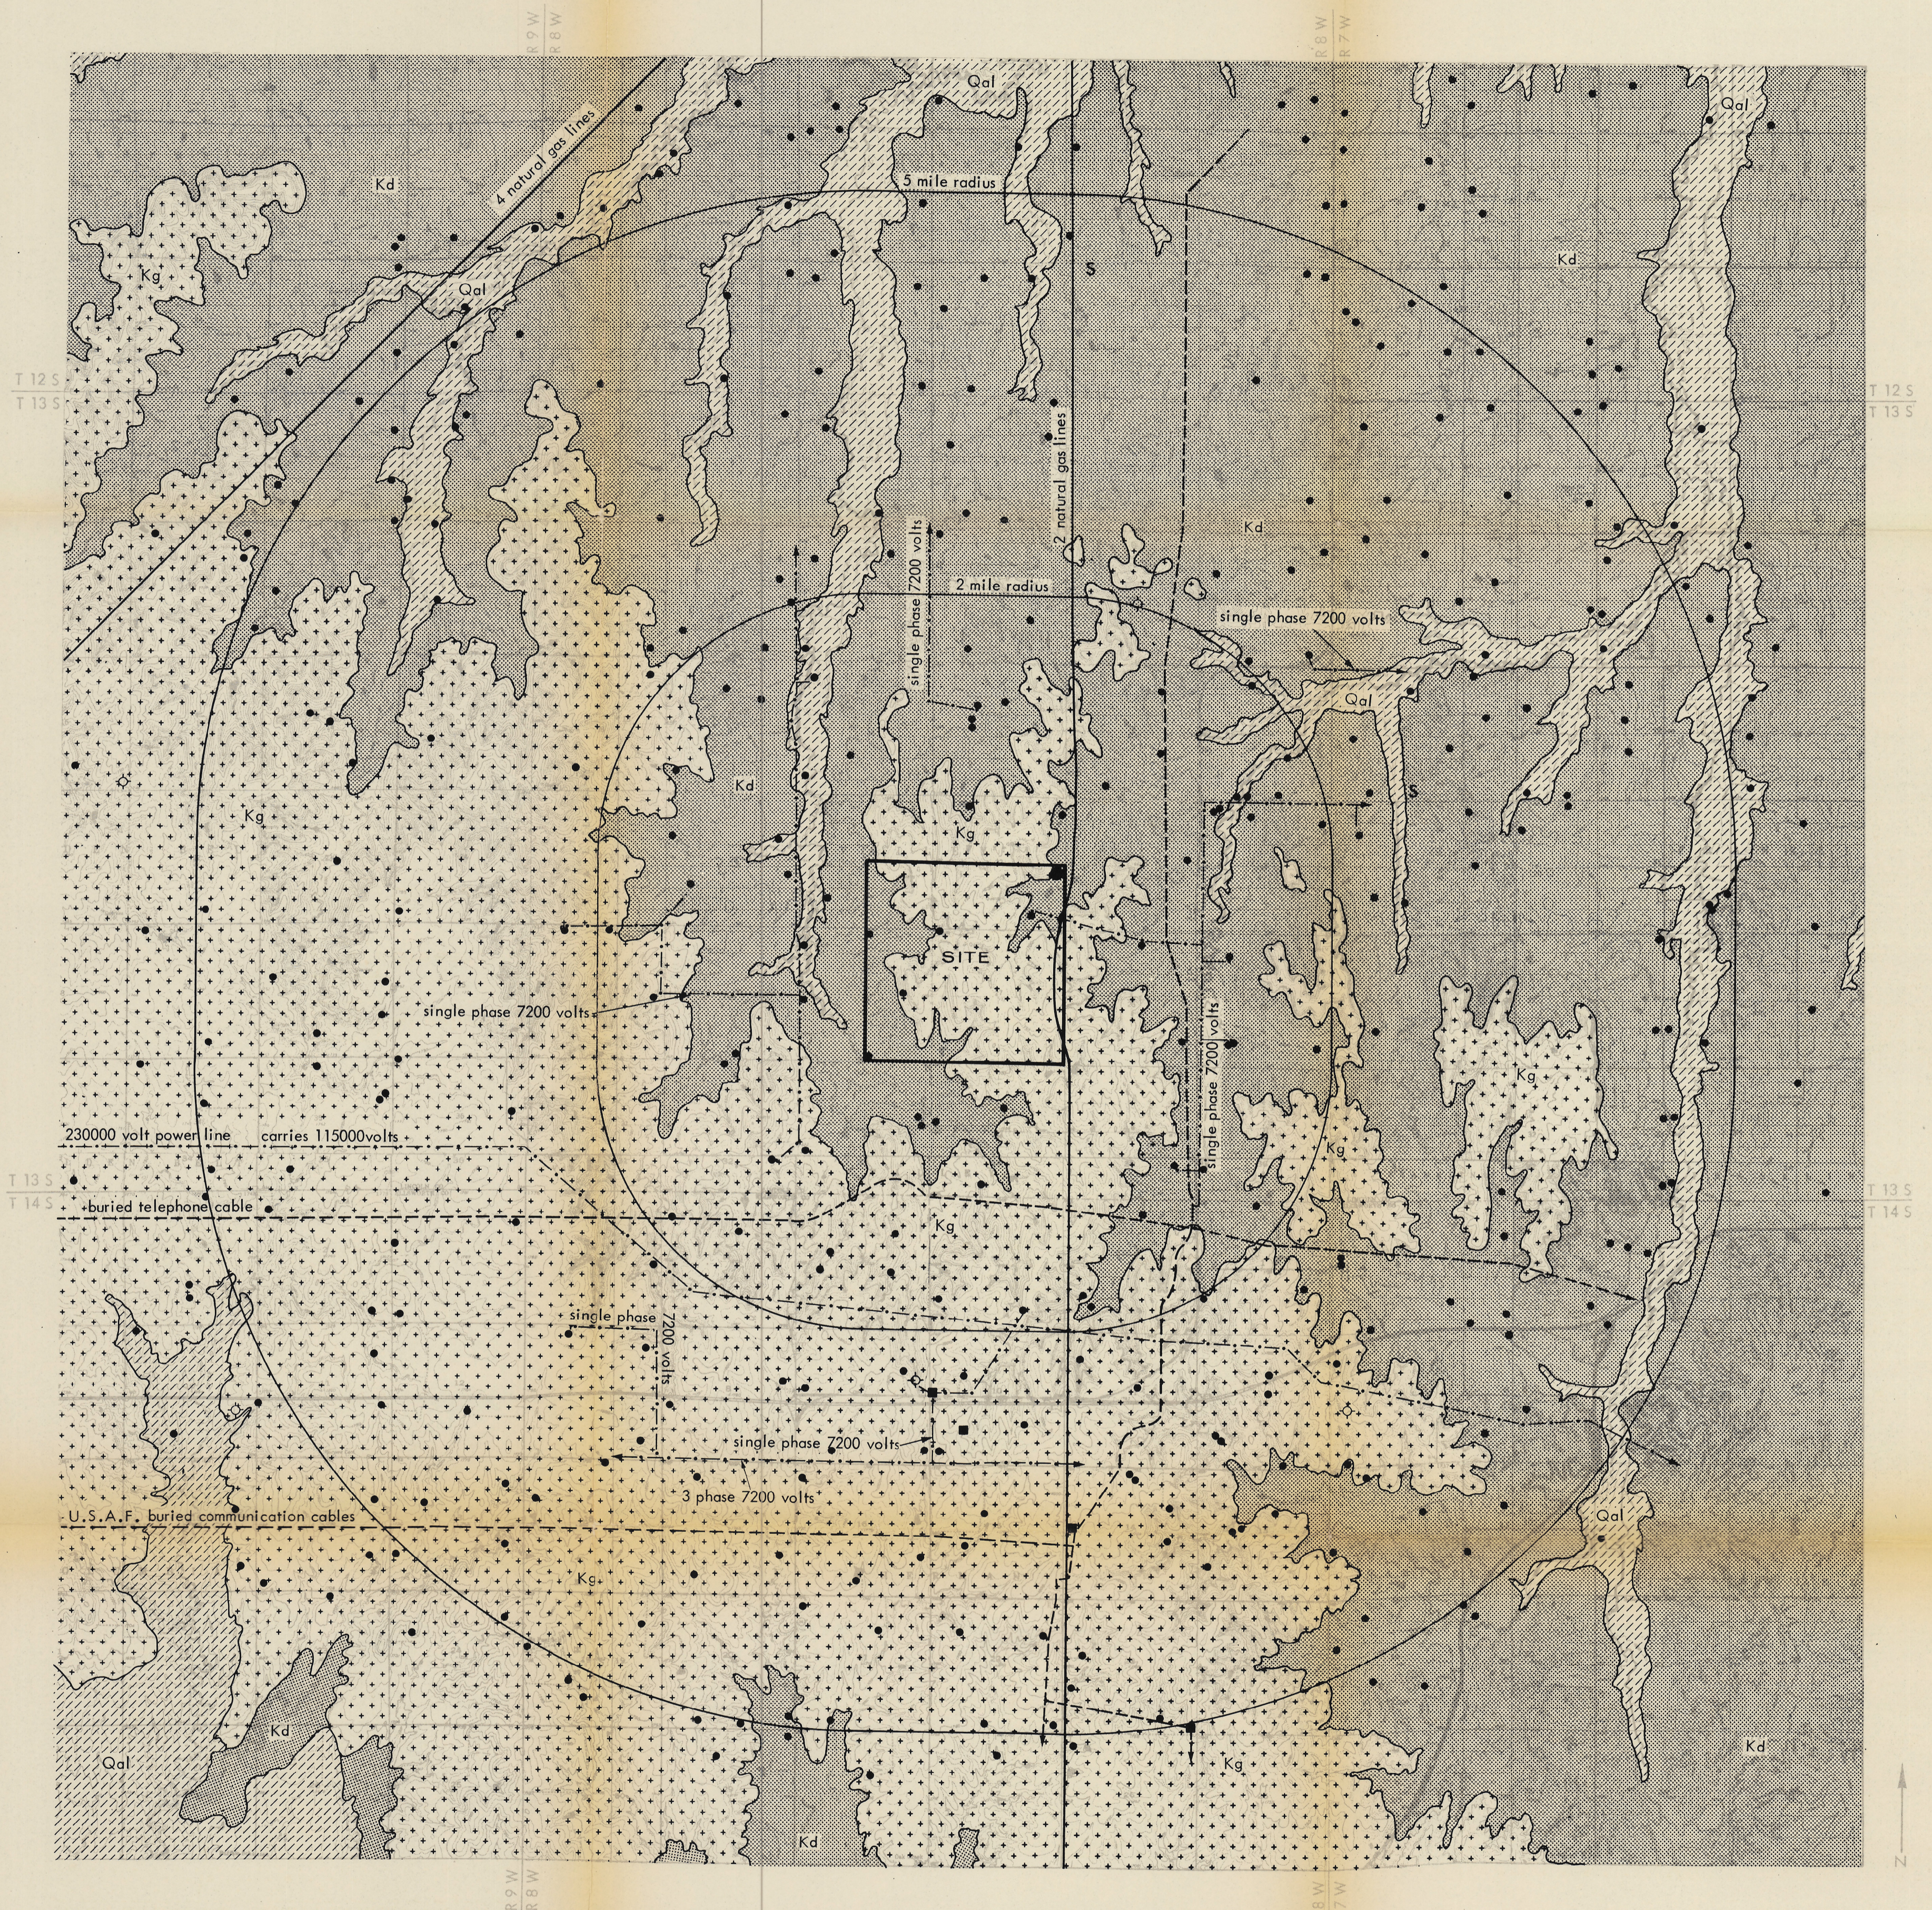
Figure 2

Contour interval - 10 feet

Scale 1:48000
