TESTING FOR POTENTIAL TREATMENT OF
PETROGLYPH-BEARING SANDSTONES AT
ST. VICTOR PROVINCIAL PETROGLYPH PARK,
ST. VICTOR, SASKATCHEWAN, CANADA
Final Project Report

Kansas Geological Survey
Open-file Report 99-42

December 30, 1999

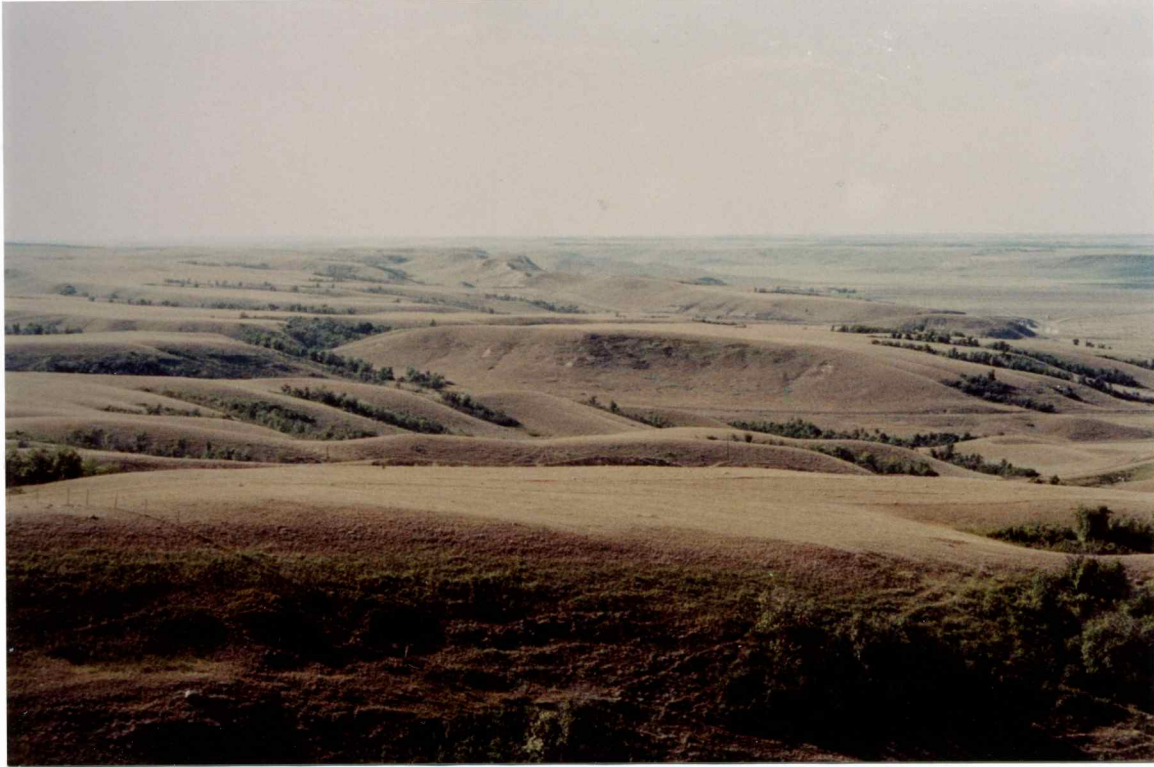
Figure 1. Weathering of the sandstone has produced the rolling hills at St. Victor.

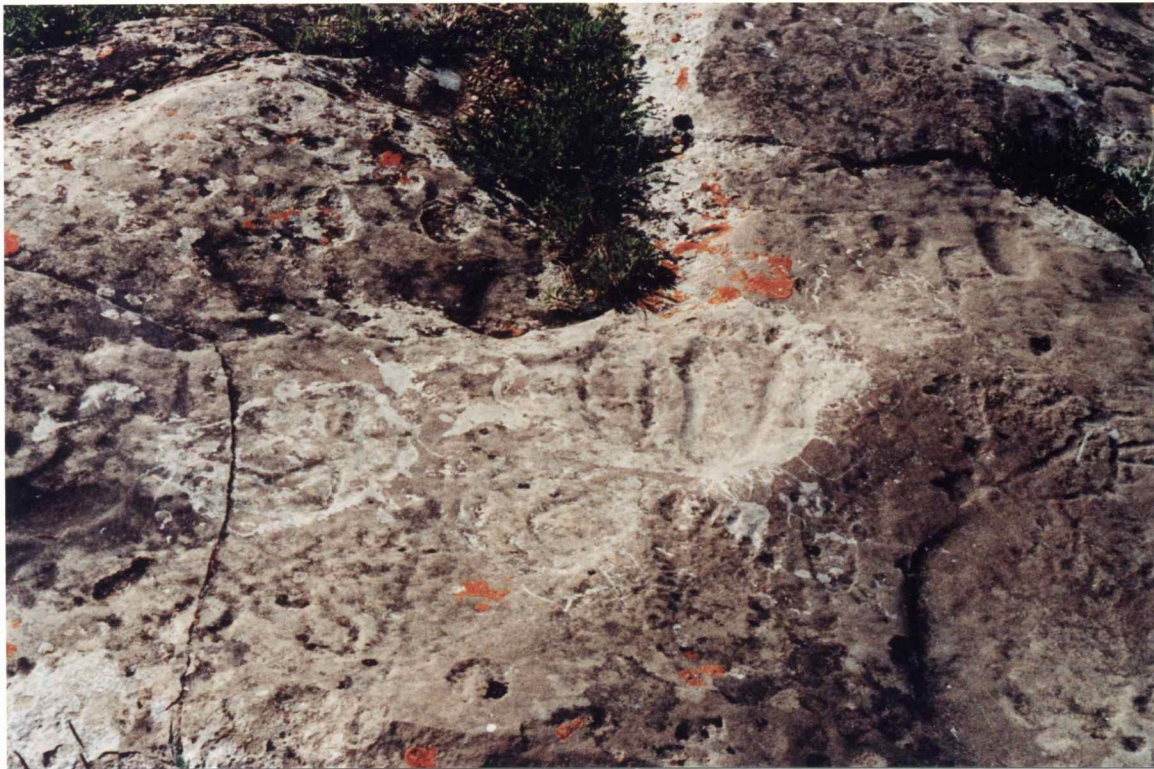
Figure 5. Petroglyphs that remain coated with white latex years after application for purposes of making impressions.

The latex coating cannot be mechanically removed without some surface damage caused by plucking sand grains from the surface. This is naturally undesirable. Any agent that could be used to dissolve the latex would undoubtedly transfer the material into the stone and affect the porosity and permeability, a similarly undesirable result.

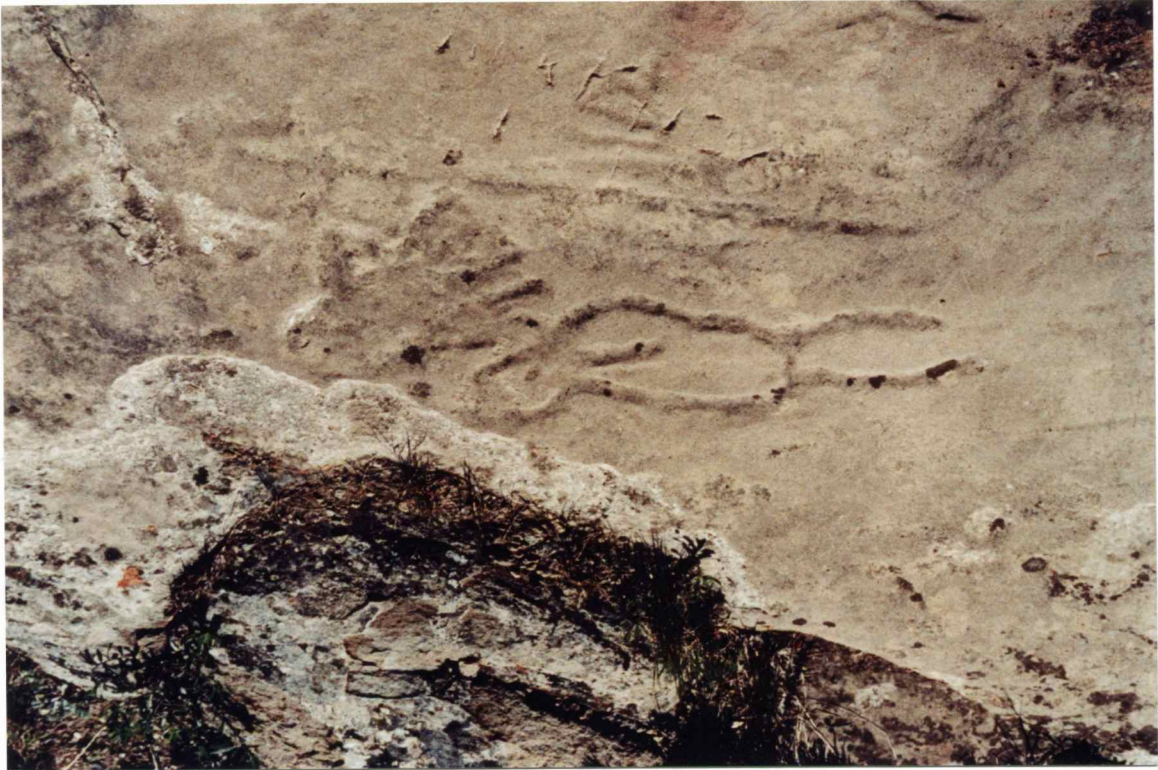
Figure 7. The white mineralization below these petroglyphs was first thought to be soluble salts but x-ray diffraction suggests a coating of solution and redeposition of the calcite cement.

The small amount of what resembled a white salt deposit, collected at the site, was also examined by x-ray diffraction but only phases found above were detected in the diffraction pattern. It is probable that the coating is the result of a long-term dissolving and redeposition of the calcite matrix of the stone.

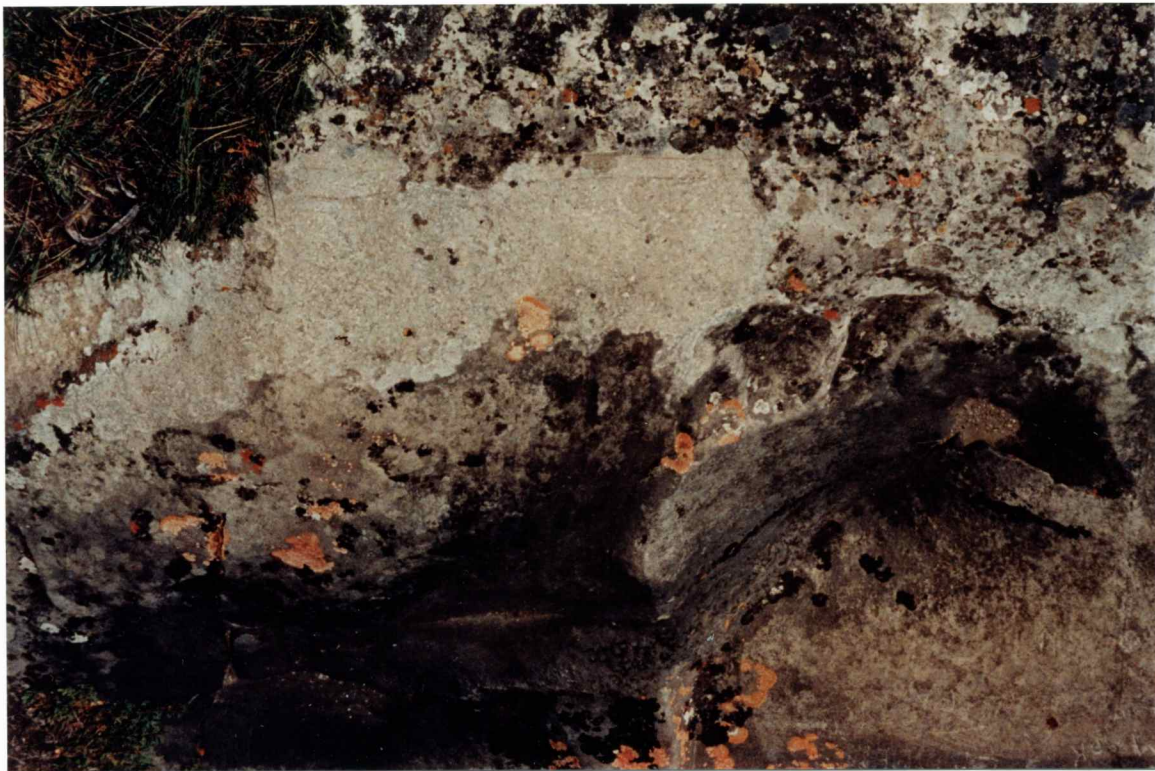
Figure 8. Most of the white (and red-orange) matter in the picture is lichen growth. Such growth is common at the St. Victor site.

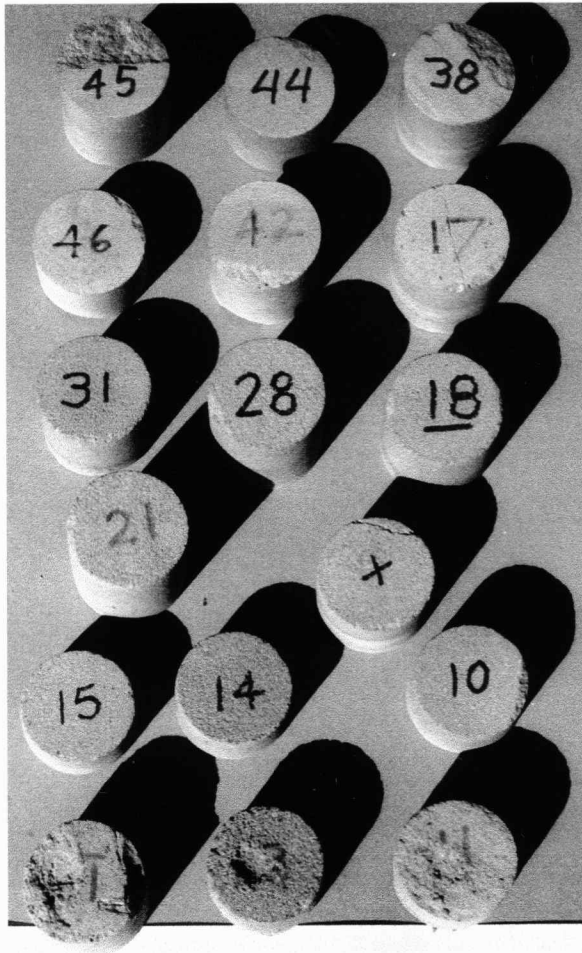
400 CYCLES

Figure 10. Freeze-thaw test results after 400 cycles. The bottom row are the porous, untreated cores and show the greatest damage. Missing stone and cracks on the other cores were present on the original samples.

The values in Table 4 clearly show an improvement in the freeze-thaw resistance of the porous sandstone that was treated with stone consolidant. Although the untreated percent weight loss of 4.7% is undesirable, it is relatively good compared to many weakly or unbonded sandstones that may completely disintegrate in less than 100 freeze-thaw cycles; sometimes as few as 25 cycles is sufficient to disintegrate cores of this type of stone (Grisafe, 1996). Surprisingly, no significant difference was observed for the mixed cores although some difference might be observed with larger numbers of freeze-thaw cycles. The lack of differences between treated and untreated dense cores is not surprising given their low porosity and their inability to absorb meaningful amounts of the ethyl silicate consolidant. Figure 10 shows the cores after 400 freeze-thaw cycles.
