**Geologic Map of the Historic Ranch Headquarters and  
School House Areas**

**Tallgrass Prairie National Preserve  
Chase County, Kansas**

**KGS OPEN-FILE  
REPORT 2004-34  
(Revised July 2008)**

# Bedrock Associated with the Ranch House at the Tallgrass Prairie National Preserve, Chase County, Kansas

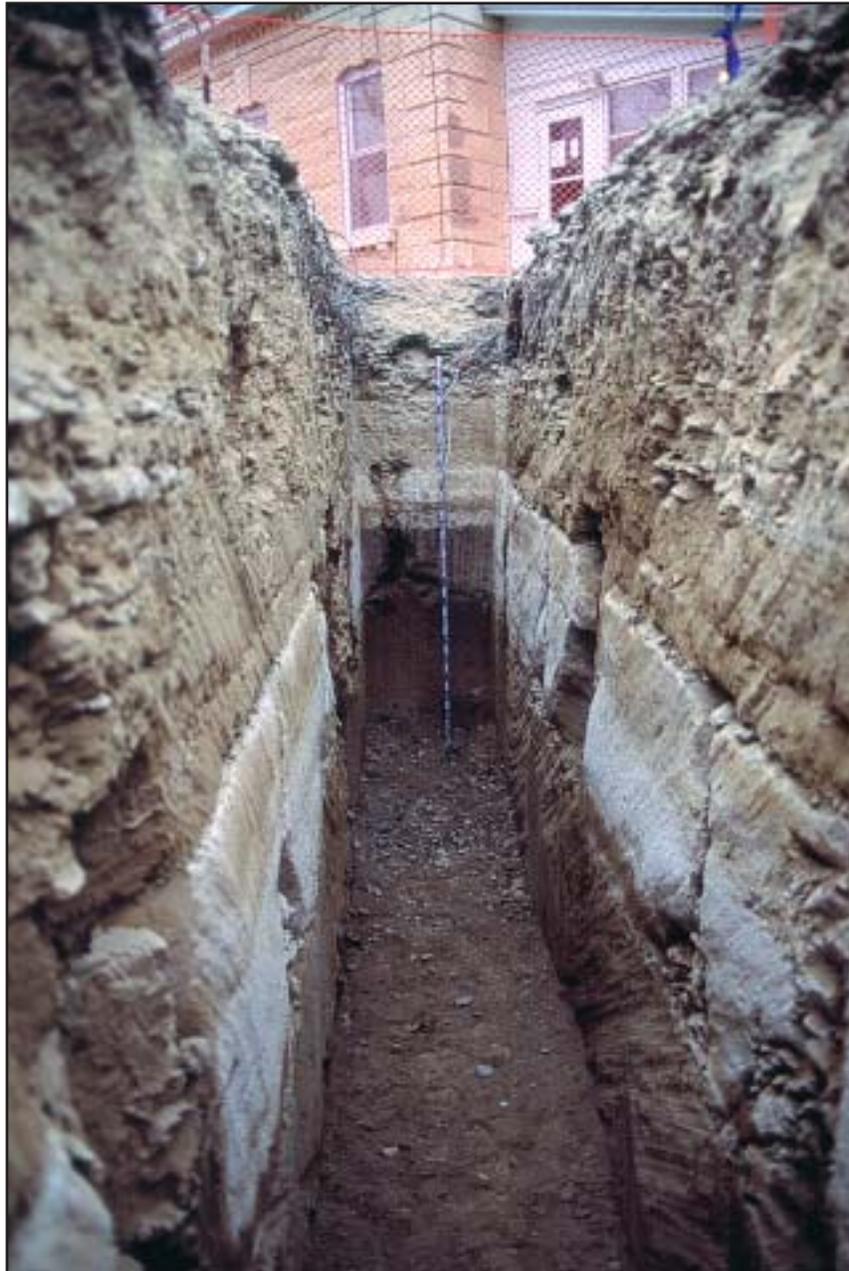
Figure 2 (Cross Section A-A') depicts the west-east cross sectional view through the Ranch House and hillside. The upper limestone shown on the cross section (probably the lower unit of the Crouse Limestone) was observed in the waterline trench southwest of the Ranch House (Figure 3). The thickness of the limestone is about 2.4 feet in this trench.

Figure 3. *Limestone layer (2.4 feet thick) in waterline trench southwest of Ranch House. This is the upper limestone in Cross Section A-A'.*

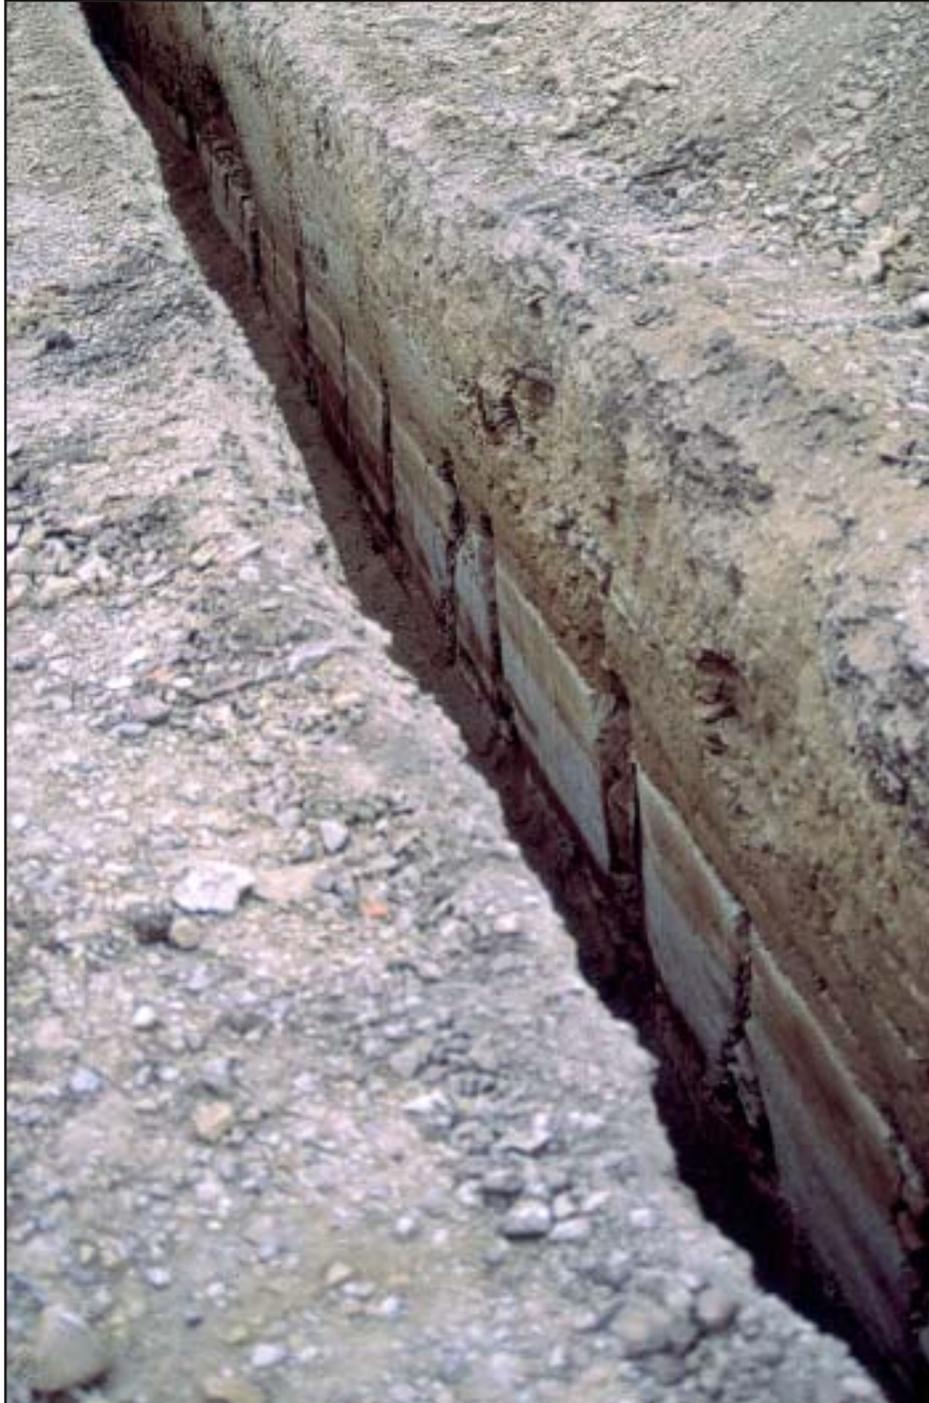
Regularly spaced vertical joints (fractures) have been widened by the flow of ground water and are easily seen in Figure 4. Figure 5 is a close-up of one of these enlarged joints. Water was observed dripping from this joint about four hours after the trench was excavated.

Figure 4. *View of the east side of trench. Note the regularly spaced vertical joints in the limestone.*

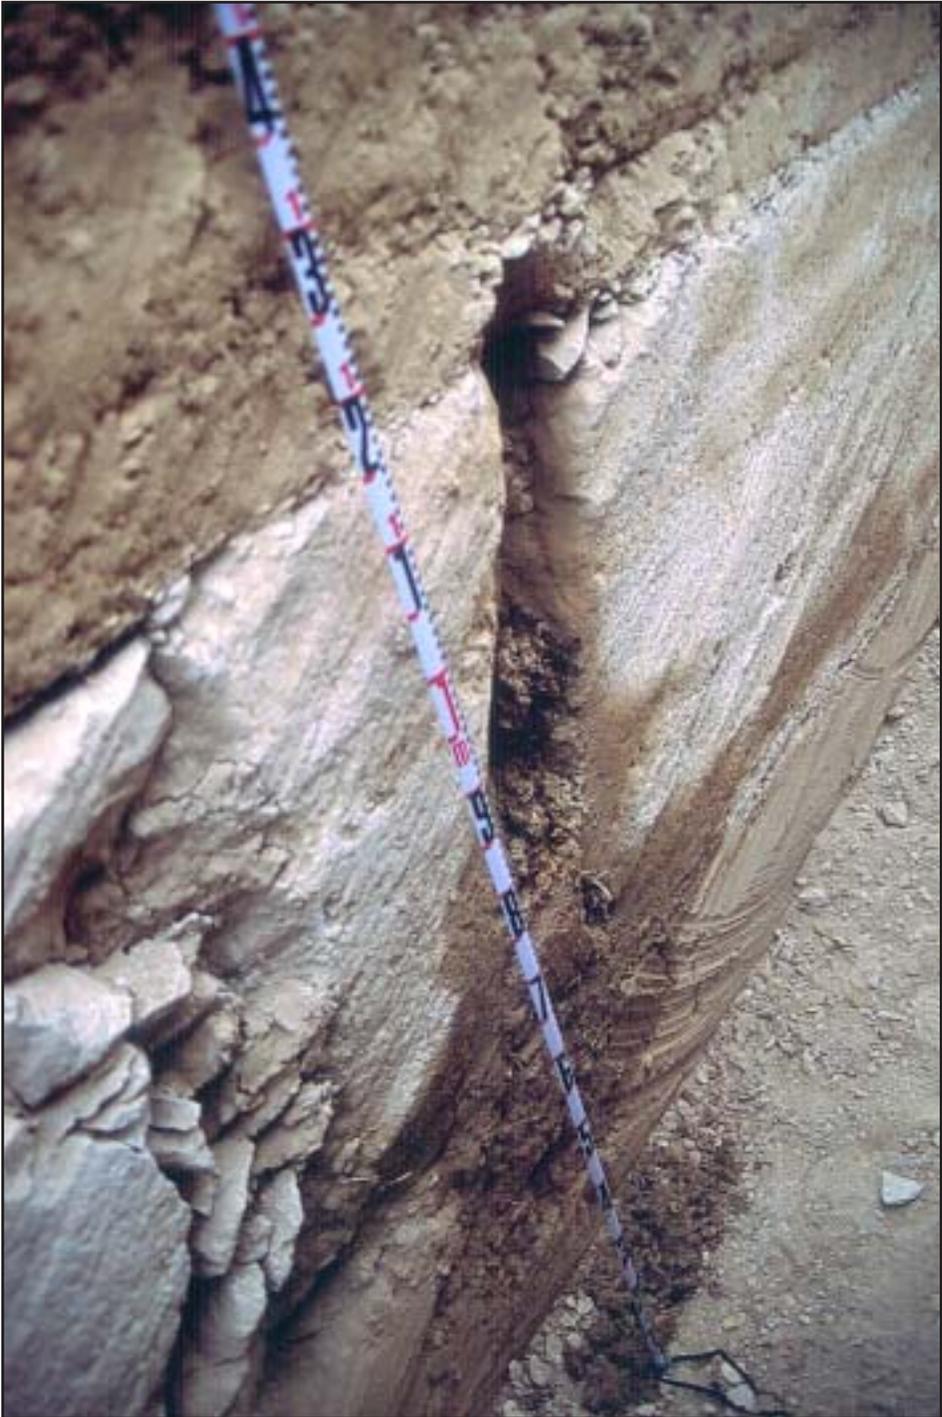
Figure 5. *Close-up of a vertical joint. This joint was dripping water about four hours after the trench was excavated.*
