**KANSAS GEOLOGICAL SURVEY
OPEN-FILE REPORT 1937-2**

Memorandum to the District Engineer
Inspection of Failure of Wyandotte County Dam

Marshall Creek Dam, Kansas

Subject: Inspection of failure of Wyandotte County Dam.

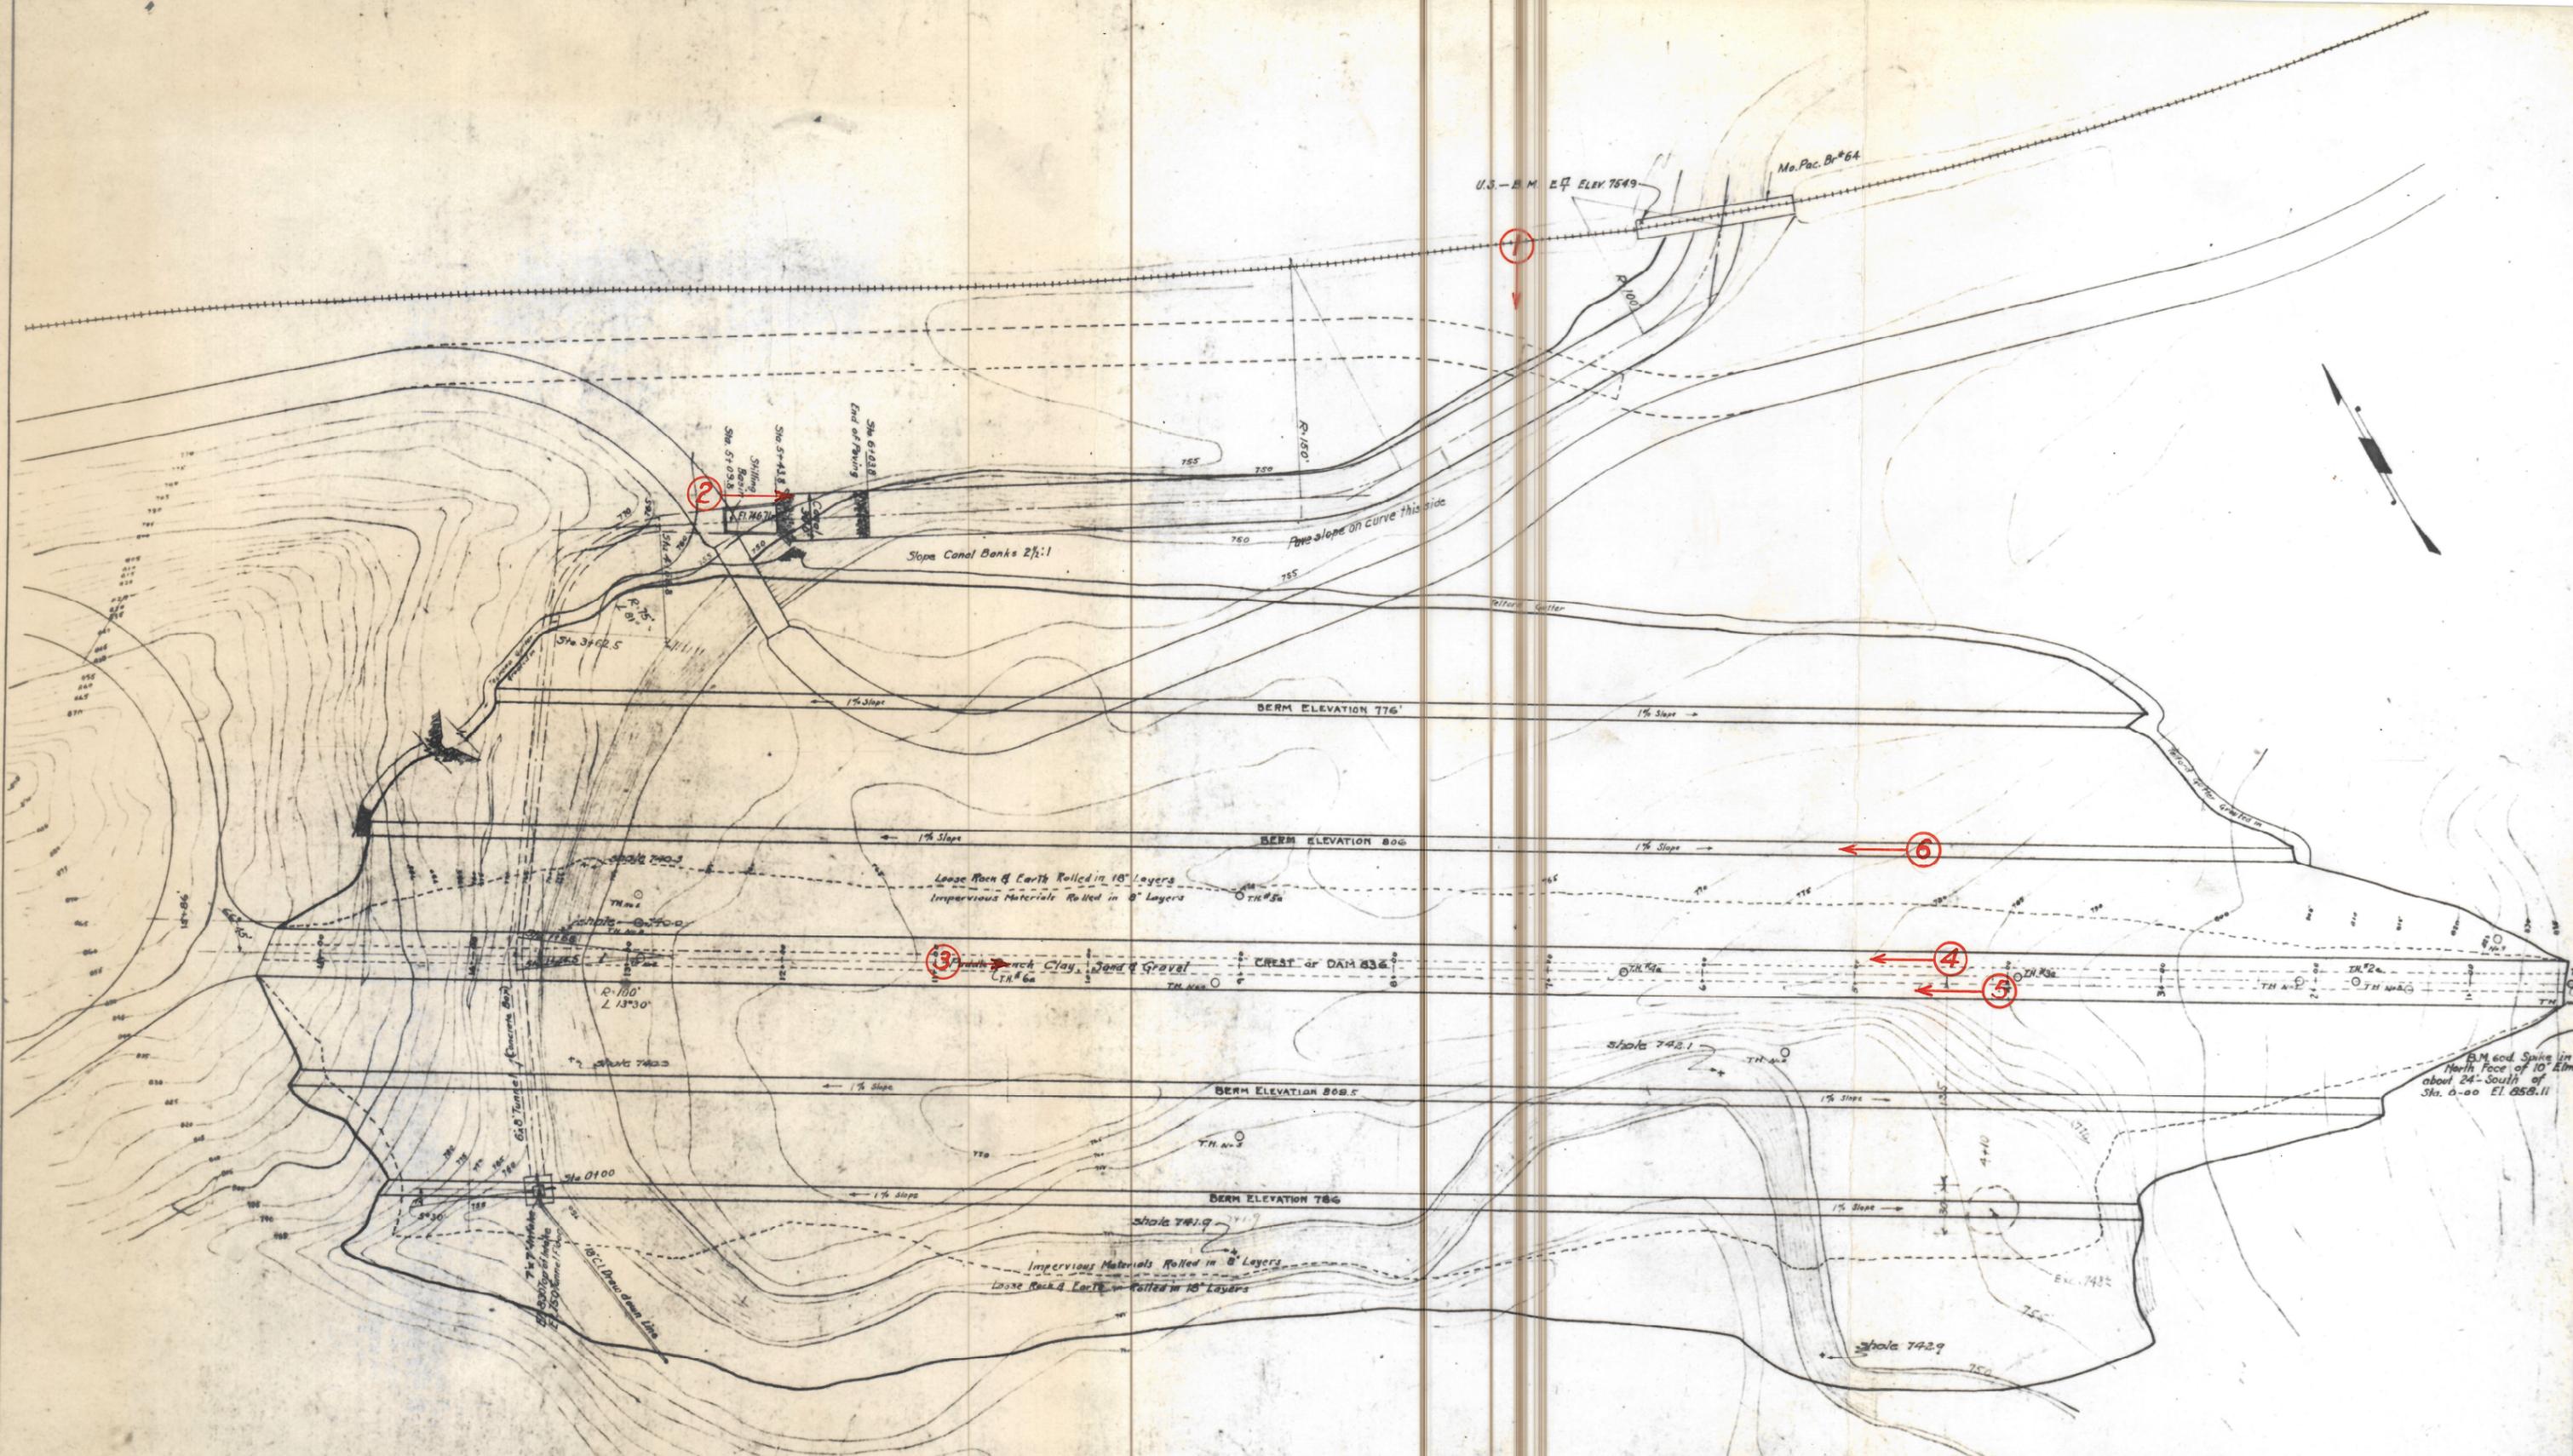
**MARSHALL CREEK DAM
 WYANDOTTE COUNTY KANS
 PLAN OF DAM
 AND
 LOCATION OF SPILLWAY ETC**

2. The entire central portion of the dam, from Station 4+00 to Station 11+00 on the center line moved out downstream. There was no perceptible movement of the upstream shell of the dam. The failure occurred at 9:20 p.m. Sunday, September 19, 1937. There has been no report of any casualties or injuries due to the failure.

5. The location of the sliding plane on which the failure took place is a matter of conjecture at present. It would appear that the failure occurred just downstream from the line of the sheet piling cut-off wall, which extends through the center of the dam. It is probably that the weight of rock and earth on the downstream half of the dam overloaded the soft blue clay stratum and caused this material to flow. The entire downstream portion of the dam apparently slid toward the railroad tracks. The material forming the downstream part of the dam from the center line to below the berm at elevation 806 suffered a vertical displacement. The point at which the displacement changed from a downward and lateral movement to an upheaval could not be determined without surveys.

8. No remedial measures or future construction plans should be made until the above investigations have been completed. It should be noted however, that a hazard exists in the structure as it now stands. The spillway crest is about at the level of the intact portion of the dam, but it would pass no appreciable quantity of water without the dam being overtopped. The standing portion of the dam would probably store a considerable quantity of water before further failure occurred. A rain similar to that over the Marais des Cygnes Basin in November 1928 occurring above the Marshall Creek Reservoir area would probably be stored and released suddenly with disastrous results to the railroad and the bottom lands. It is believed that a trench should be excavated through the dam in the immediate future to relieve this hazard.
