**KANSAS GEOLOGICAL SURVEY
OPEN-FILE REPORT 2001-74**

Case History of the Collapse, Eruption, and Emergency
Backfilling and Grouting of the Abandoned Crystal Salt
Mine Shaft, Ellsworth County, Kansas

Bruce K. Stover
Senior Mining Geologist
Hayward Baker Inc.
11575 Wadsworth Blvd.
Broomfield, Colorado 80020

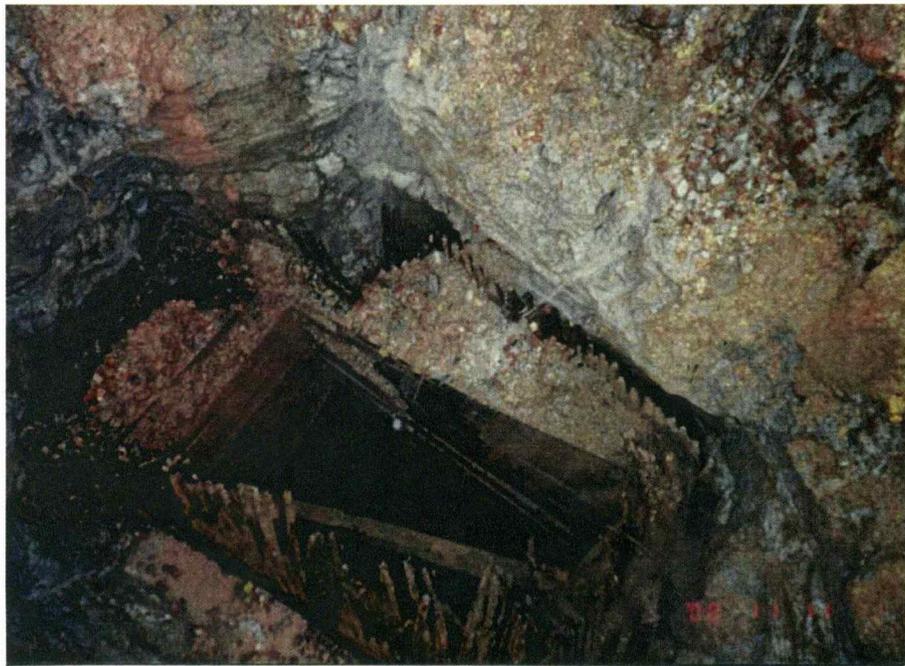
Figure 5.

A second logging truck was used to lower a weighted bar and sound the bottom of the shaft in more detail. This survey indicated a debris pile at the bottom of the shaft, with its top at 670 feet, and slopes extending at least another 30 feet.

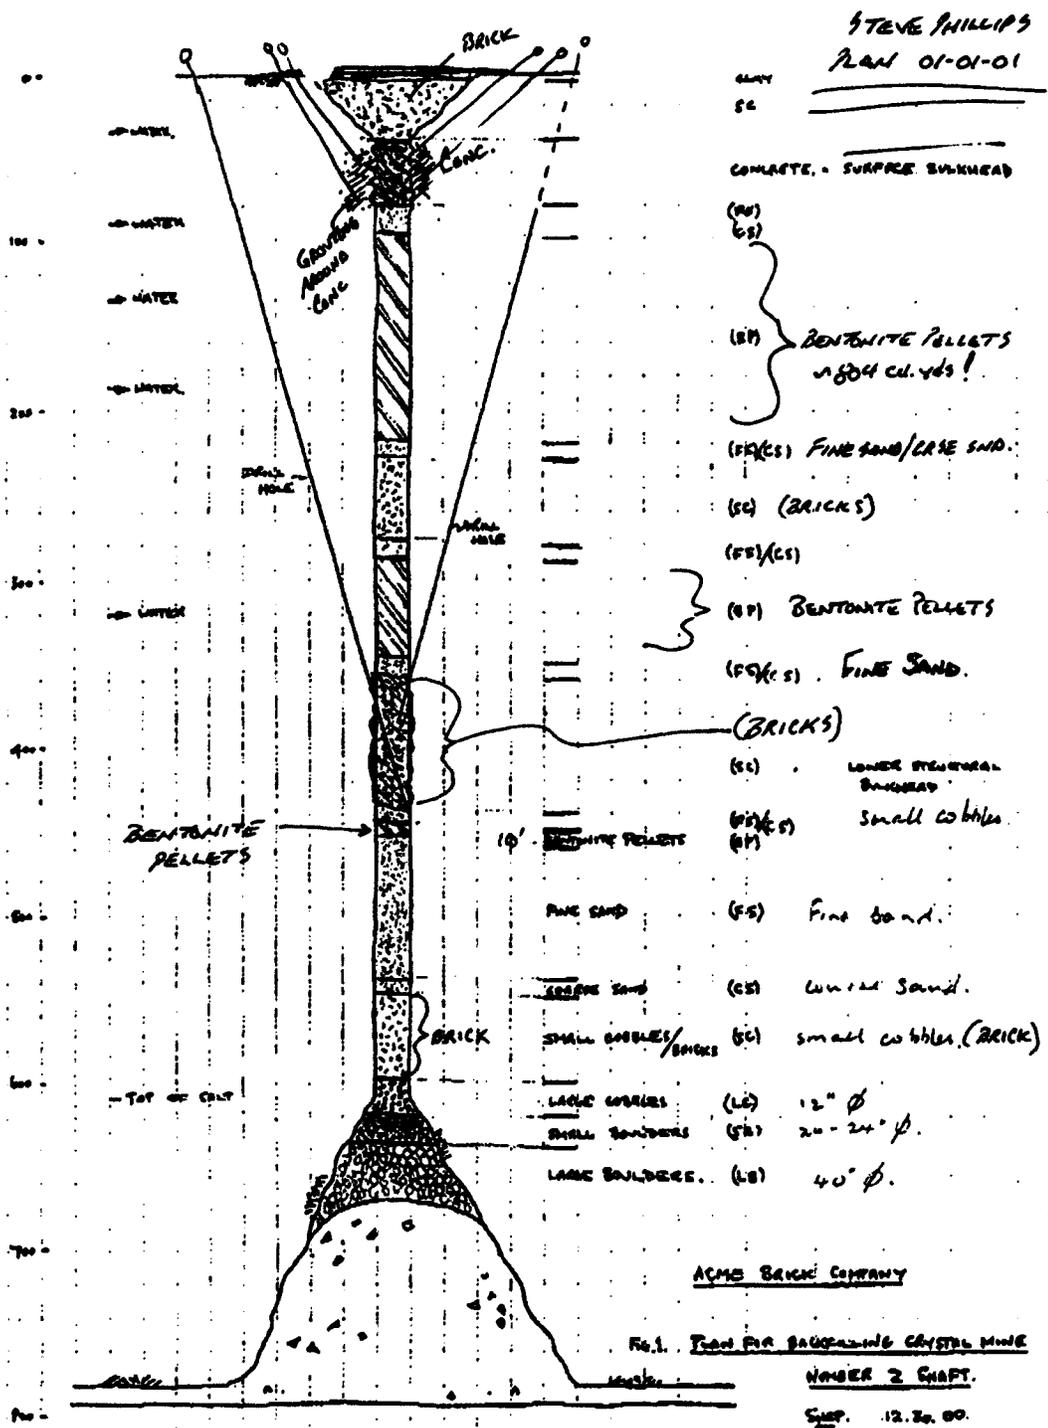
Several plans were considered, all having advantages as well as disadvantages. Acme Brick Company adopted the plan finalized by Stephen Phillips of Phillips Mining, Geotechnical & Grouting Inc. (PMGG), on 19-Dec-00. This plan is shown schematically in Figure 6. This concept called for backfilling the lower section of the shaft with large boulders and cobbles, in order to provide a stable, solid base for the remaining fill column. Subsequent fill would decrease in size from boulders to cobbles to small cobbles, then granular fill materials. The PMGG plan called for

bentonite seals to be placed into the shaft during backfilling. A grouted structural plug incorporated into the shaft below the lowest aquifer-sealing layer was designed to hold the backfill column in the shaft, preventing it from settling into the cavern believed to be at the bottom of the shaft. An upper structural concrete plug was to be cast in place on a ledge of resistant rock at the 71-foot level. The concept and details of the closure are described in the report prepared by PMGG.

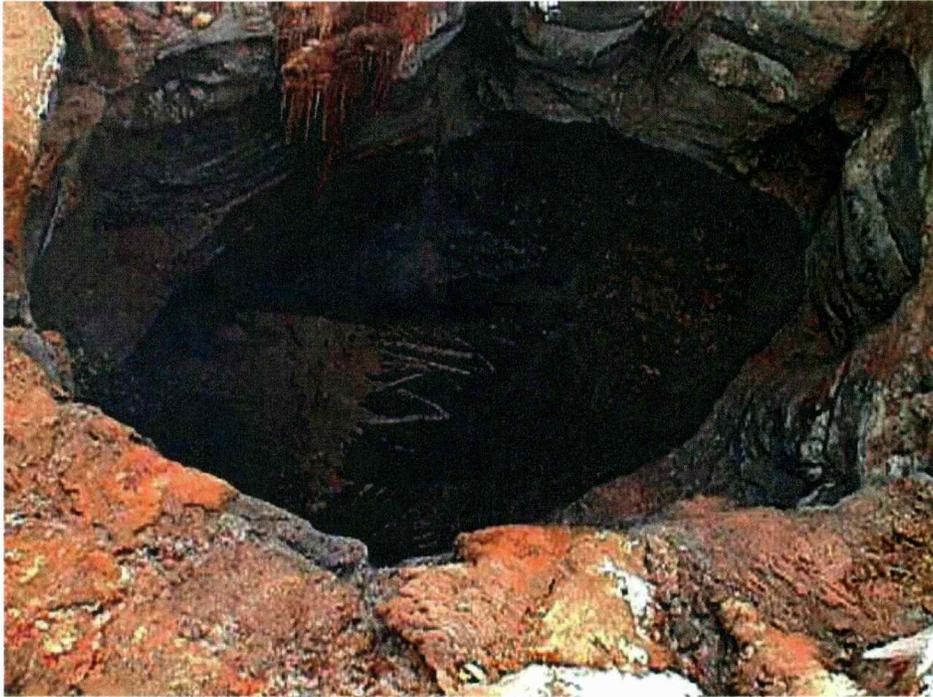
Figure 7.

On 20-Decmeber-00 the cribbing was found to have fallen and tilted farther down, exposing a large part of the open shaft. A decision was made to begin dropping large rock, called for as the base layer of fill, through the shaft cribbing into the open hole (Figure 7). Hard, quartzite-sandstone rock was dumped from barrel-bottom tandem axle trailer trucks at a location well back from the crater, and then pushed by dozer closer to the edge of the opening. A large excavator picked up the rocks and spooned them into the shaft crater from a safe location back from the edge of the hole. This work proceeded, and within a half hour, part of the ledge holding the tilted cribbing was knocked out, causing the cribbing to fall farther into the shaft, upside down (Figure 8). This revealed an even larger cavern at about the 90-foot level. The cavern was undercut at least 10 to as much as 18 feet beyond the original shaft excavation lines.

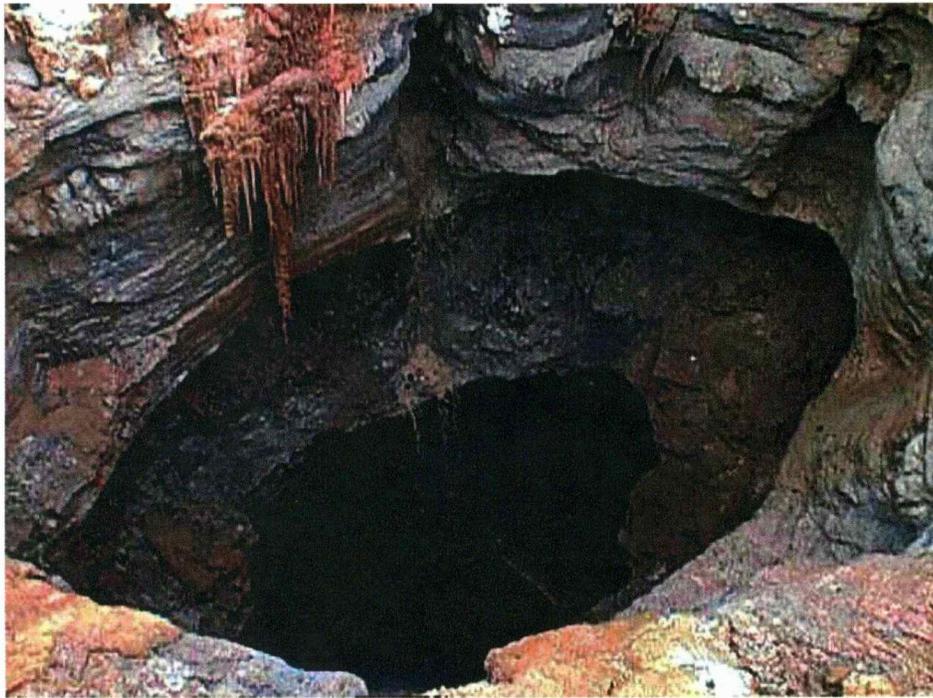
Figure 8.

With the base of the cribbing now facing up, rocks began to knock the timbers out of the box-section of cribbing. Within another half hour, most of the timbers were dislodged from the cribbing and fell one by one into the open shaft. Without the internal support of the timber, rocks sliding in off the sides of the shaft crater crushed the remaining sheet piling, causing it to fold up and fall into the shaft.

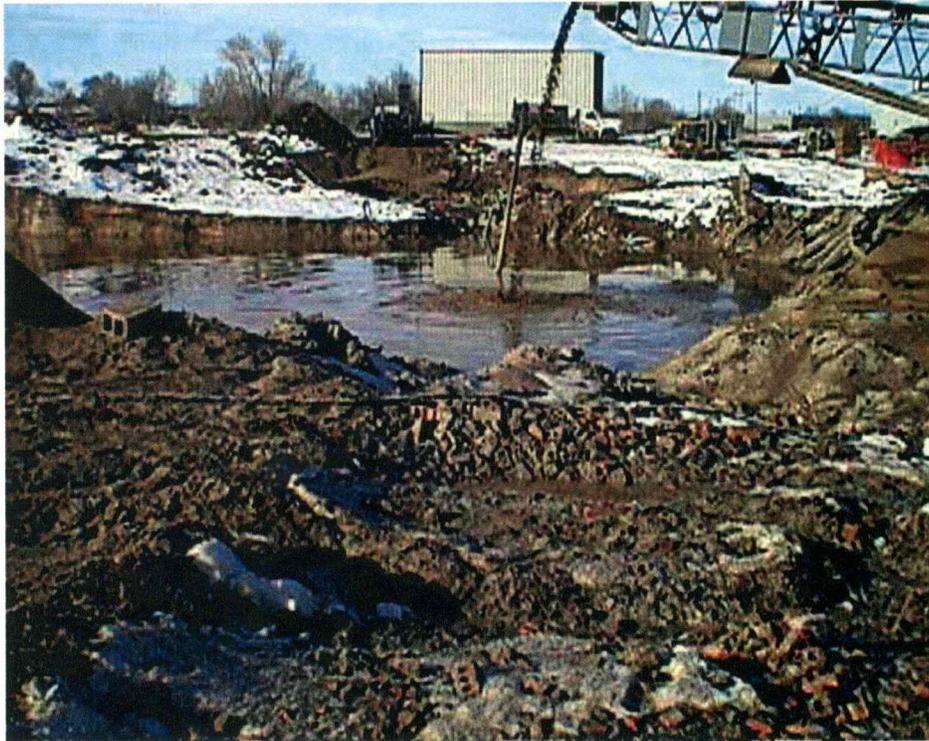
Figure 11.

Backfilling with the conveyor system continued until sand piles rose out of the crater pond. A series of sand piles was placed around the perimeter of the crater edges, for later grading into the pond (Figure 11). This final backfilling work in the crater was completed in February.
