# The Relationship Between Geology and Landslide Hazards of Atchison, Kansas, and Vicinity

Gregory C. Ohlmacher

Kansas Geological Survey, 1930 Constant Avenue, Lawrence, Kansas 66047

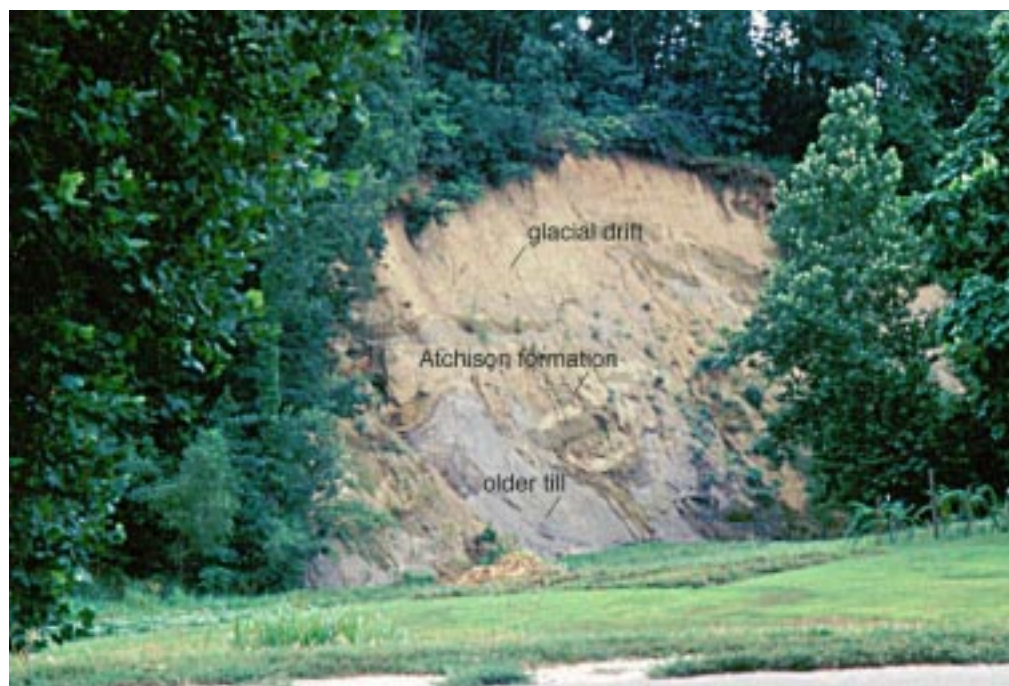
FIGURE 6. Exposure of the Atchison formation along White Clay Creek west of Atchison (SE NW sec. 10, T. 6 S., R. 20 E.). The older till and Atchison formation were deformed by the later glacial event that deposited the glacial drift. At this location, the drift is a younger till. For more information on this outcrop, see Aber (1991).

The Quaternary geology of the study area includes the Atchison formation (Moore et al., 1951), glacial drift, loess, and alluvium (Ohlmacher, 1999). An older glacial till (Frye, 1941) is exposed at stream level along White Clay Creek west of Atchison (fig. 6).

The Atchison formation is alluvium comprising tan to gray sand and gravel (table 1, fig. 6); it ranges in thickness from 0 to 24.3 m (0 to 80 ft). The unit is below the glacial drift and rests unconformably on bedrock and the older

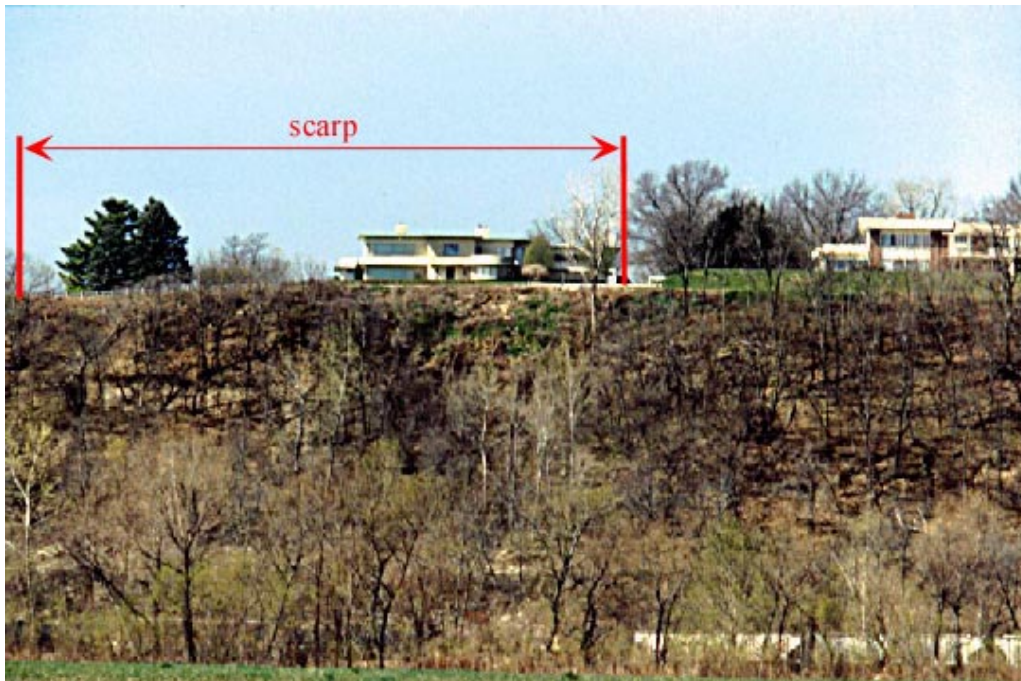
FIGURE 8. A recent landslide along Riverview Drive south of downtown Atchison (SW NE sec. 7, T. 6 S., R. 21 E.). The scarp (the surface break at the top of the landslide) is along the road at the top of the hill, and the toe (where material piles up at the bottom of the landslide) is at the base of the slope. The houses in the photograph are set back from the top of the hill and are not currently involved in the landslide.

Damaging landslides have occurred in the Atchison area. A 1997 landslide in the city of Atchison, along Riverview Drive (fig. 8), damaged the street at the top of the hill (fig. 9) and broke a sewer line along the base of the slope. This landslide has been active intermittently since 1959 (Zey and Ferguson, 1995). The houses visible above the landslide (fig. 8) were not affected by the landslide. Another landslide in 1997 occurred adjacent to a house. The house was not visibly damaged, but the scarp (the ground-surface break at the top of the landslide) was along the foundation of the house. Field mapping and aerial photographic interpretation revealed 145 recent landslides, along with rock-fall hazards and other landslide features.

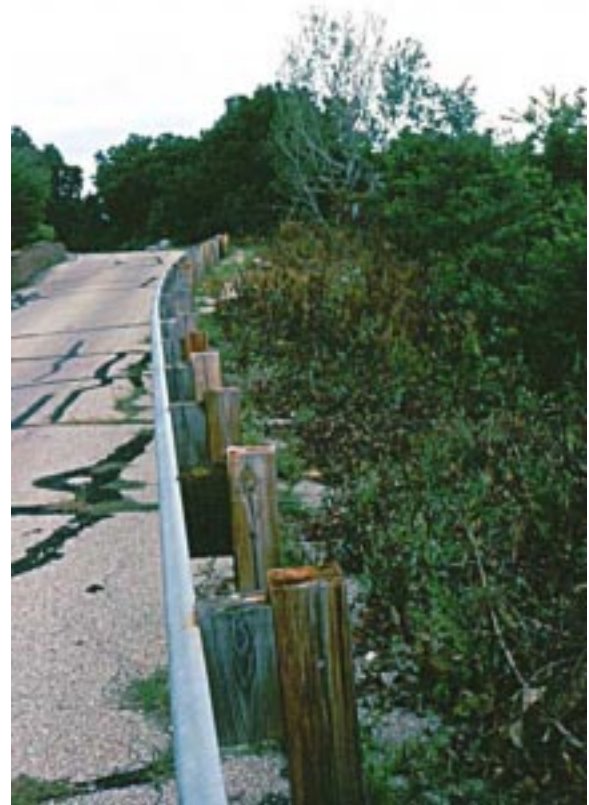
FIGURE 9. Scarp of the recent landslide along Riverview Drive (see fig. 8). The landslide has removed one lane from the street.

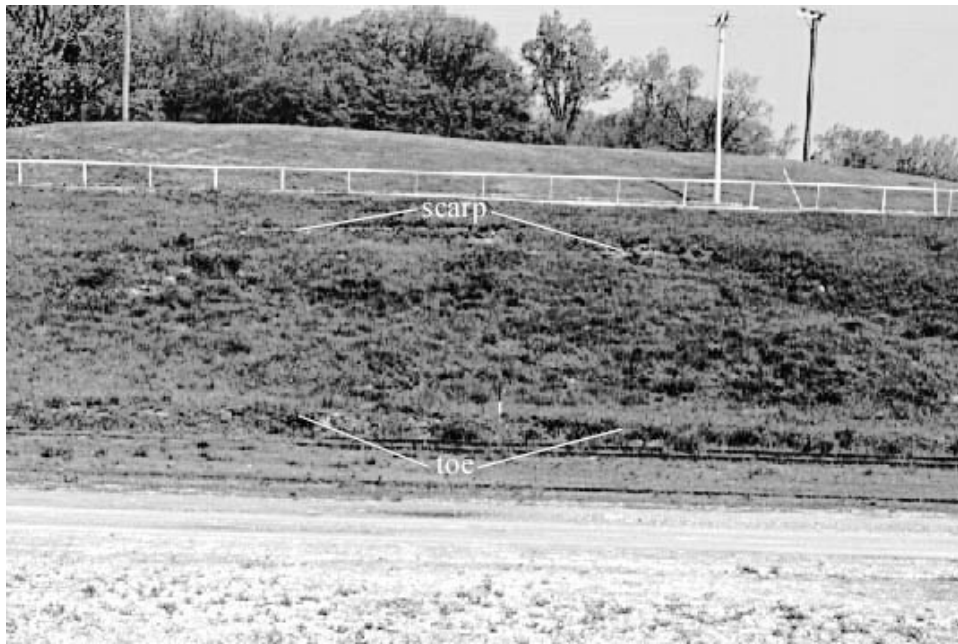
FIGURE 11. An earth flow at the U.S. Army underground storage facility in the south end of Atchison, Kansas (SW SE sec. 7, T. 6 S., R. 21 E.).

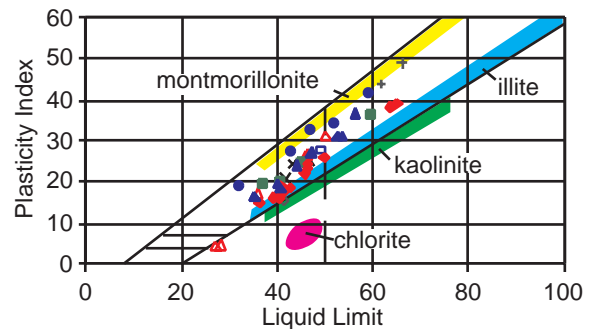
FIGURE 12. A plasticity chart showing the relationship of the soil samples to clay mineralogy. The figure includes samples from the Lawrence Formation (blue triangles), the Kanwaka Shale (red diamonds), the Tecumseh Shale (black open diamond), the Deer Creek Limestone (green squares), the Calhoun Shale (blue open squares), glacial drift (blue circles), the “Nortonville Clay” (black pluses), loess (red open triangles), and landslides (black crosses). The points where Atterberg limits plot on plasticity charts relate to the dominant clay mineralogy of the sample (Casagrande, 1948; Holtz and Kovacs, 1981). The Atterberg limits of the Atchison samples plot in the area between montmorillonite, a smectite clay, and illite, with some samples having more illite and others more montmorillonite.

The shale samples were subjected to a variety of soil analyses (table 3). They were analyzed for Atterberg limits—that is, the water-content boundaries between the semiliquid and plastic states (called the liquid limit) and between the plastic and semisolid states (called the plastic limit) (Jackson, 1997). Based on their Atterberg limits, most samples were classified as clays of low plasticity (CL) and clays of high plasticity (CH), using the Unified Soil Classification System (USCS) (table 3). CL and CH soils have the behavior of clays due to the minerals present but may not necessarily contain high concentrations of clay-sized particles.

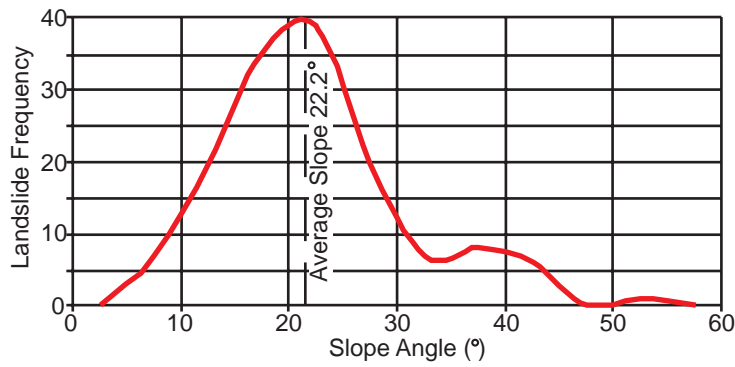
FIGURE 13. The frequency of recent landslides for a given slope angle. The frequencies were determined by counting the number of landslides for 5-degree intervals of slope angle. The average slope angle for recent landslides is 22.2 degrees.

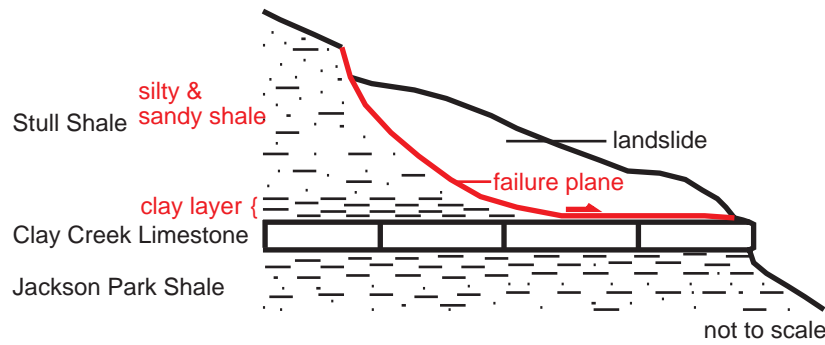
FIGURE 14. Diagram of the failure plane of a landslide in the Kanwaka Shale. The clay layer above the Clay Creek Limestone Member is weak, and the failure plane of the landslide would be located within this layer. Earth slides and earth flows on gentle slopes (5 degrees to 15 degrees) may be the result of thin, weak clay layers.

slides were mapped above the Clay Creek Limestone, placing the failure planes of the landslides in the 20-cm clay layer (fig. 14). As fig. 14 shows, the portion of the failure surface that runs through the clay layer has a very low dip. This and other thin clay layers may be controlling some of the recent landslides, including those on gentle slopes (5 degrees to 15 degrees).

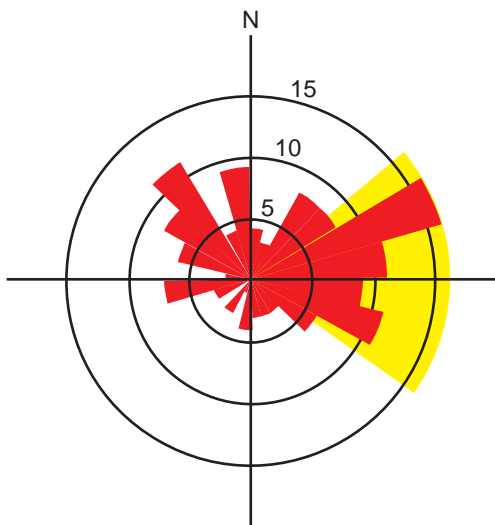
FIGURE 15. Rose diagram showing the slope lines for the recent landslides. Two maxima are observed in the data. The first is from northeast to southeast and is related to the bluffs of the Missouri River (yellow area in figure). The second is to the northwest and may be related to ground-water flow.

According to conventional wisdom, landslides are more likely to occur on slopes with slope lines to the north (north-facing slopes). The hypothesis is that less direct sunlight and slightly cooler temperatures lead to less evaporation and more moisture in the soils on north-facing slopes. Slope lines for the recent landslides are plotted in fig. 15. Two maxima are observed in figure 15. The first ranges from the northeast to southeast and coincides with the slope lines for the Missouri River bluffs (the yellow area in fig. 15). The second maximum is to the northwest.

This is partially due to the fact that Deer, White Clay, and Walnut creeks tend to flow along the southern side of their valleys, eroding the toe of the northwest-facing slopes. Ground-water flow may also contribute to landslides on slopes with slope lines to the northwest. Precipitation that infiltrates at the top of a hill migrates down until it reaches an impermeable layer and then flows above the impermeable layer to the face of the hill. An example of an impermeable layer is the clay layer above the Clay Creek Limestone Member (fig. 14). Bedrock in the study area dips very gently to the northwest and west (fig. 7). When ground water reaches the impermeable layer, it would flow to the northwest and exit on slopes with slope lines to the northwest, west, and north, increasing the susceptibility of these slopes to landslides.
