GULLY EVOLUTION IN THE UPPER DELAWARE RIVER BASIN
NORTHEASTERN KANSAS

Kansas Geological Survey
Open-file Report 93-34

A Thesis

In Partial Fulfillment
of the Requirements for the Degree
Master of Arts
University of Nebraska at Omaha

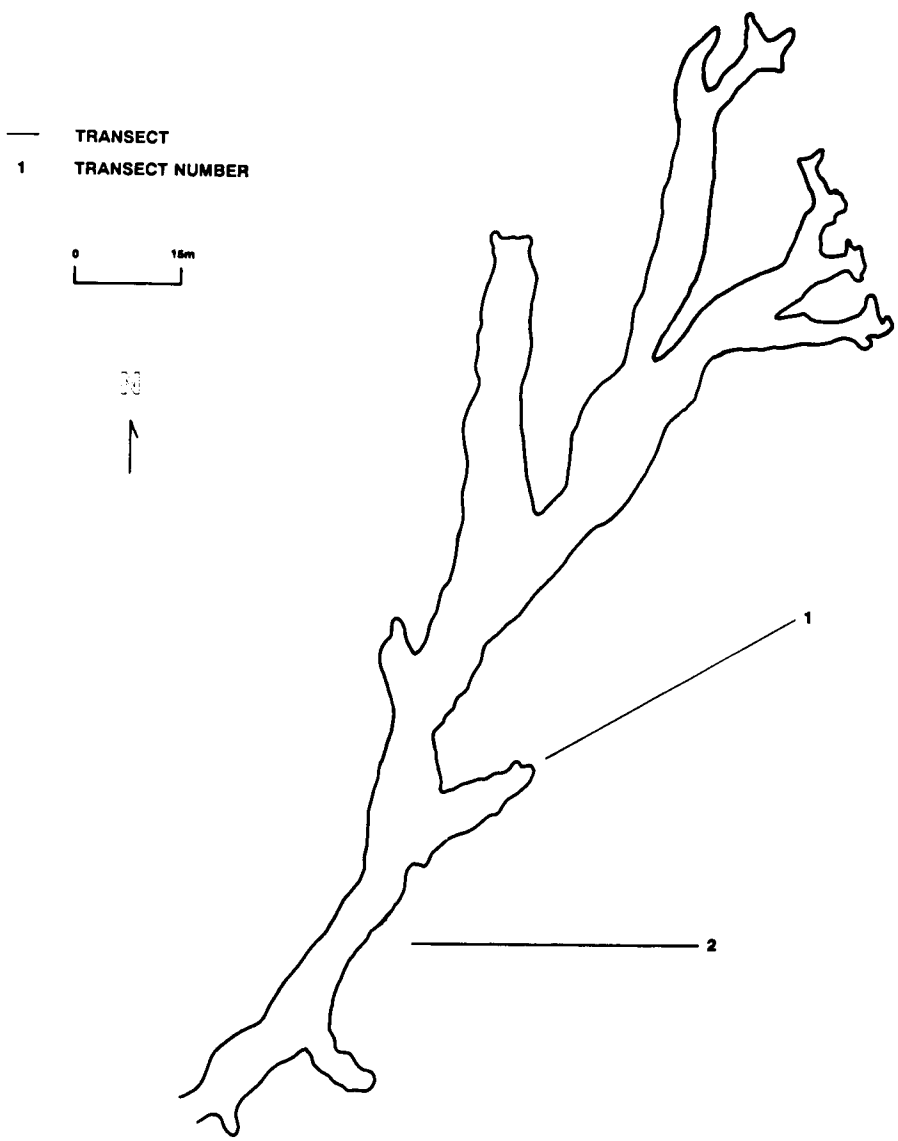
Figure 11. Plan view of gully showing location of biomass transects.

A 30 m transect was established upslope from HC 3,

and another 30 m transect was established between HC 2 and HC 3 (Figure 11). An 0.18 m² metal frame was randomly placed at three locations along the transect line. All plant species within the frame were clipped, bagged, air dried for two weeks, and then weighed. The total production was added and divided by three to determine the average production per transect.

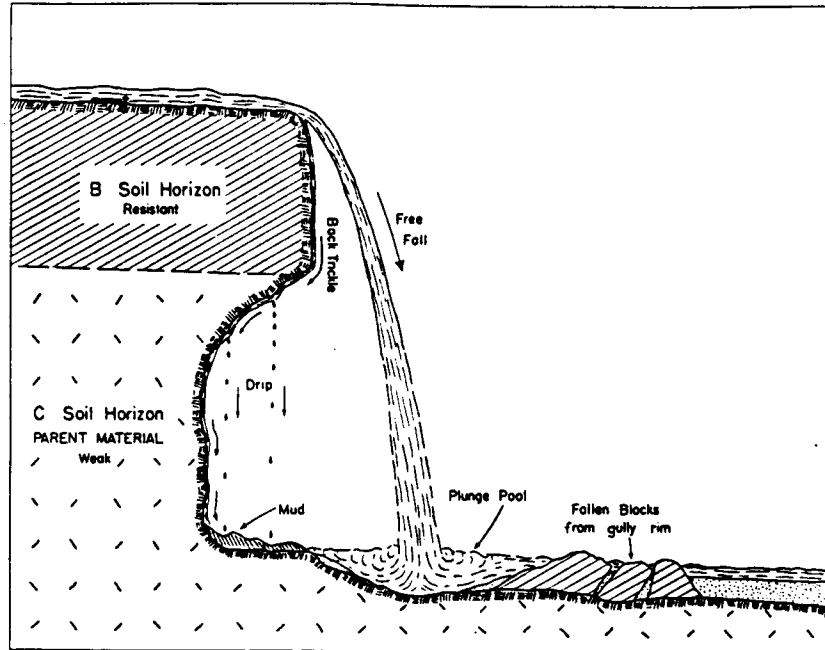
Figure 12. Gully plungepool (Ireland et al. 1939).

Ireland et al.(1939:48) and Brice (1966:333) noted that saturation at the base of headwalls is an important headward extension process. Base saturation often occurs in response to the effects of plungepools and waterfalls. Brice suggested that gullies cutting into loess-derived soils advance in response to plungepool action. Plungepools are potholes at the base of a headcut scoured out by water flowing over the headcut (Figure 12). Water in the pool aids in saturating the basewall, and loess erodes easily. In addition, water flowing over headcuts produce spray, which often wets headwall bases.

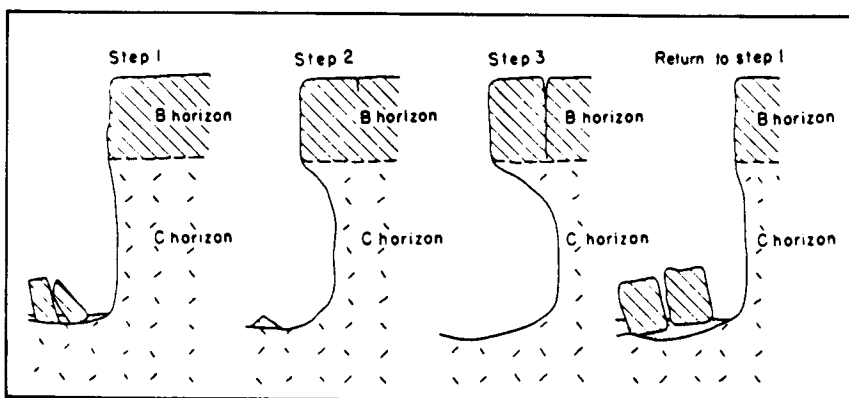
Figure 13. Steps in headcut retreat by gully-head caving (Ireland et.al 1939).

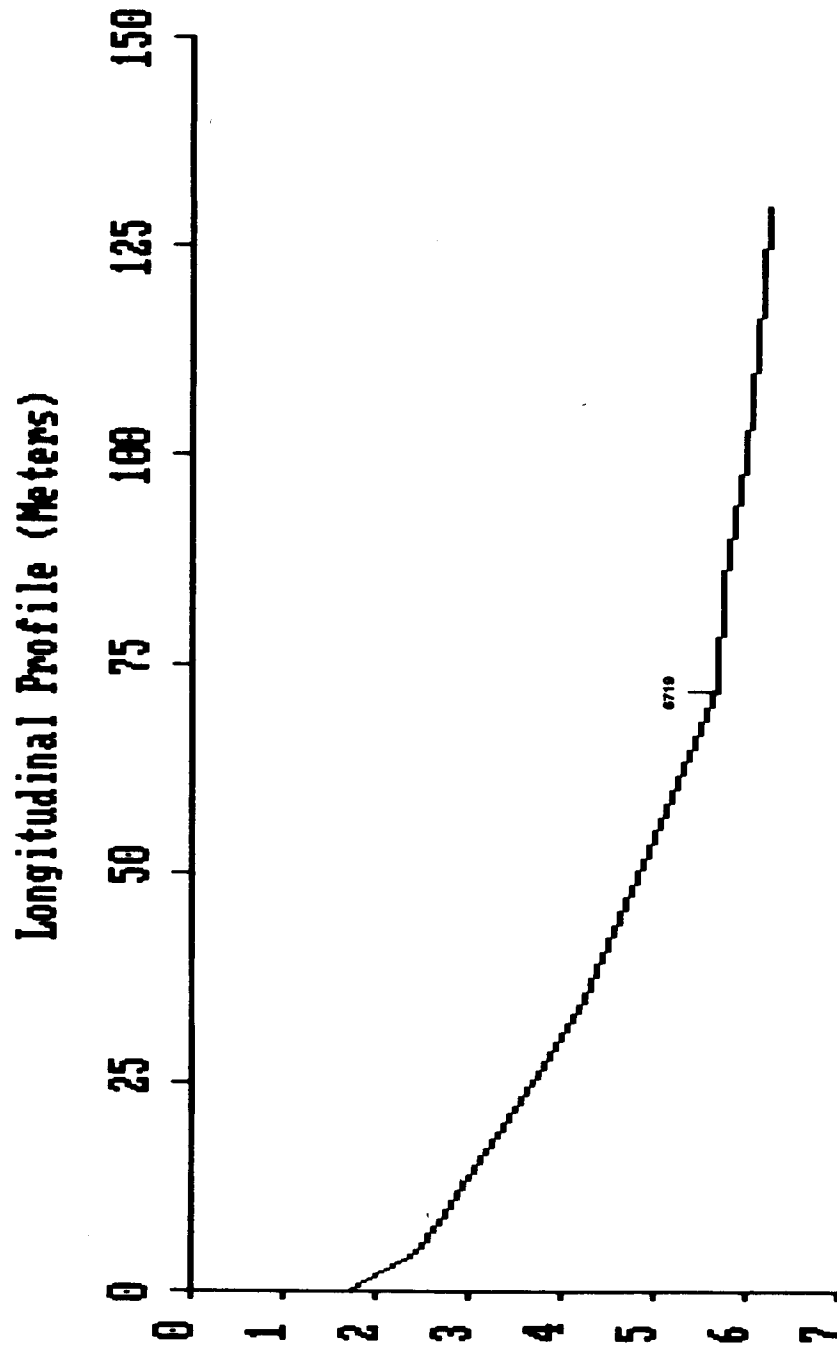
Figure 15. Decreased channel gradient at transect 6719.

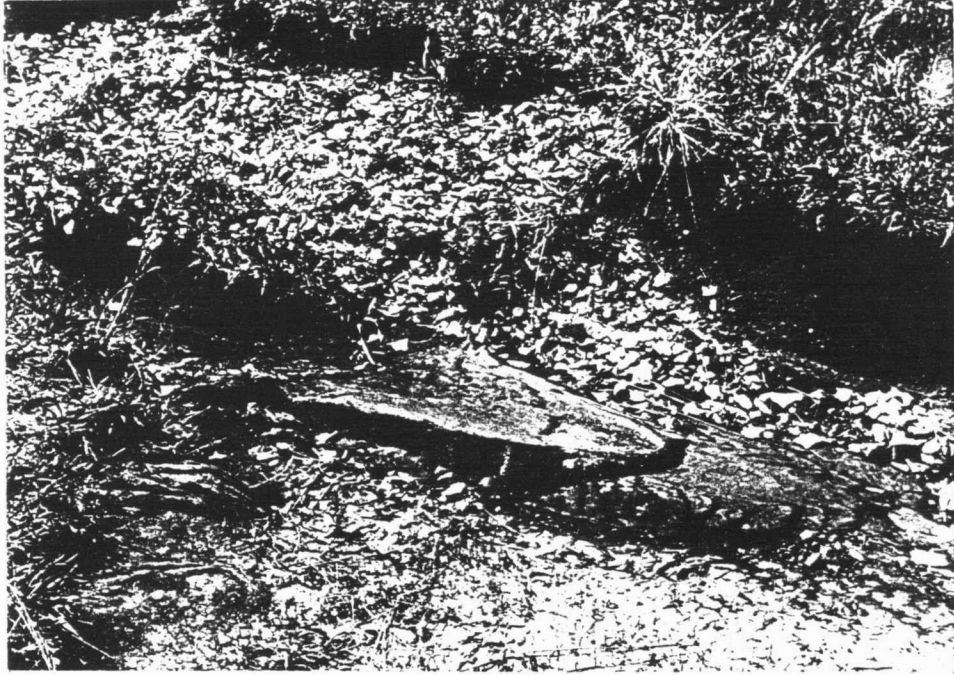
Figure 18. Photo of knickpoint in gully element 2.

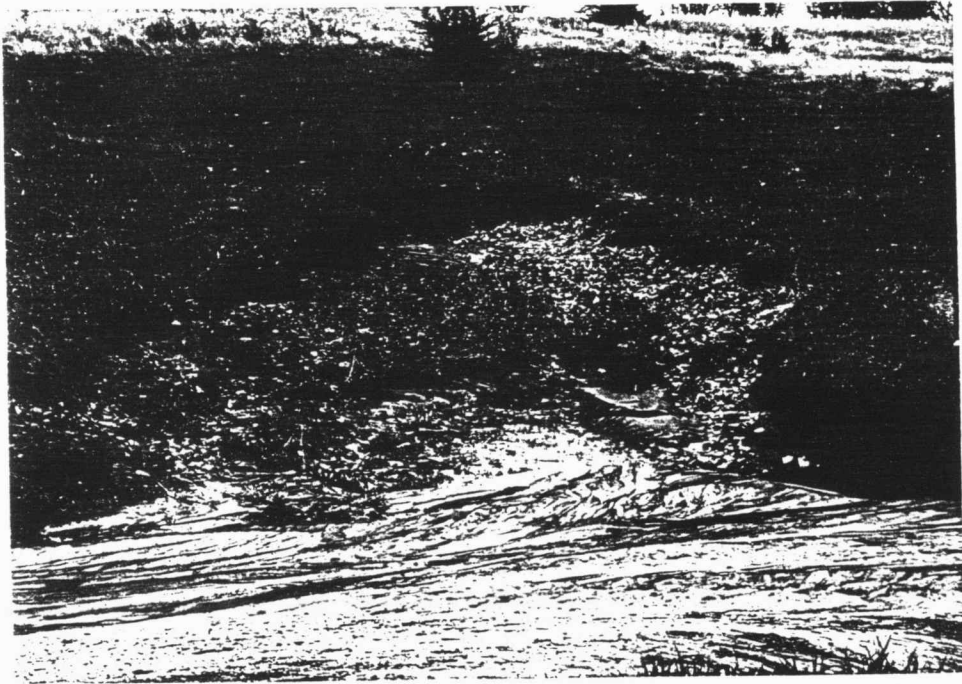
Figure 19. Photo of knickpoint in gully element 2.

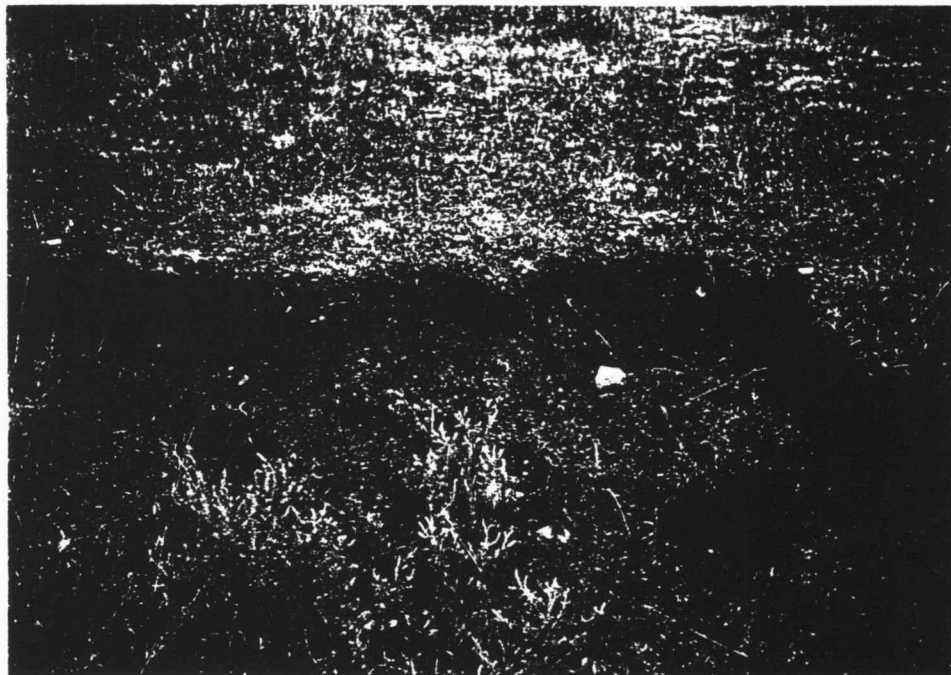
Figure 30. Photo of vertical shrinkage cracks extending down headwalls 3 and 4.

In some cases, shrinkage cracks may extend to the base

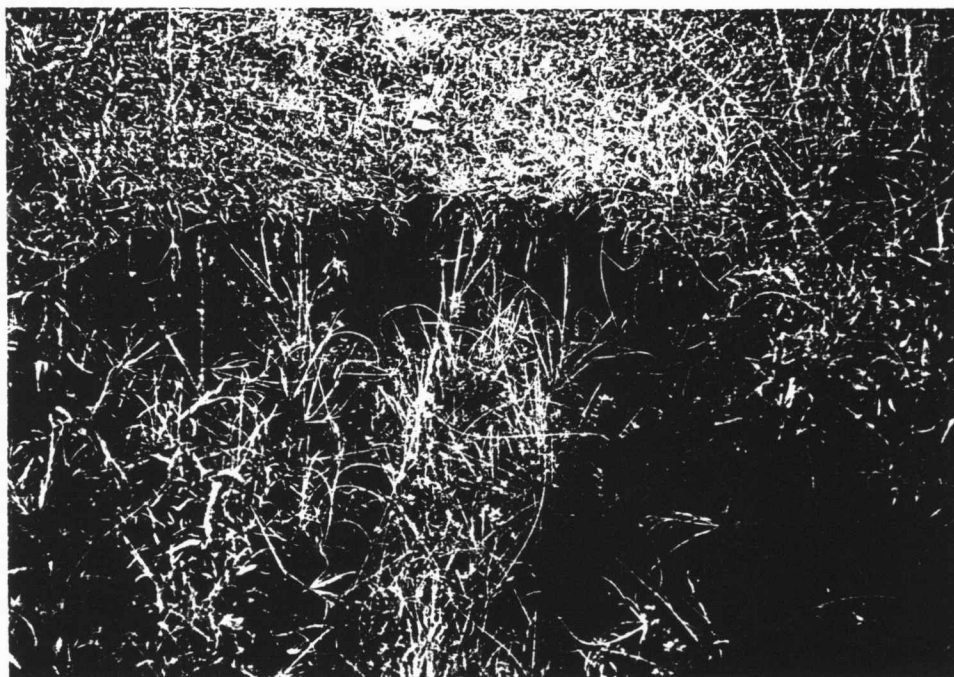
Figure 31. Photo of shrinkage crack extending away from headcut 13.

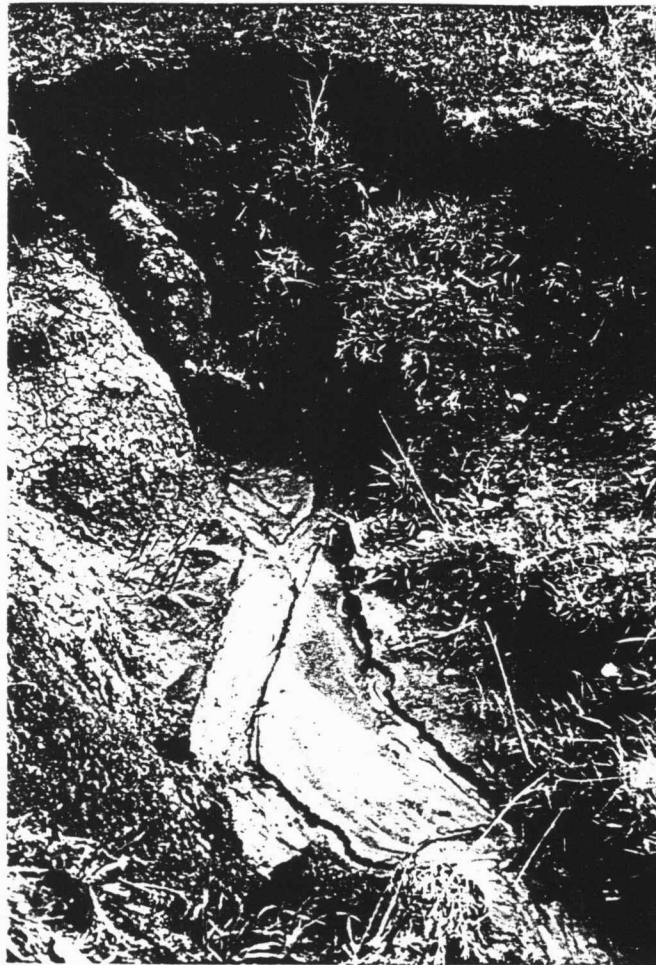
Figure 32. Photo of material toppling at headcut 14.

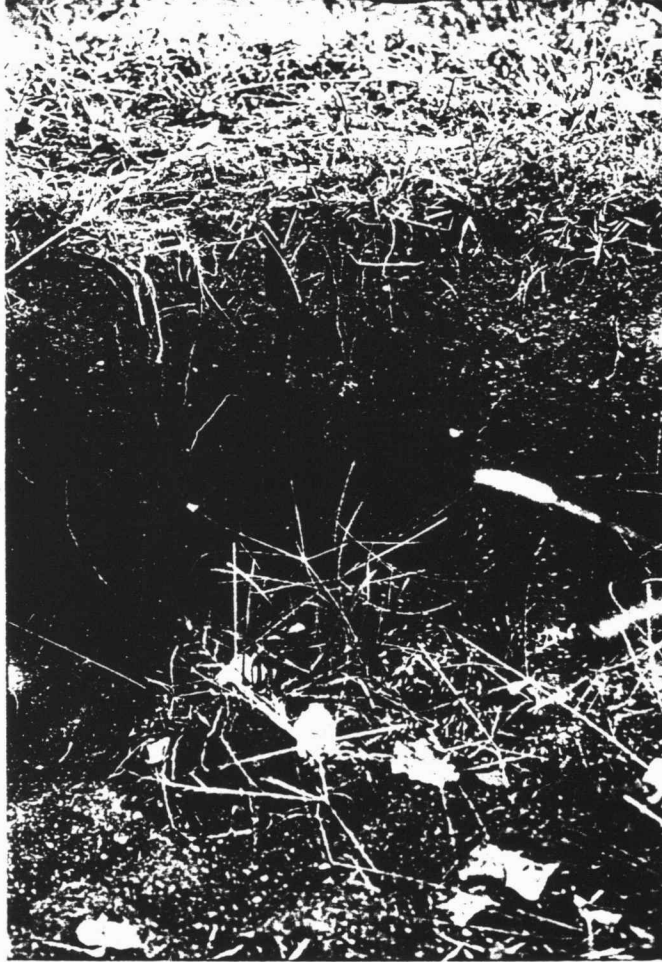
Figure 33. Photo of shrinkage crack extending to base of headcut 3.

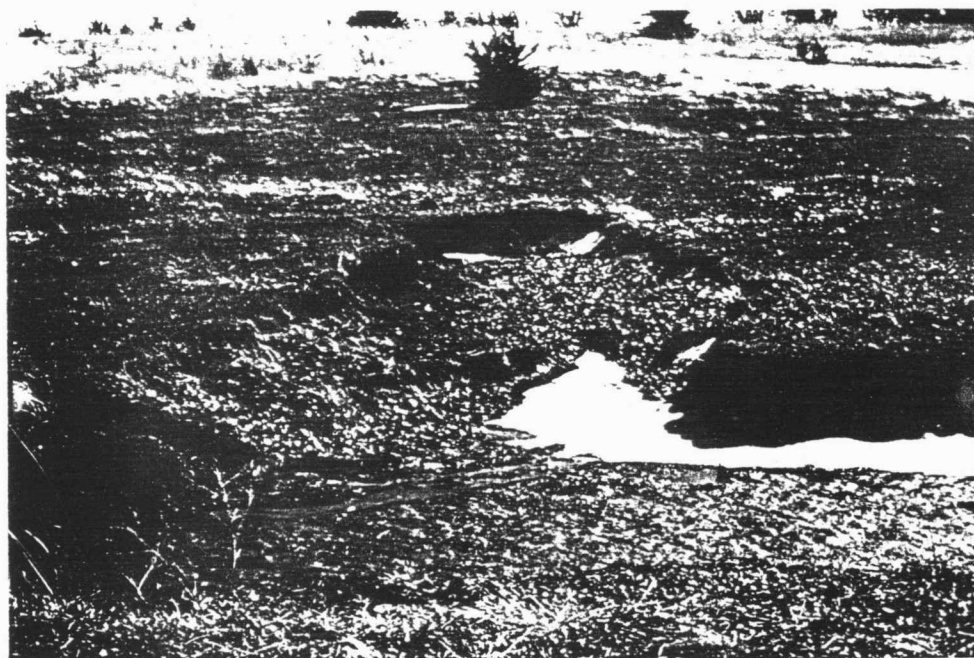
Figure 34. Photo of snow accumulating at the base of the headwall in gully element 2.

Saturation of headwalls also may be facilitated by the accumulation of rainfall and snowmelt in plungepools. Rainfall ponding in a small plungepool at the base of headcut 2 was observed numerous times during the monitoring period. Accumulated snow and ice near headcuts were also observed (Figure 34). Both conditions promote headwall failure by saturating headwall bases.

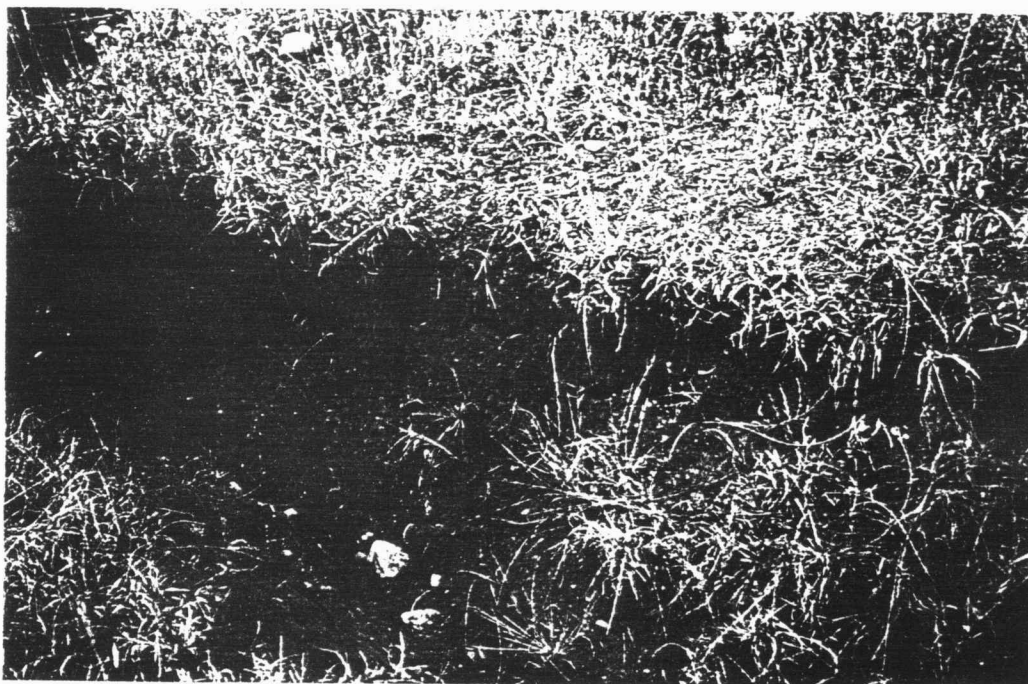
Figure 36. Photo of horizontal cracks along gully walls.

Based on field observations, wet/dry cycles contributed to slope failure during late spring and early summer. Slope failure occurred along horizontal shrinkage cracks that developed 10 to 22 cm below the surface along sidewalls

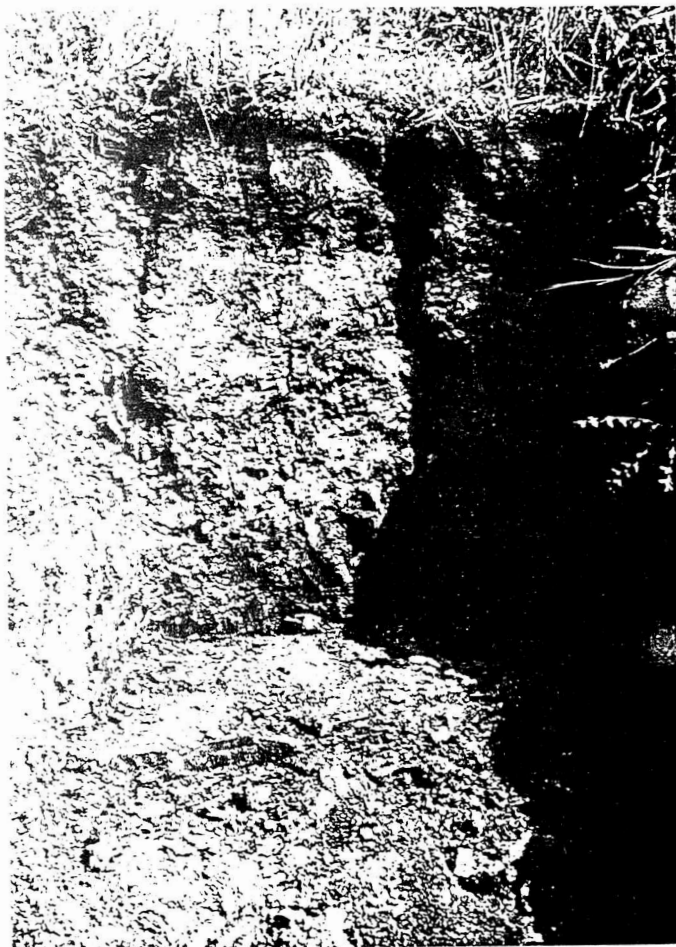
Figure 37. Photo of shrinkage crack 63 cm deep along
sidewall near reference point 44.

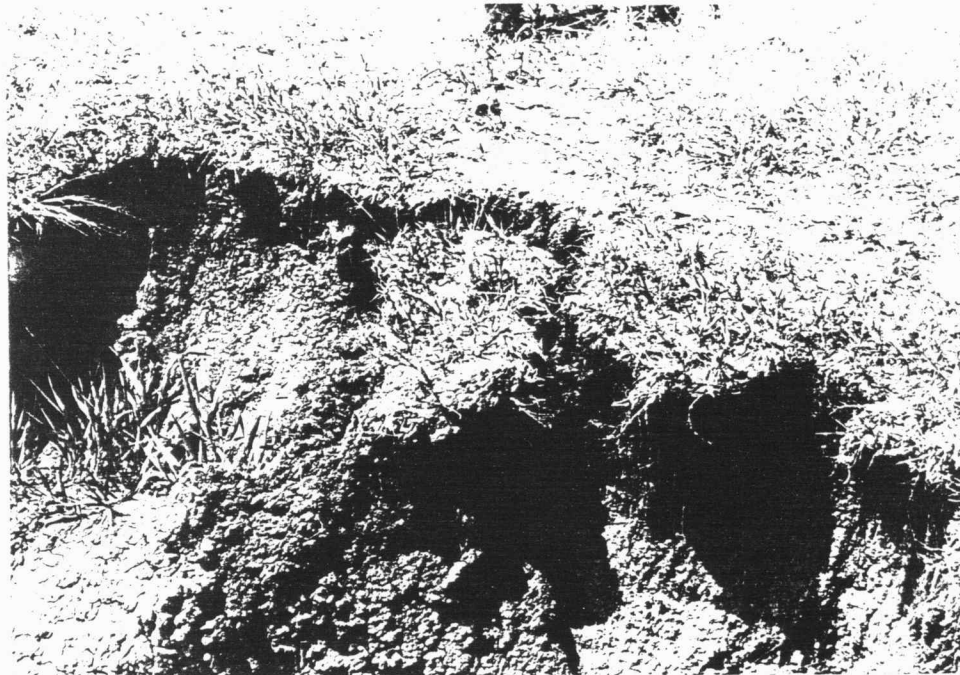
Figure 38. Photo of enlarged shrinkage crack separating soil mass from gully rim near reference point 65.

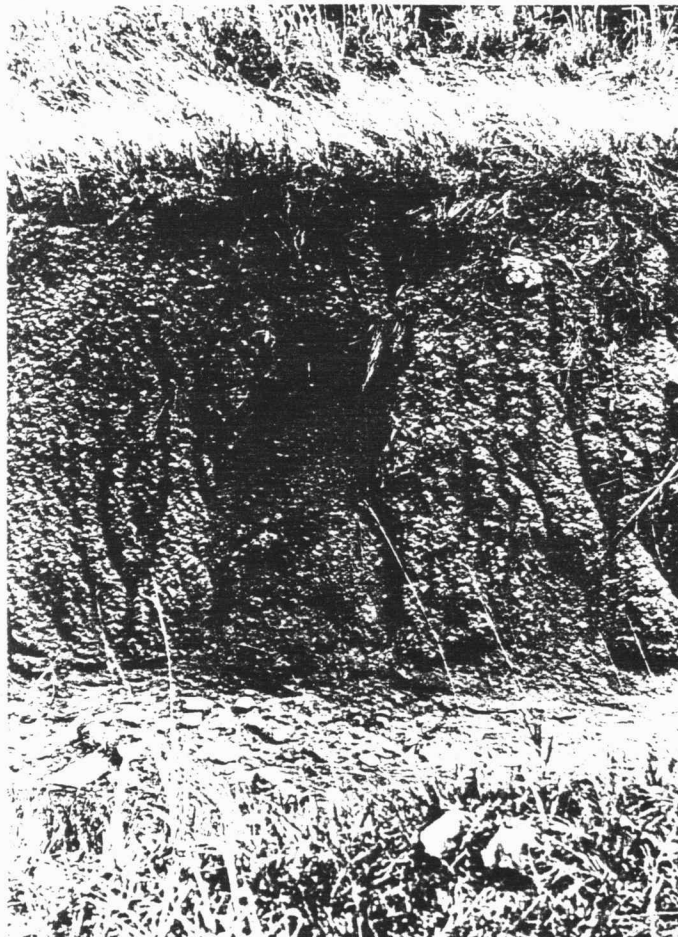
Figure 39. Photo of wall failure near reference point 44.

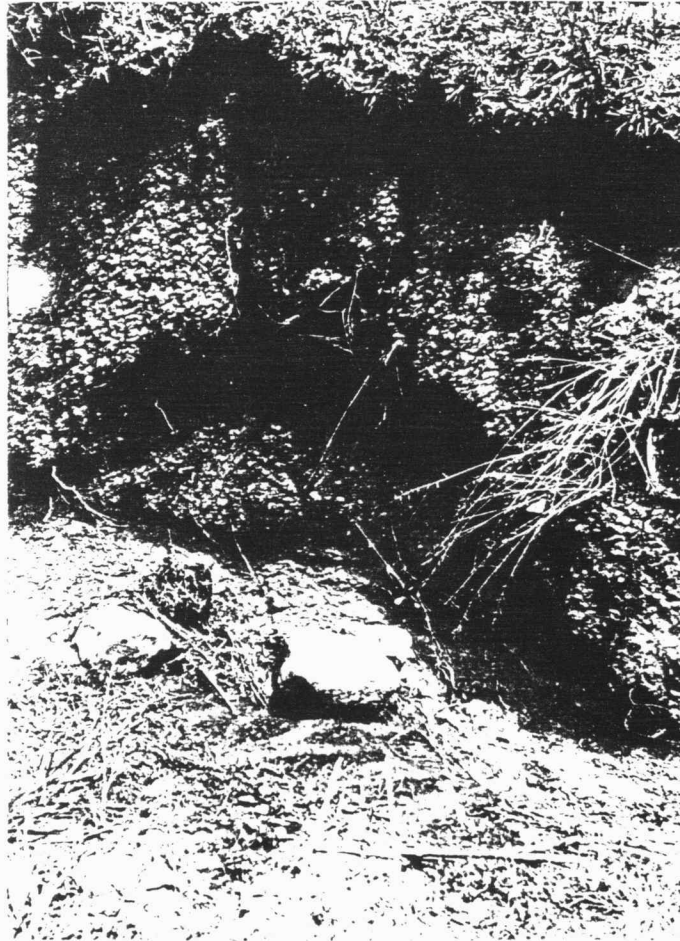
Figure 40. Photo of wall failure near reference point 47.

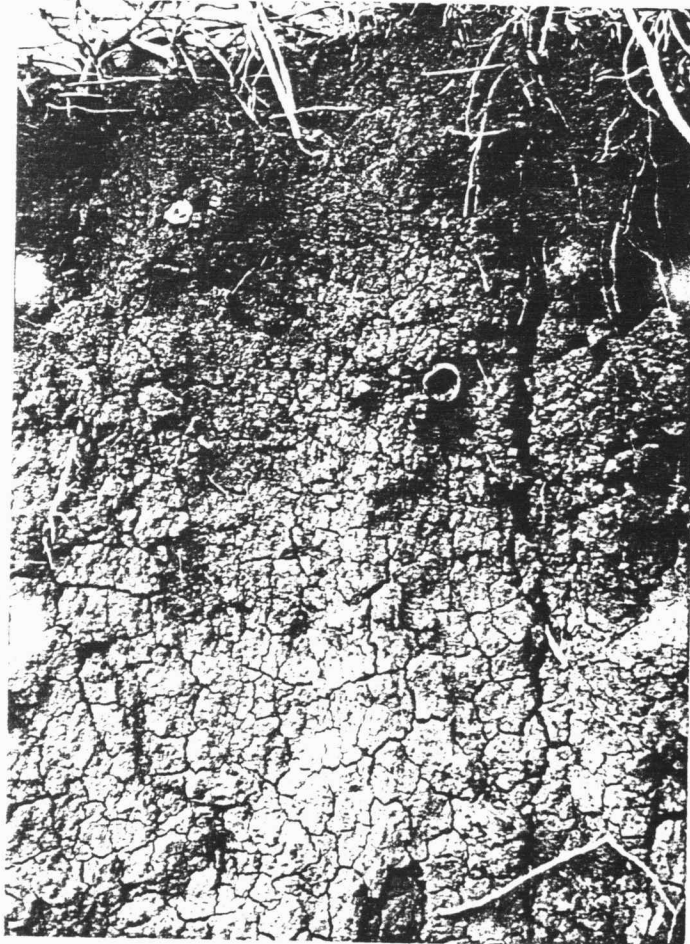
Figure 41. Photo of polygonal-shaped platelets on sidewall.

Wet/dry cycles also enhance gully widening. As the face of the wall dries after a rain event, it develops polygonal-shaped platelets (Figure 41). The platelets easily spall from sidewalls, and once detached, the material

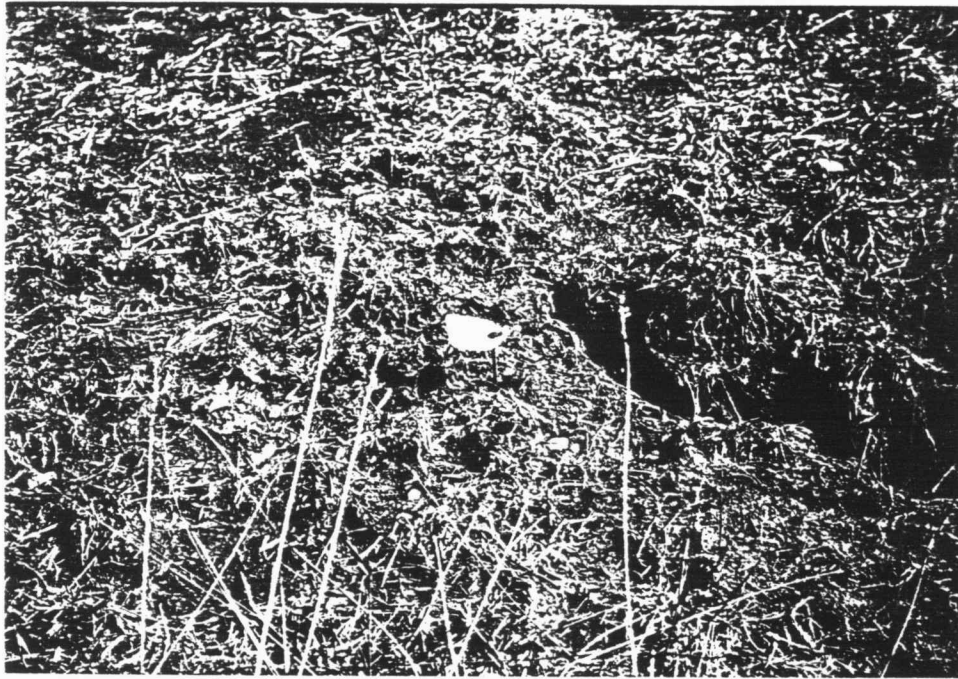
Figure 42. Photo of a reference tag elevated by frost heave in late winter.

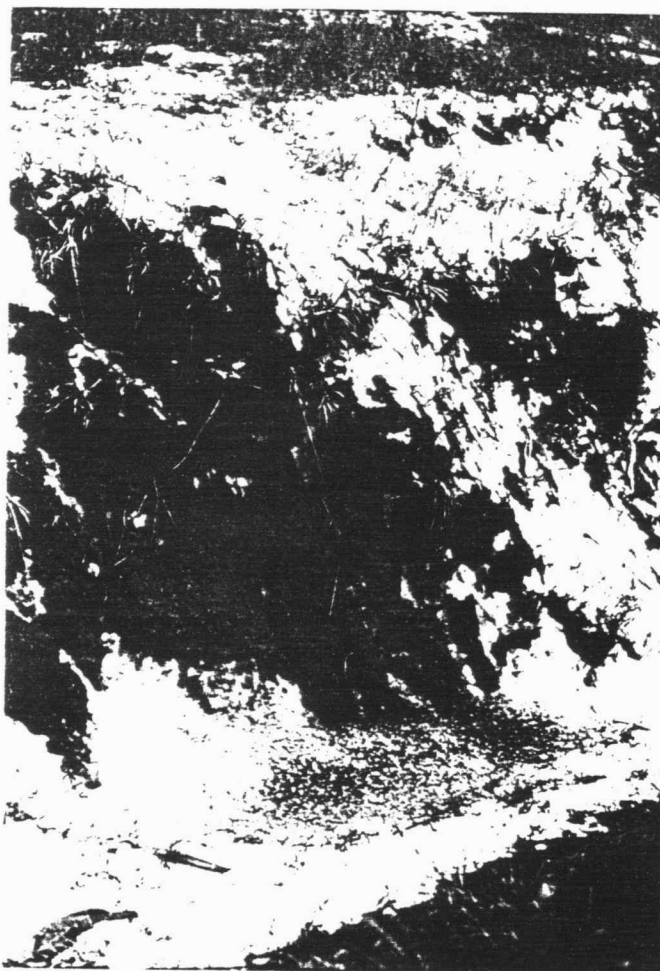
Figure 43. Photo of sediment from gully wall accumulating on toeslope during winter months.

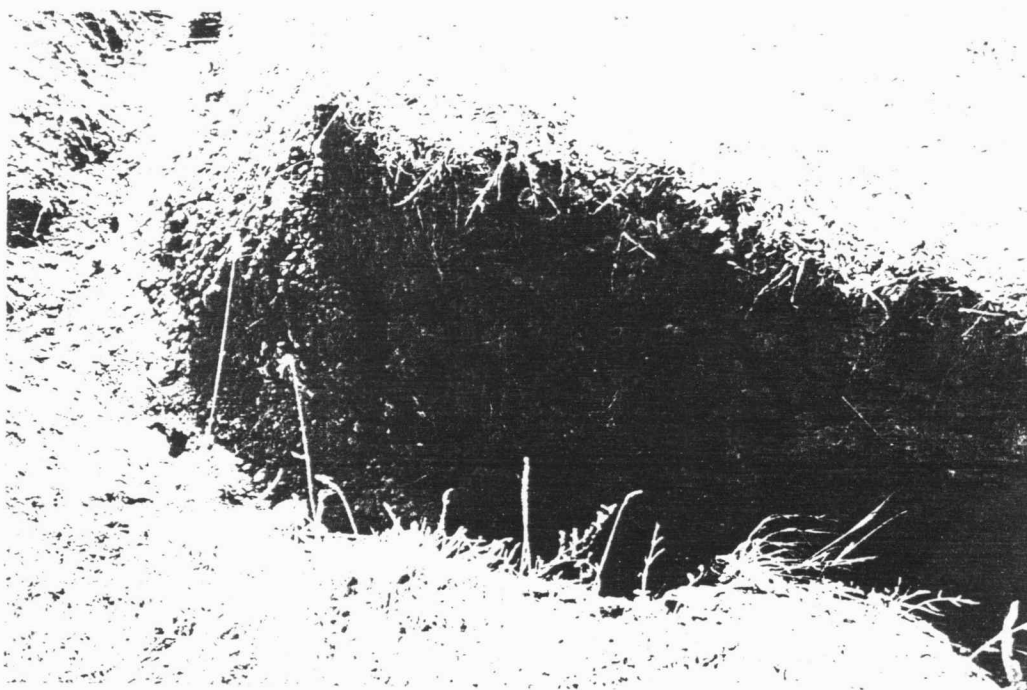
Figure 44. Photo of protrusions on sidewall due to soil drying.

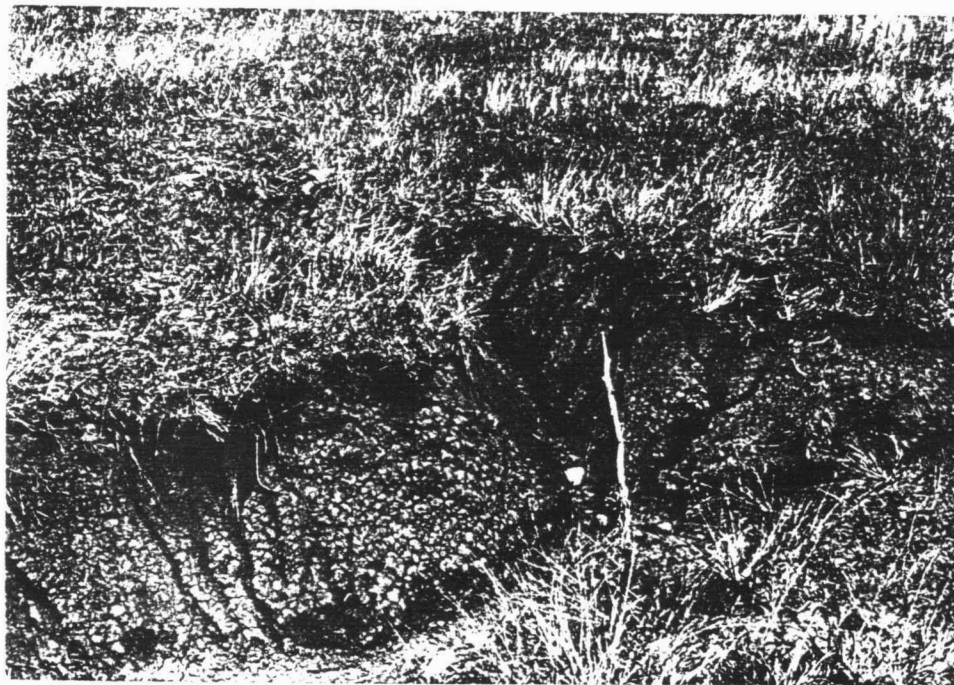
Figure 45. Dissection of sidewalls by rilling in upper reach.

Another process observed in sediment production was rilling. As rills dissected sidewalls, they produced soil debris and assisted in sidewall retreat (Figures 45 and 46). Rilling occurred throughout the site, but was more common on west-and north-facing slopes. Solar insolation is fairly intense on west-facing slopes, causing a reduction in vegetative cover. Reduced cover, in turn, enhances rilling. Also, since most summer storms track west to east across the

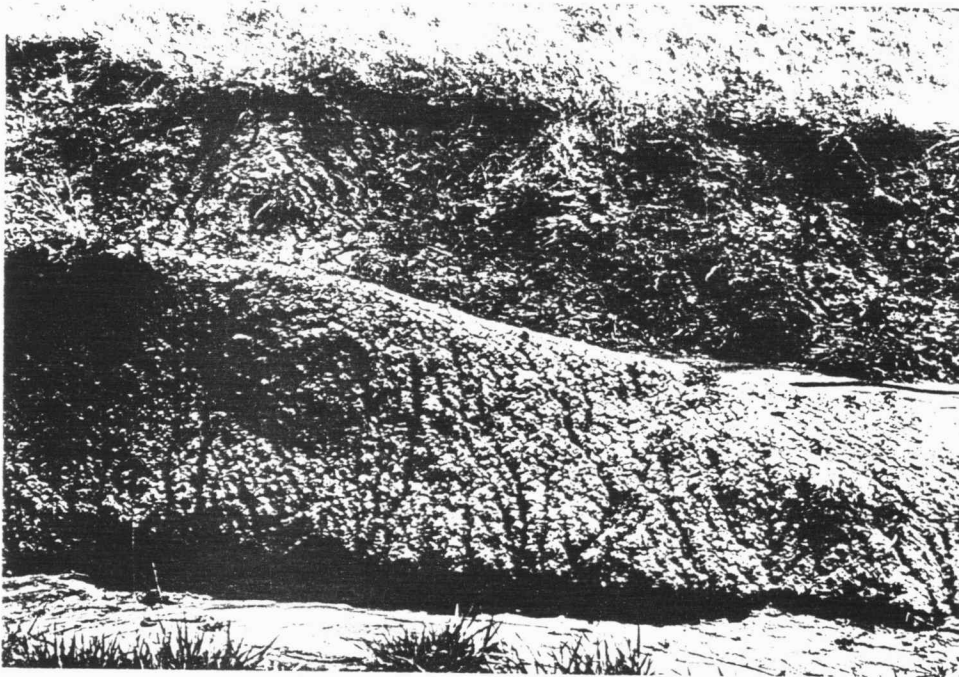
Figure 46. Photo of rilling and undercutting processes eroding sidewall in middle reach.

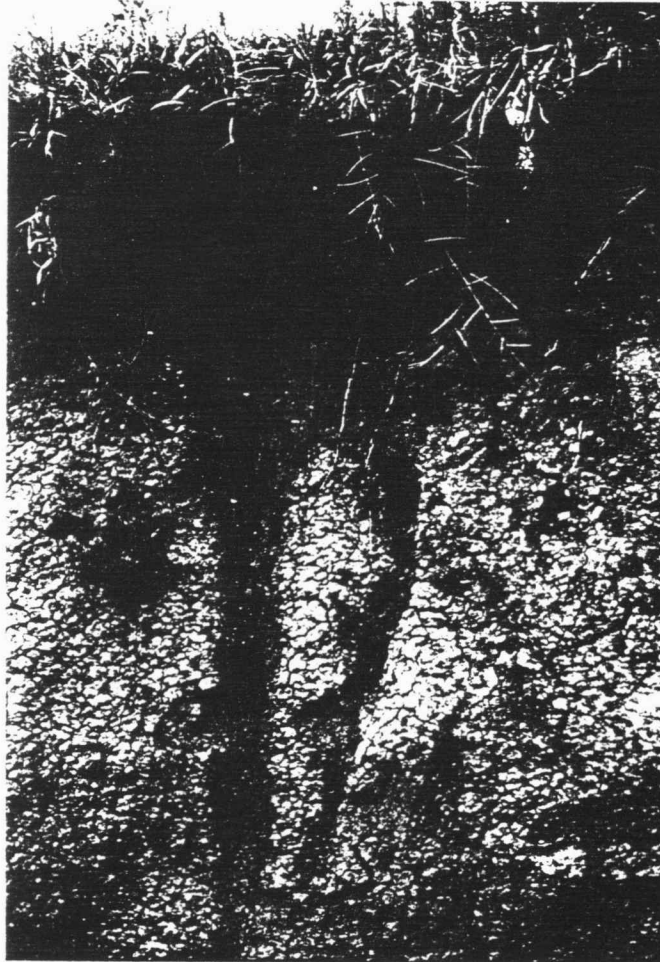
Figure 47. Photo of rills occurring below shrinkage crack.

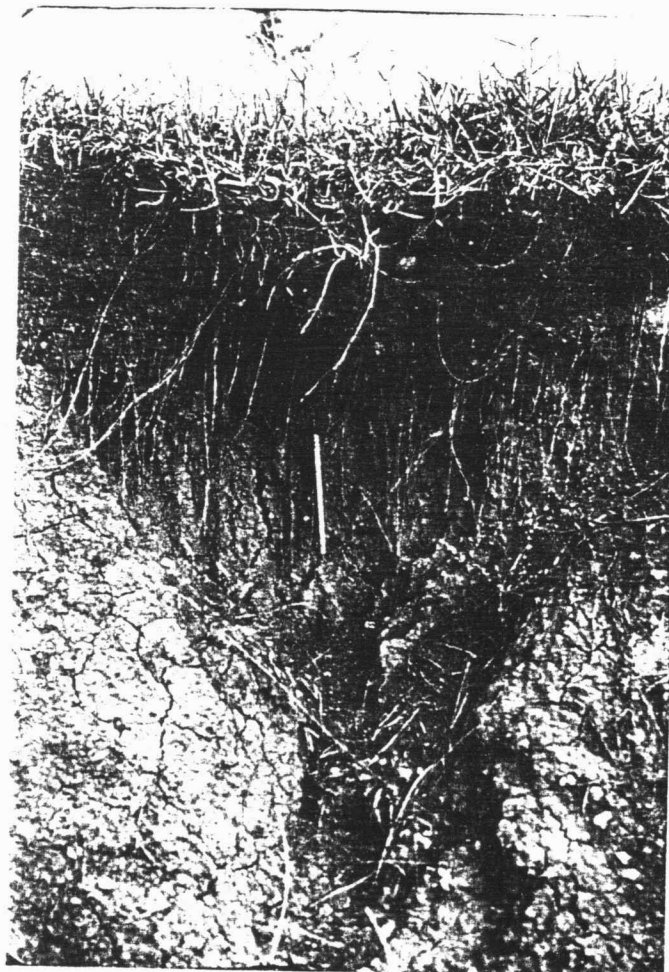
Figure 48. Photo showing coalescence of rills below sod.

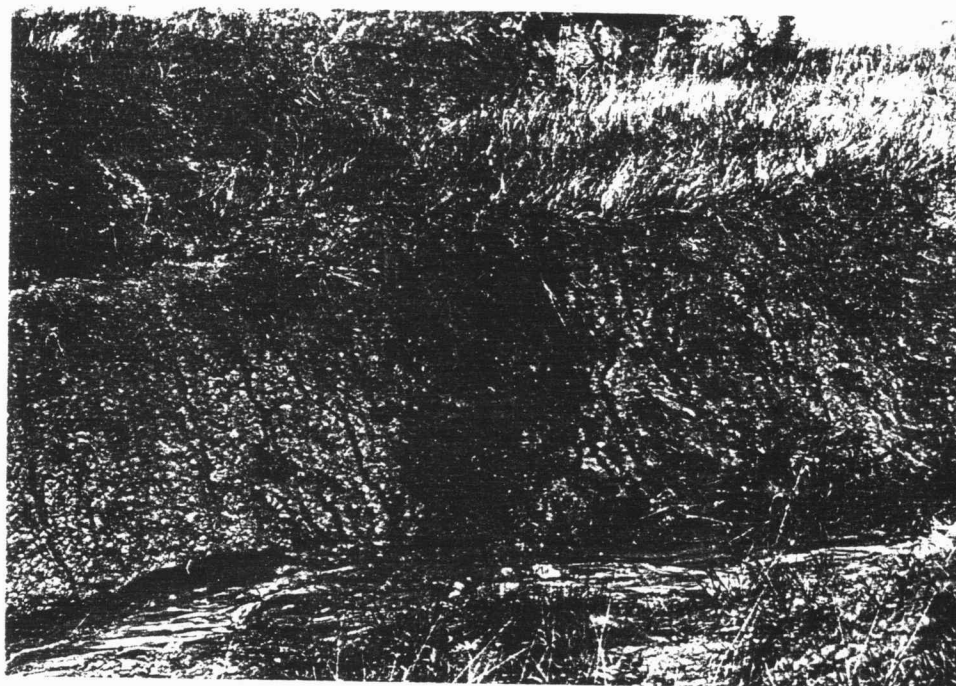
Figure 49. Photo of soil debris (center) brought downslope by cattle.

Headcut extension probably is encouraged by the formation of cattle trails. Several headcuts, including 9, 10 and 12, are advancing up what appear to be cattle trails. Cattle are noted for travelling along the same path; hence, cattle trails are often well developed, and are prime locations for channel development.

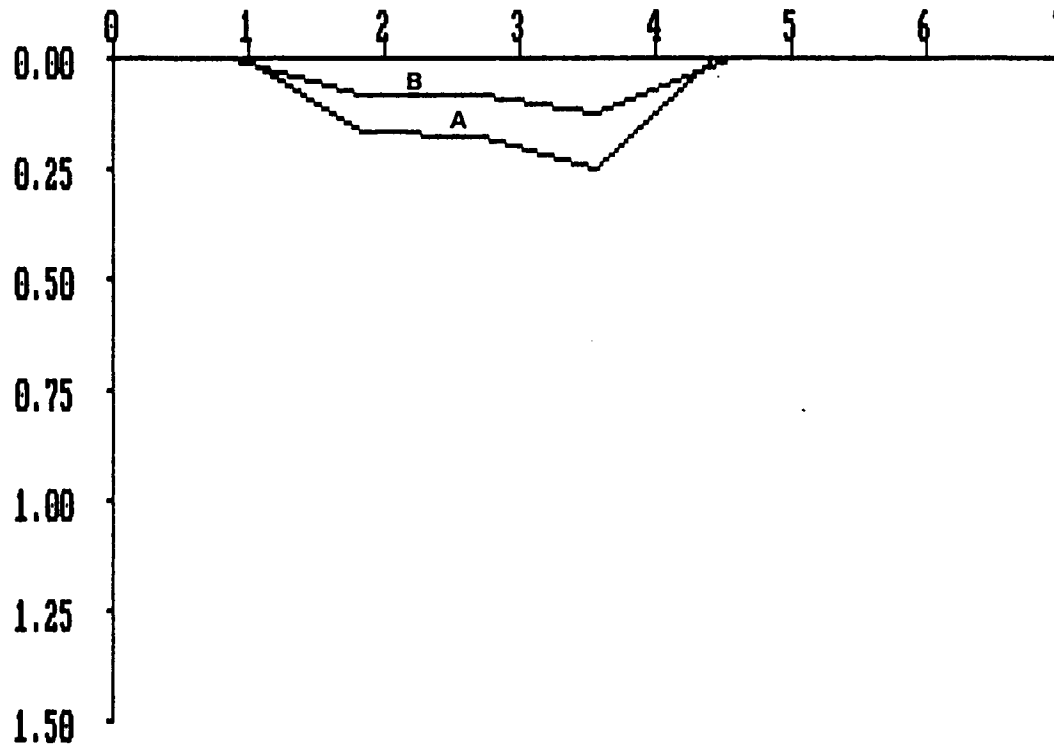
Cross-section Profile (Meters)
Transect Number 778 Section 'A' on 05:12:90 Section 'B' on 05:07:91

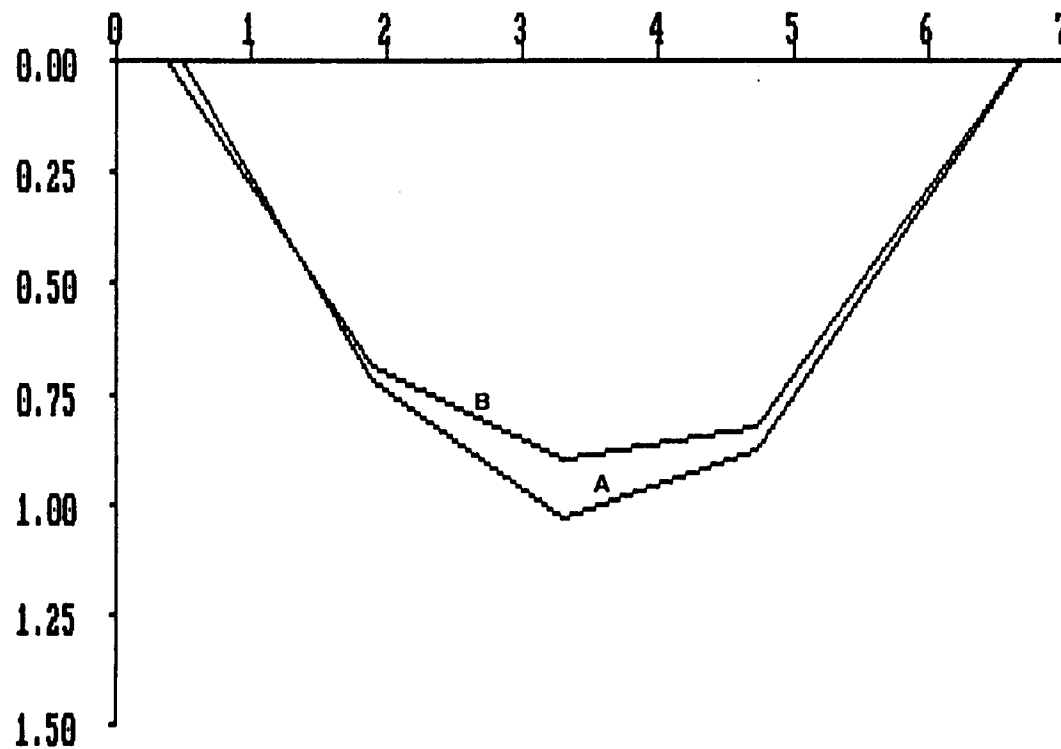
Cross-section Profile (Meters)
Transect Number 6719 Section 'A' on 05:12:90 Section 'B' on 05:07:91
